POST-WILDFIRE NATURAL HAZARDS RISK ANALYSIS OF THE 2023 MCDOUGALL CREEK WILDFIRE (K52767)

Dated:	January 4, 2024
Presented To:	Ministry of Forests – BC Wildfire Service
Attention:	Mr. Gareth Wells, P.Geo.
CGL Project #	23-0106
Version:	Final - Issued for Use

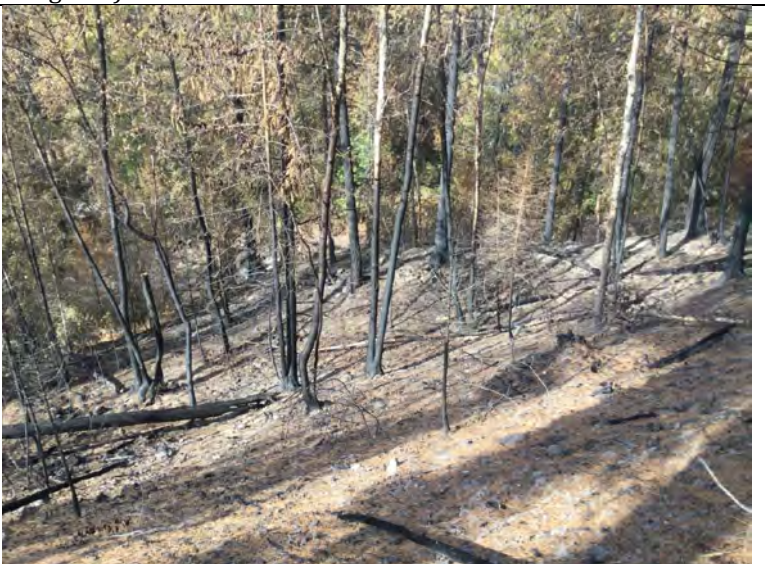
Photo 8: Moderate burn severity along riparian forest and adjacent slopes. Note scattered green canopy, needle cover mantling soil surface, and weak soil-water repellency (McDougall-5).

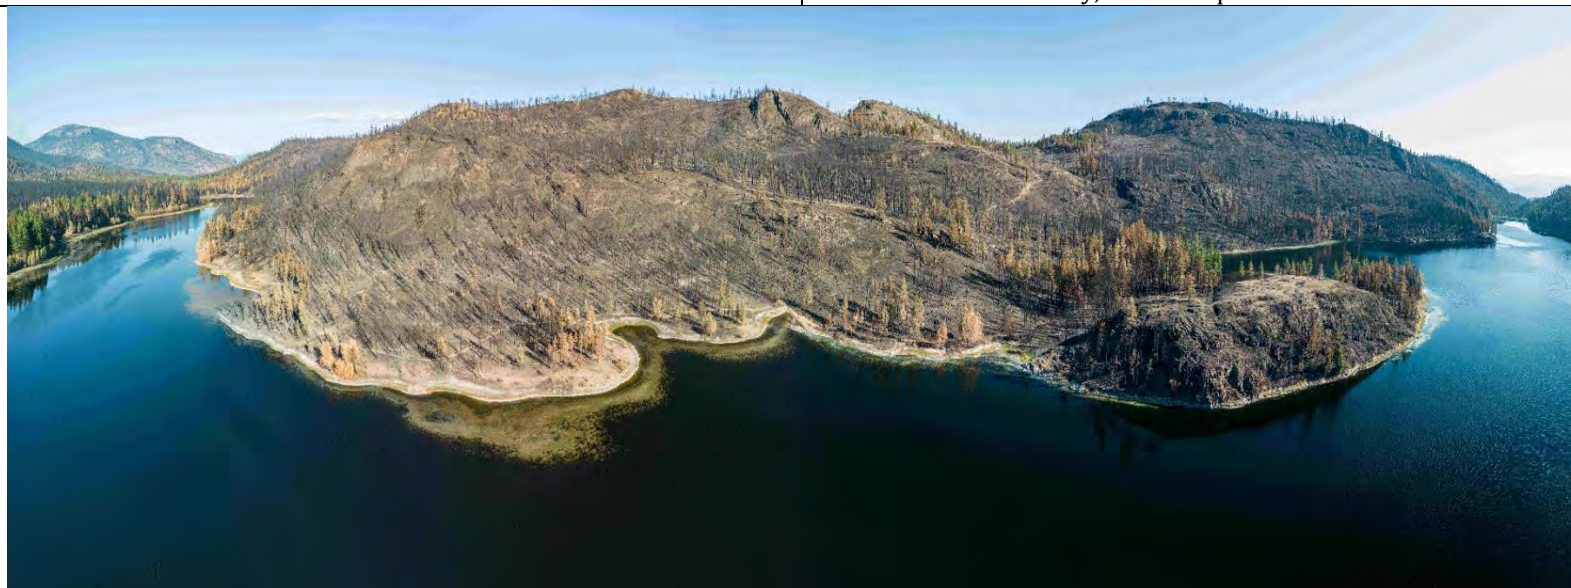
Photo 3: Panorama view of the burned slopes on the south side of the Rose Valley Reservoir. (Photo Credit: S. Wensley, Larratt Aquatic)

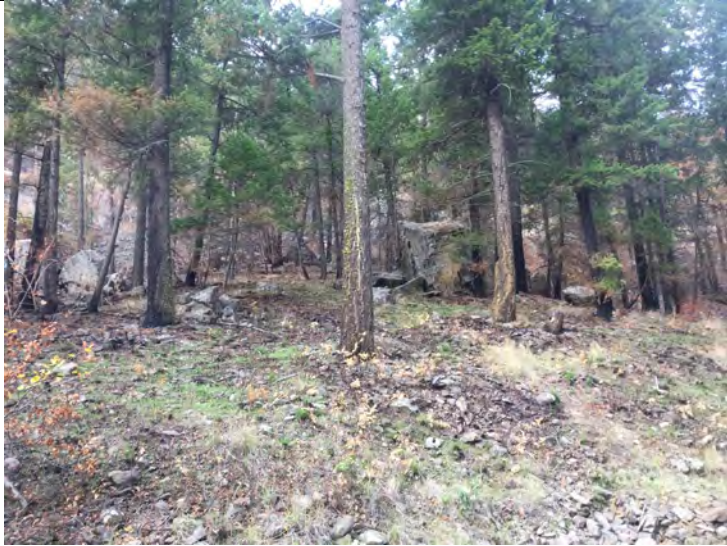
Photo 1: Upper Faulkner Creek along Rose Valley Dam Access Road – Pre-existing rockfall hazard along west side of road (Faulkner-1).

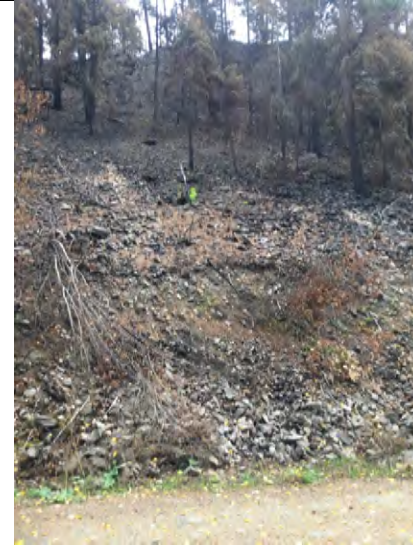
Photo 2: Upper Faulkner Creek along Rose Valley Dam Access Road – moderate to high burn severity along 250 m long section of steep colluvial slopes on east side constitutes increased rockfall hazard (Faulkner-2).

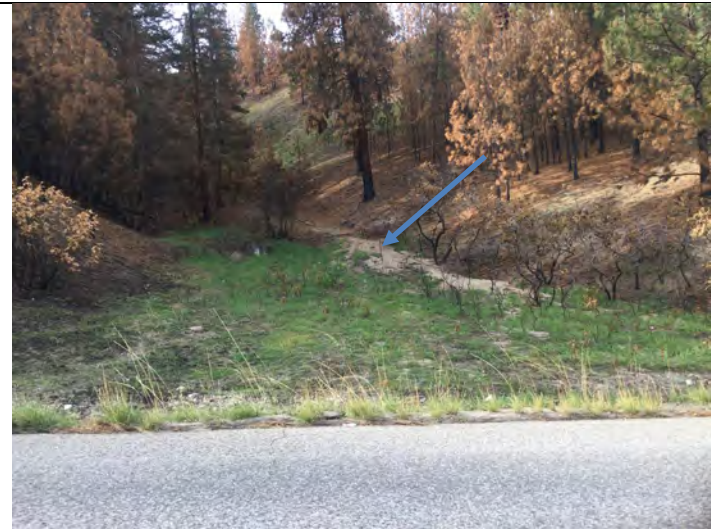
Photo 6: Burned gully, view upslope from Bear Creek Road. Note recent sediment movement in gully (arrow) (Keefe-2)

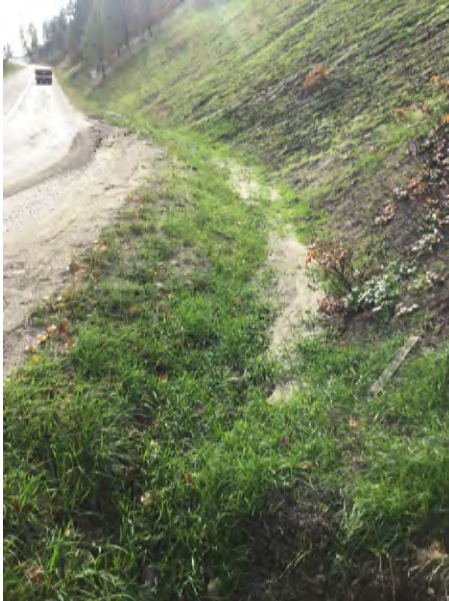
Photo 7: Sediment-filled ditchline along Bear Creek Road, at Westside Road (Keefe-3)

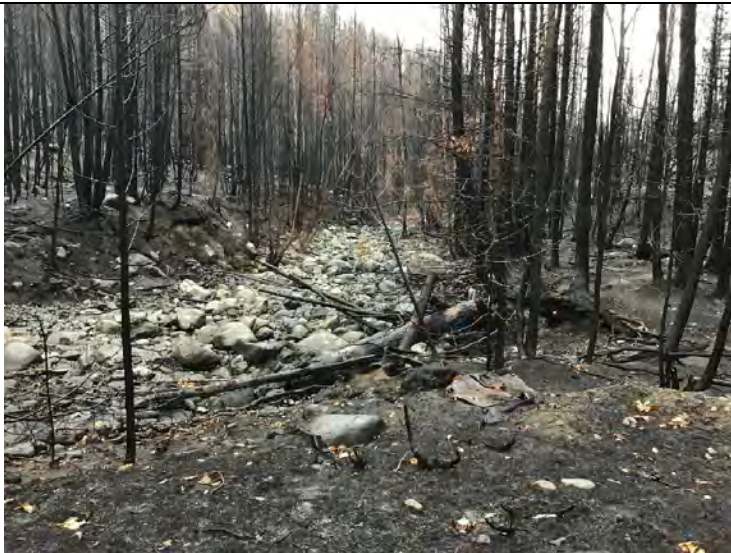
Photo 14: Lambly Creek channel downstream from diversion. Note undercut banks, abundant substrate sediment, and burned riparian forest (Lambly-8)

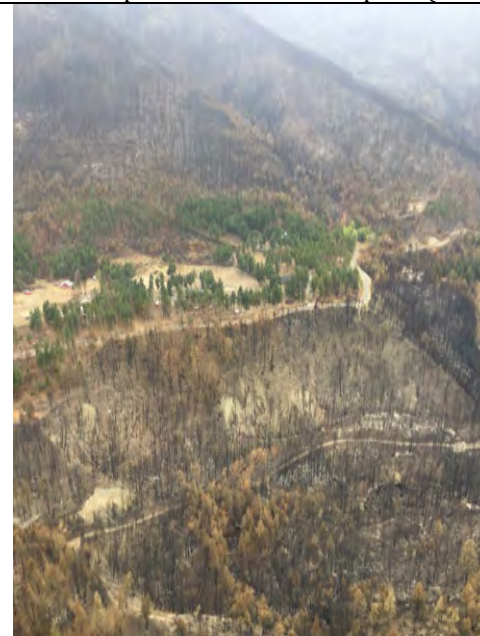
Photo 15: View of steep burned slopes below Bear Creek Road. Water pipeline ROW is visible along toe of slope adjacent to Lambly Creek (Bear Ck Rd-1)

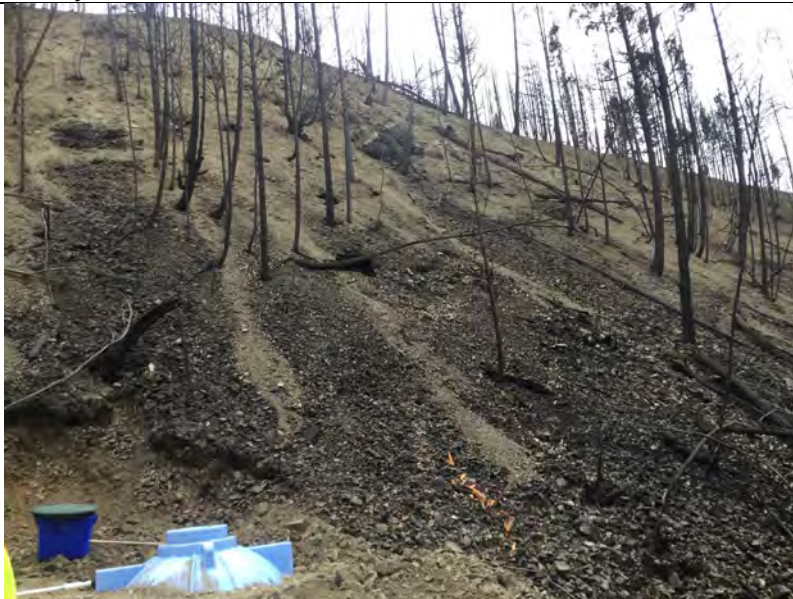
Photo 30: View of slopes adjacent to Cedar Creek Tributary, which is an ephemeral channel. Note small-scale soil erosion along slope (Cedar Trib-1)
