CLARKE GEOSCIENCE LTD.

POST-WILDFIRE ENVIRONMENTAL AND HAZARDOUS CONDITIONS ASSESSMENT OF THE NORTH WESTSIDE ROAD AREA

Dated:	February 23, 2022
Presented To:	Regional District of Central Okanagan
Attention:	Brittany Nichols, Environmental Planner
CGL Project # 21-0115	EOC #A21-674
Document Control:	Version Rev. 1 (corrected civic and legal property addresses for 3 properties)

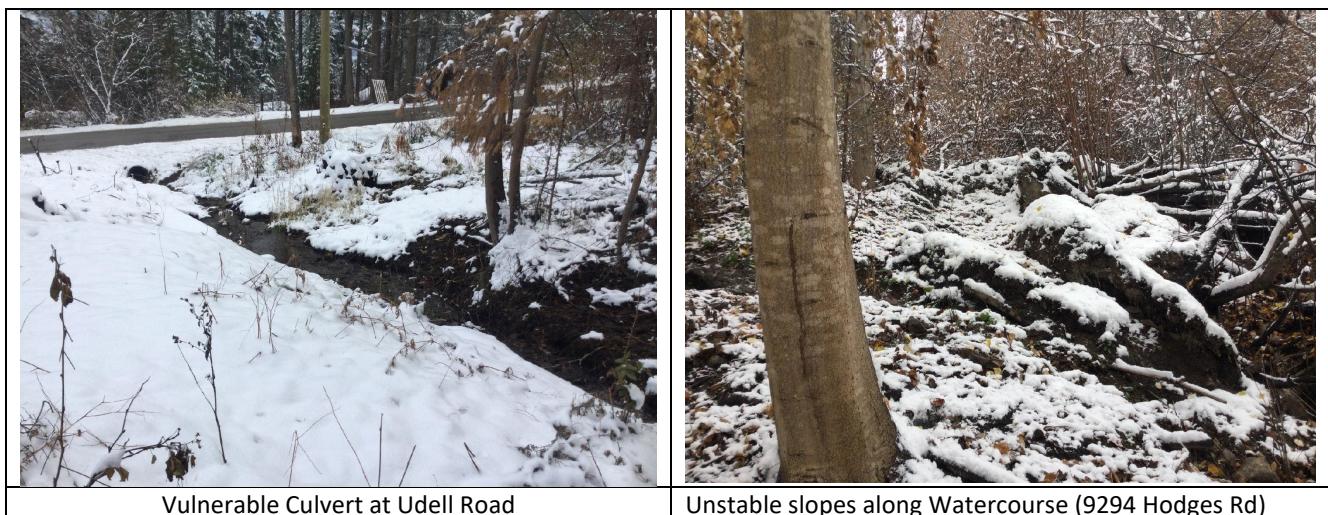
Figure 4-1: Vulnerable Culvert and Unstable Slopes in the Killiney Beach area

Because of the moderate to high hazard level associated with post-wildfire hydrologic effects and the close proximity to the water course (high spatial likelihood of impact), the risk is determined to be high to very high. The downstream property at 9294 Hodges Road has an elevated hazard (i.e., high) and risk (i.e., very high) because of observed soil slumping and instability along the stream channel (see Figure 4.1, photos). For these identified properties, increased peak flow runoff from the slopes above may result in a hazardous condition with the potential to cause damages to property and/or infrastructure.

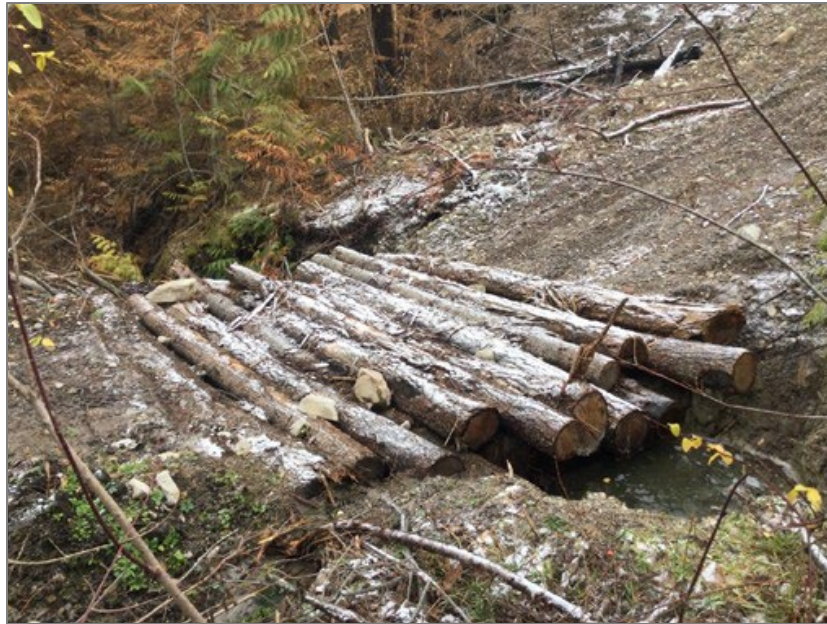
Figure 4-2: Woody Debris within Channel at Fireguard Crossing on Norris Creek

1. A fireguard crossing on Norris Creek, located south of the Killiney Beach area and accessed off the end of Winchester Road. Logs placed in the channel to facilitate fire suppression efforts through the area constitute a hydrologic hazard that may potentially impact properties downslope (see Figure 4.2, photo). The site conditions were communicated to staff at the Ministry of Forests, Lands and Natural Resource Operations and Rural Development (Shuswap Okanagan Forest District office) for rehabilitation. It is recommended that the logs within the channel be removed and the fill material along the banks be pulled back to a stable angle.

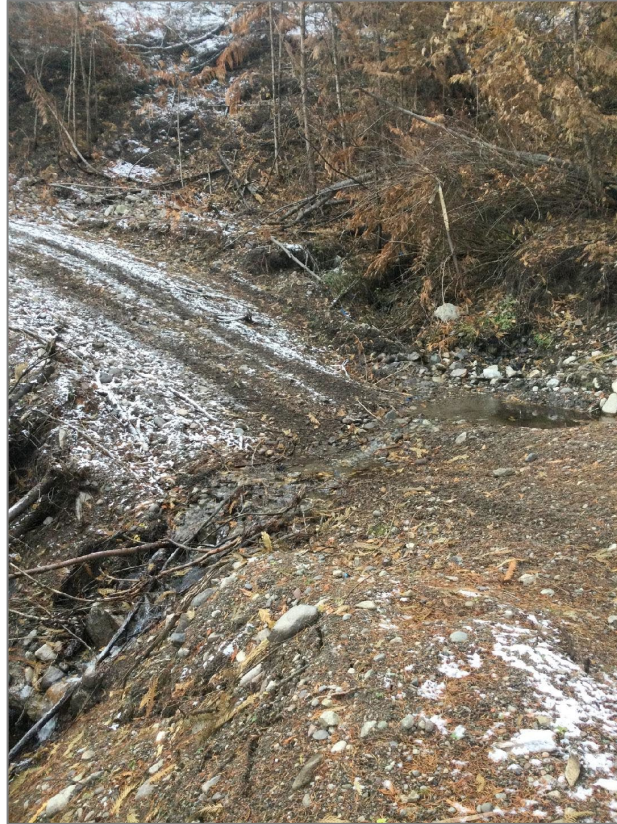
Figure 4-3: Unstable Fills at Trail Crossing on Norris Creek

2. A trail crossing on Norris Creek, just upstream of the fire guard crossing described above (see Figure 4.3, photo). Instability along the channel and trail fill slopes likely pre-date the wildfire, but now present a risk to downslope properties if the channel experiences increased runoff. The trail crossing location appears to be associated with a domestic water intake site (RDCO) that is no longer in use. Conditions at this site were communicated to RDCO staff.

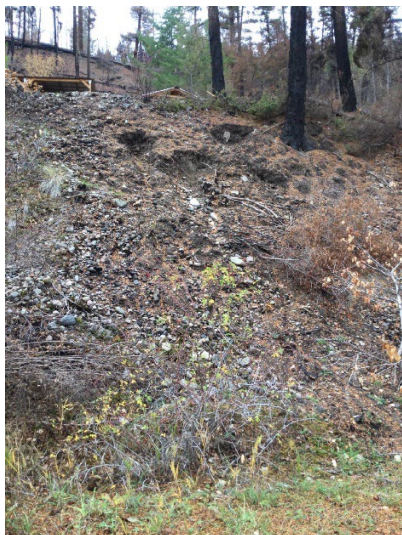
Severely burned steep slopes above and below Beachwood Road appeared to have observed soil slumping, small scale instability, and had exposed mineral soils considered to have a high potential for soil erosion (see Figure 4.4, photos). There is a high likelihood that sediment would reach Beachwood Road, the downslope properties, and Okanagan Lake. At the time of the assessment, a privately retained landscape contractor was clearing burned trees from the slopes along three properties and was intending to plant and seed the area. Further recommendations for the area are provided in Section 6 of this report.

Small landslide above Beachwood Rd

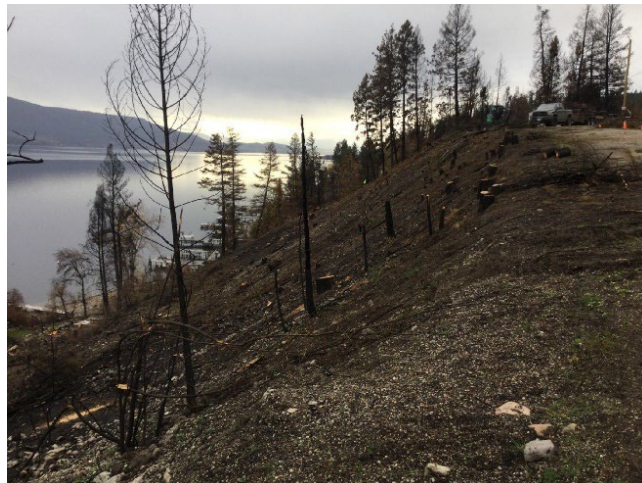
Burned (and recently cleared) slopes below Beachwood Rd

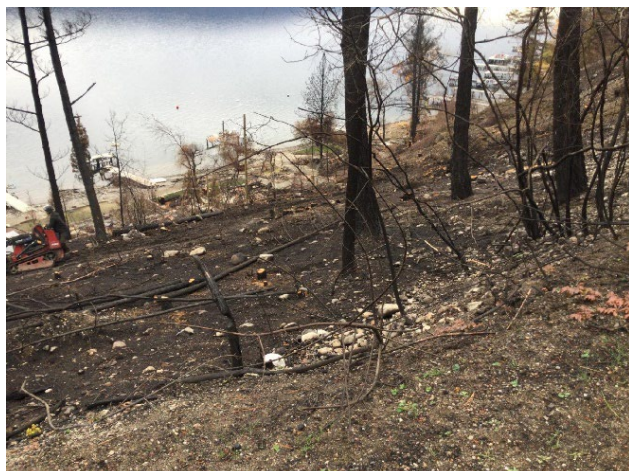
Burned slopes below Beachwood Rd

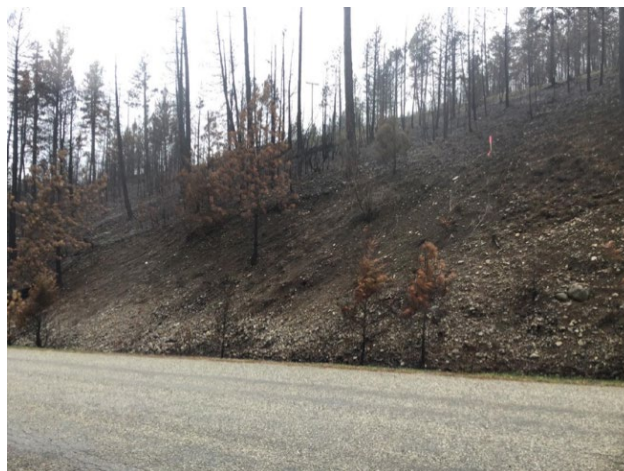
Exposed mineral soils above Beachwood Rd subject to soil erosion and shallow landslide

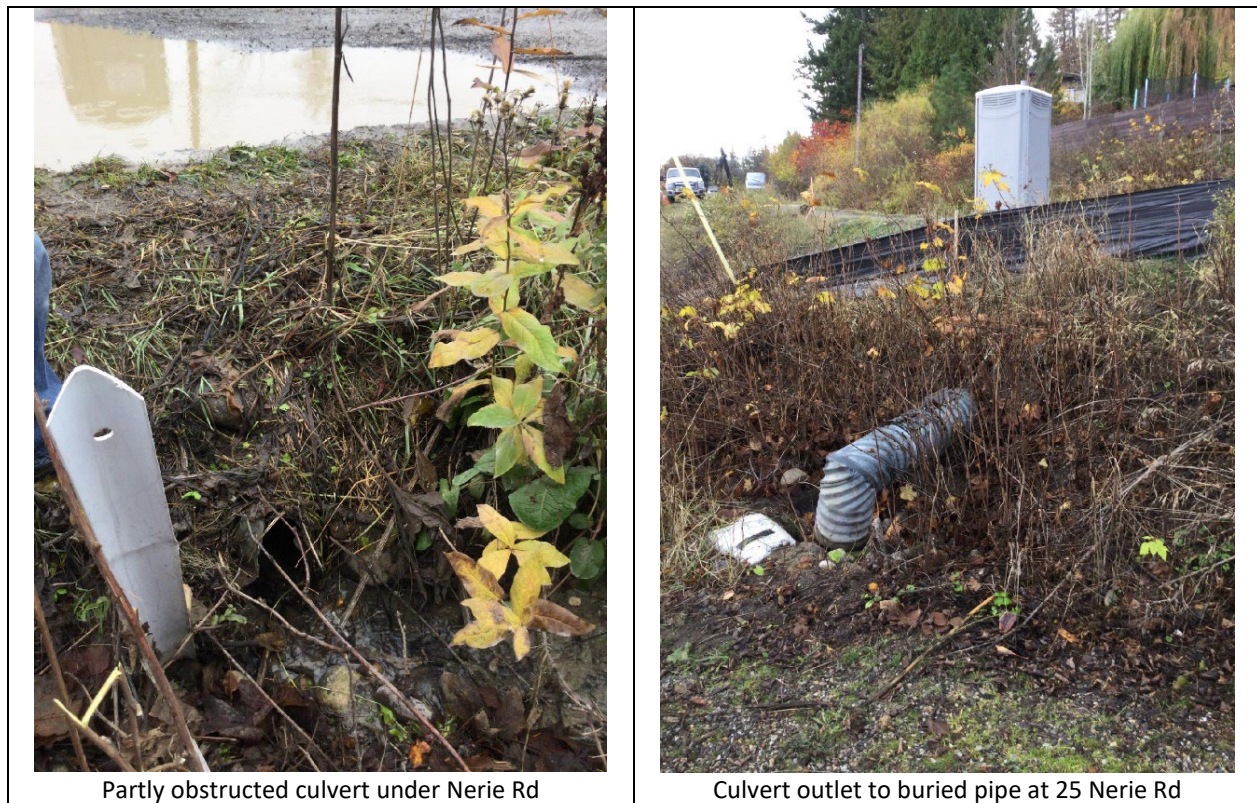
Figure 4-5: Potentially Vulnerable Culverts along Buchanan Spring along Nerie Rd (Estamont Area)

Two of the twenty-one assessed properties in the Nerie Road area have a high-risk level associated with groundwater seepage and the potential for geotechnical instability. A small watercourse identified as Buchanan Spring emerges from a zone of groundwater emergence above 104 Elliott Road, then flows through a culvert under Nerie Road (see Figure 4.5, photos). Runoff is conveyed by pipe through downslope properties before emerging within and between 23 Nerie Road and 25 Nerie Road. It is unclear whether culverts and pipes in the area can accommodate increases in groundwater discharge. Soil and groundwater effects in the general area may result in a hazardous condition with the potential to cause damages to property and/or infrastructure.

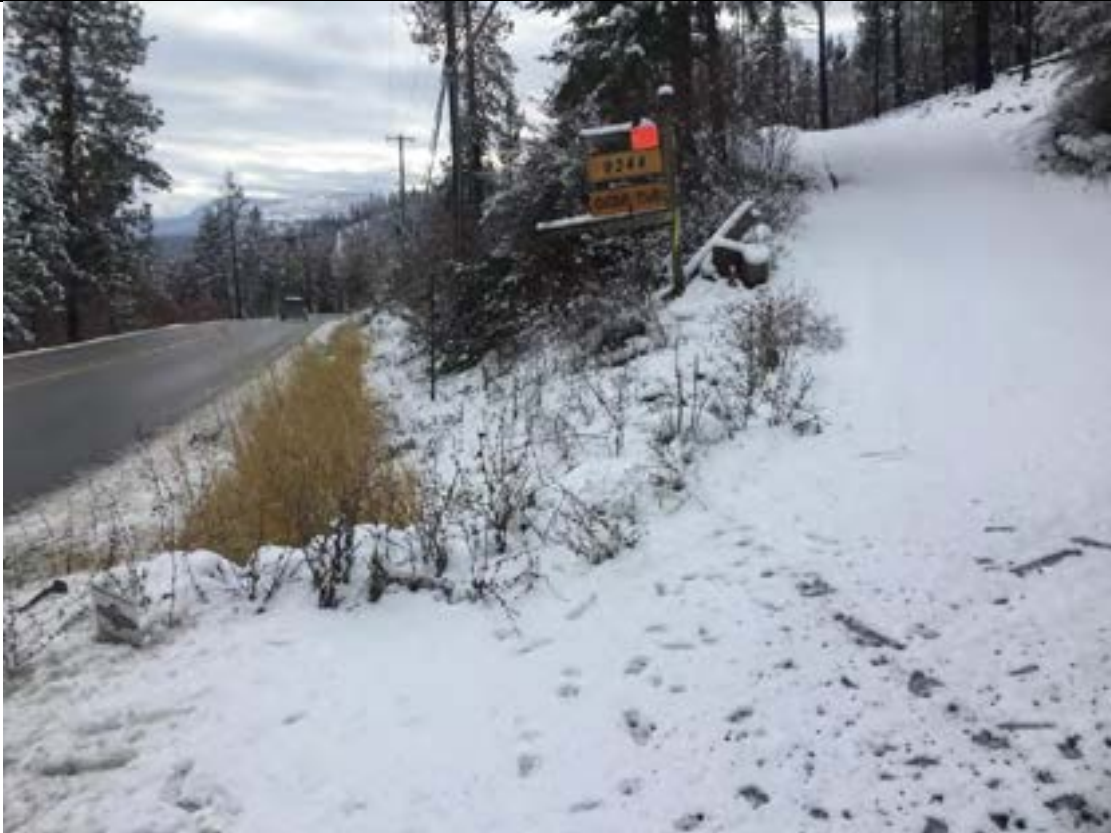
Photo 1: View of driveway entrance at 9344 Westside Road, stream flows south through culvert under driveway

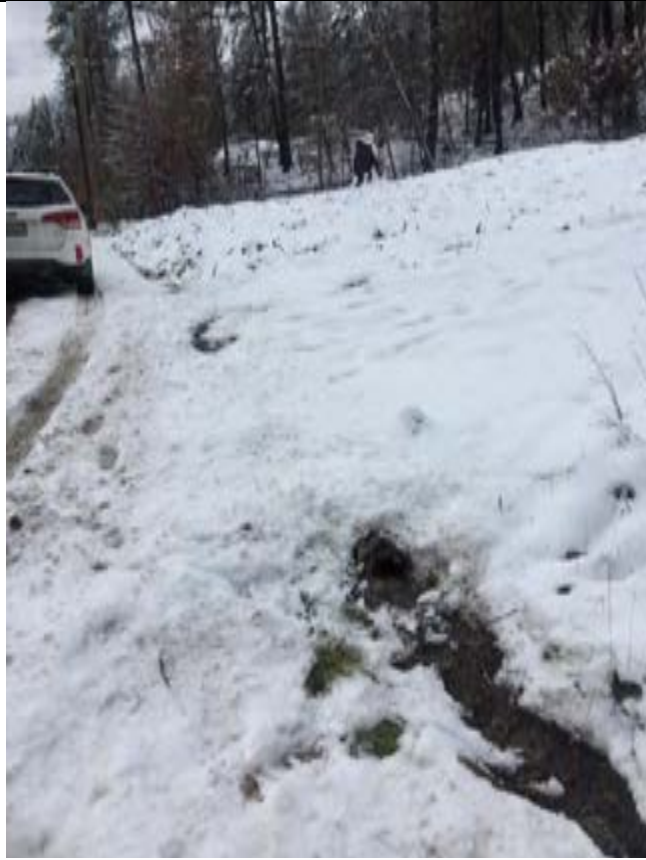
Photo 1: View of driveway entrance at 654 Udell Rd, culvert under driveway visible

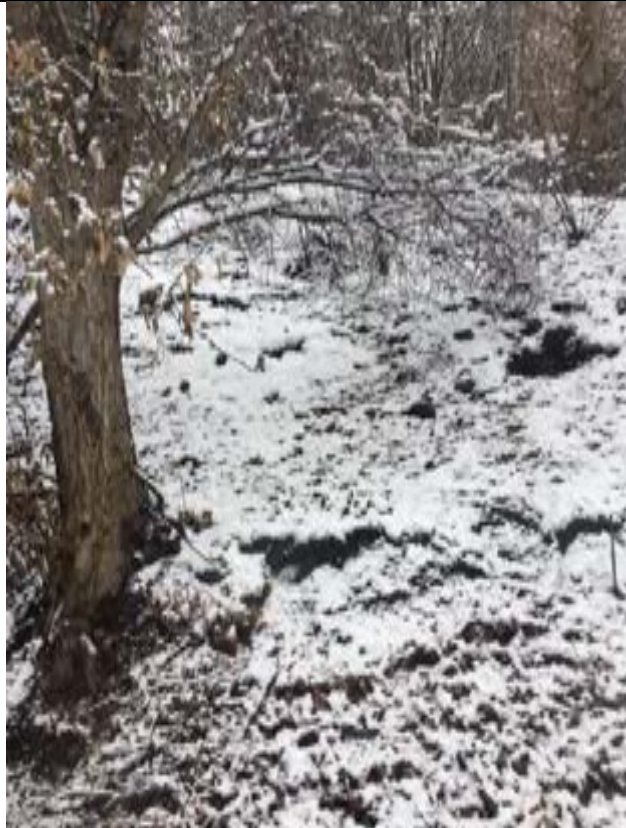
Photo 1: View upslope from driveway access right of way at 9294 Hodges Rd.

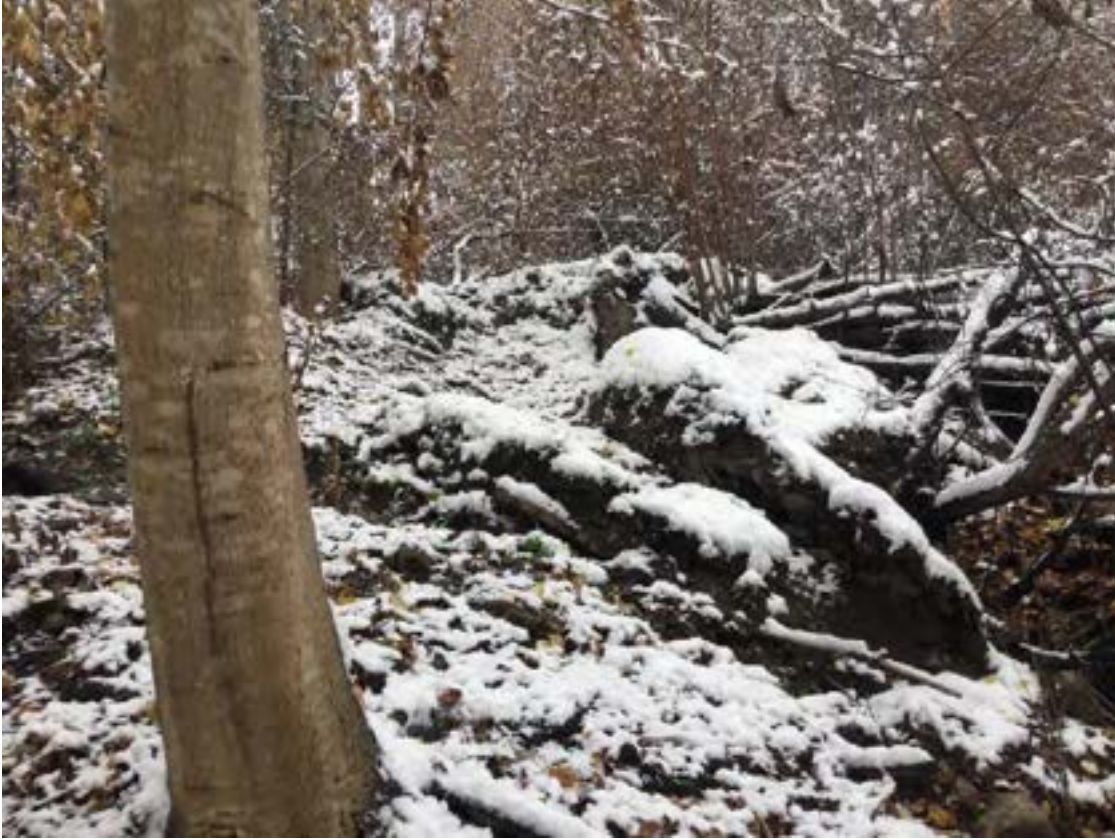
Photo 3: Unstable slopes observed along watercourse within 9294 Hodges Rd.

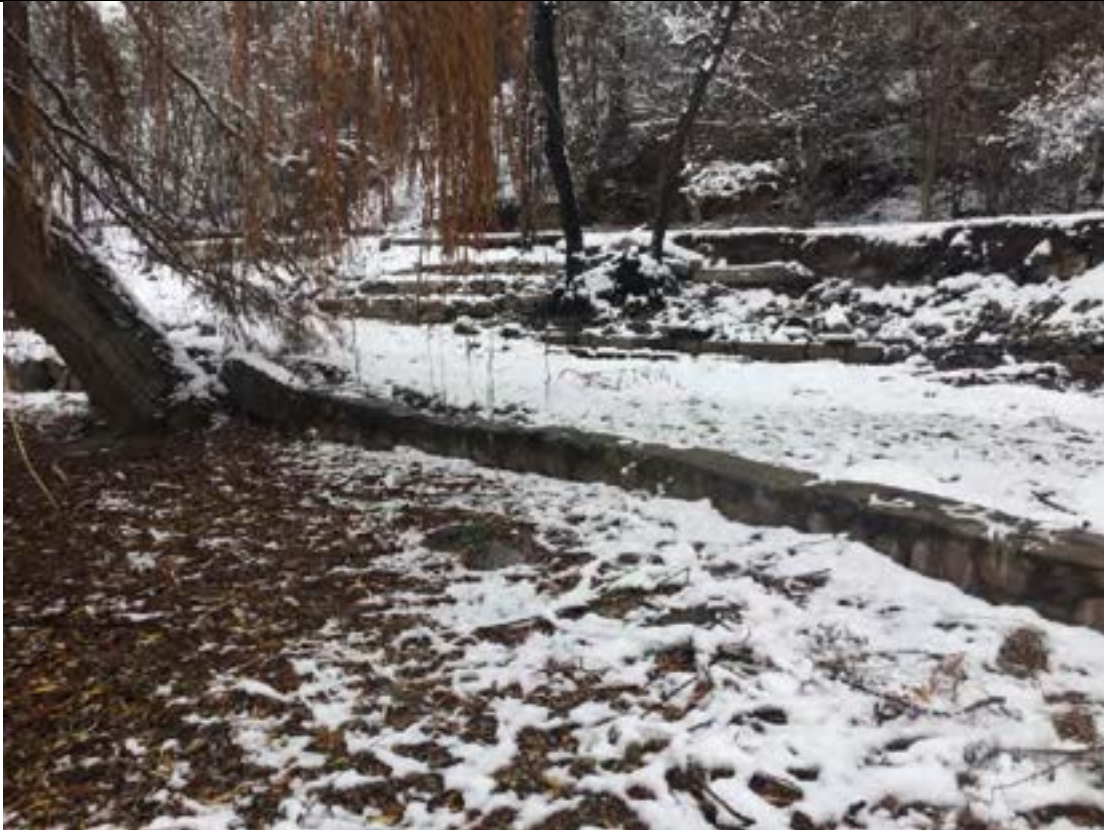
Photo 1: View upslope of foreshore area from the lake, concrete retaining wall and burned wood retaining wall

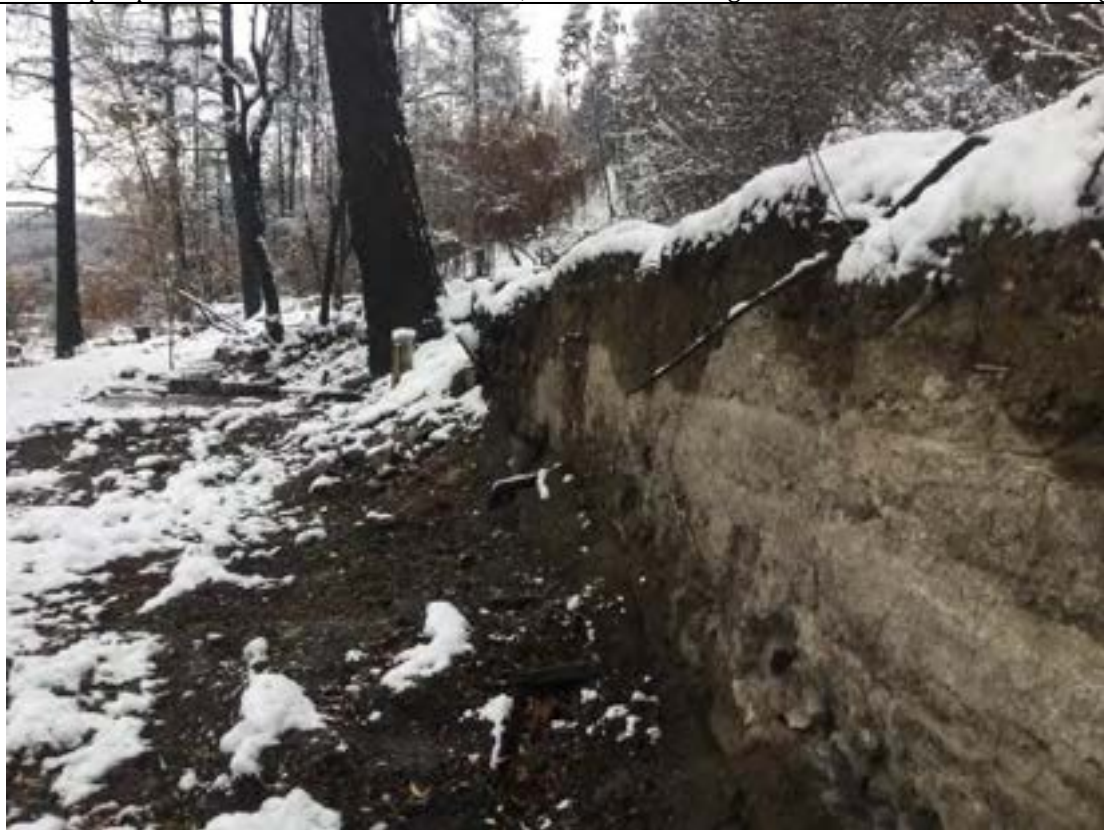
Photo 2: Close up view of burned wood retaining wall at 55 Killarney Pl.

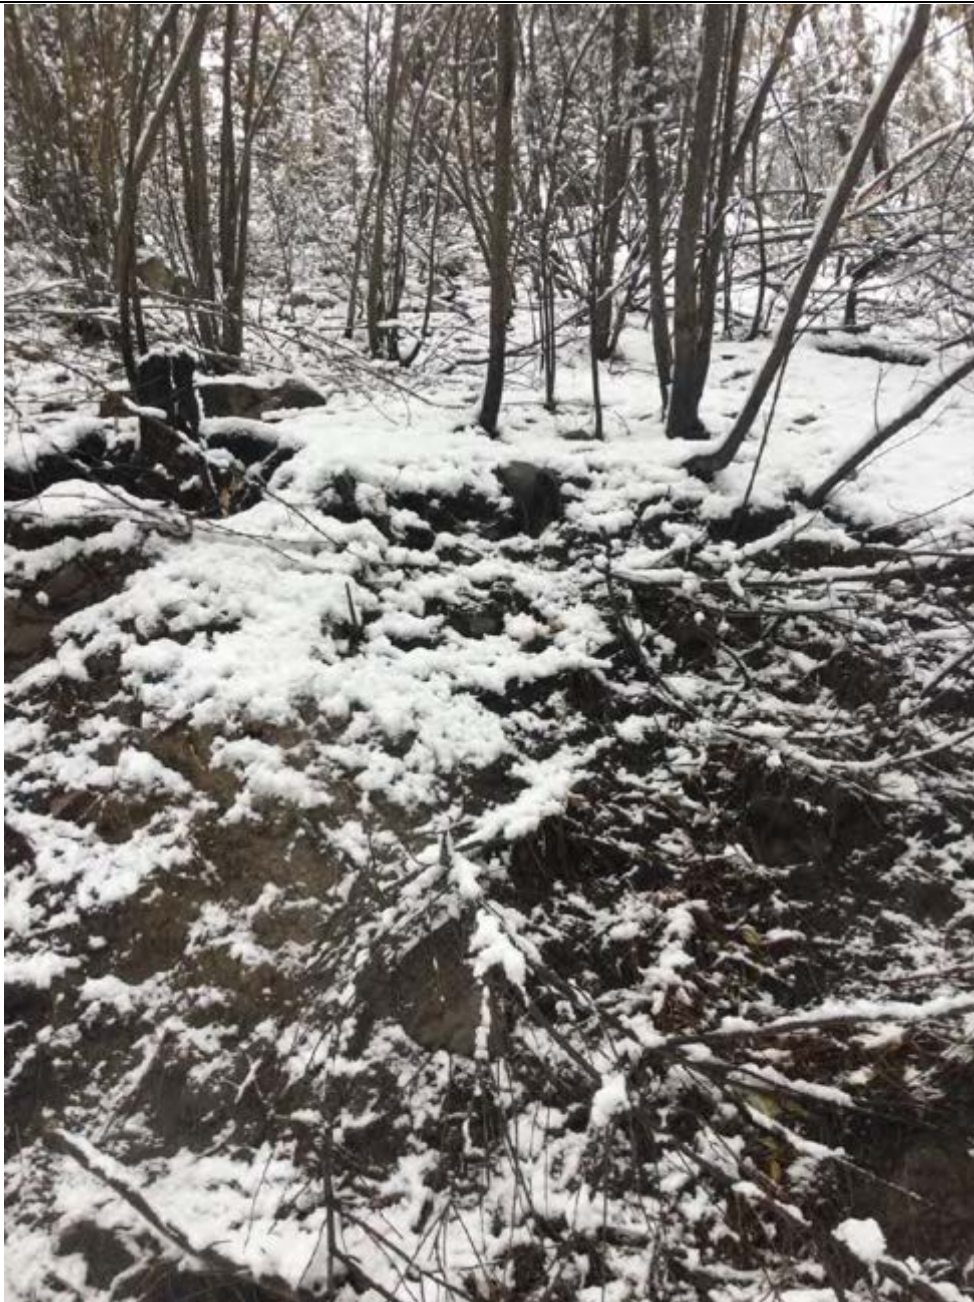
Photo 3: View of steep slopes above foreshore area at 55 Killarney Pl.

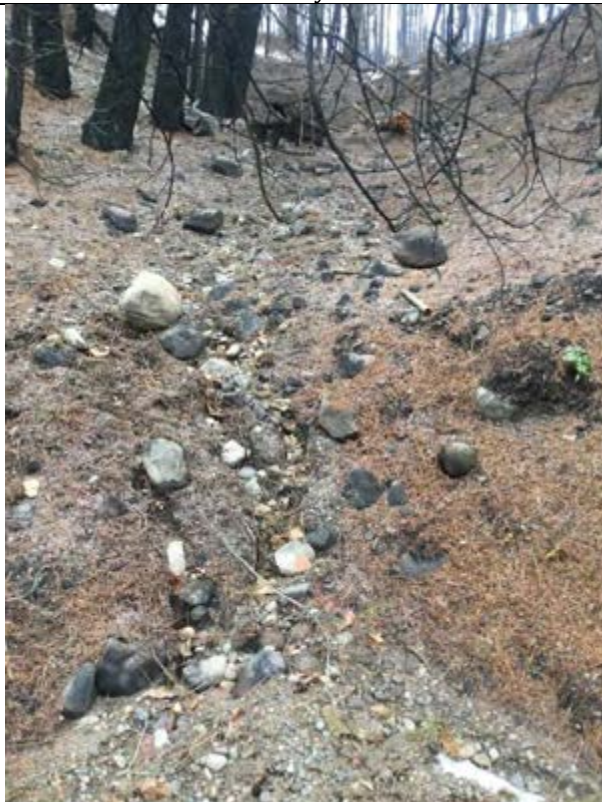
Photo 4: Small gully located on 81 Killarney Pl, with evidence of sediment transport through burned area

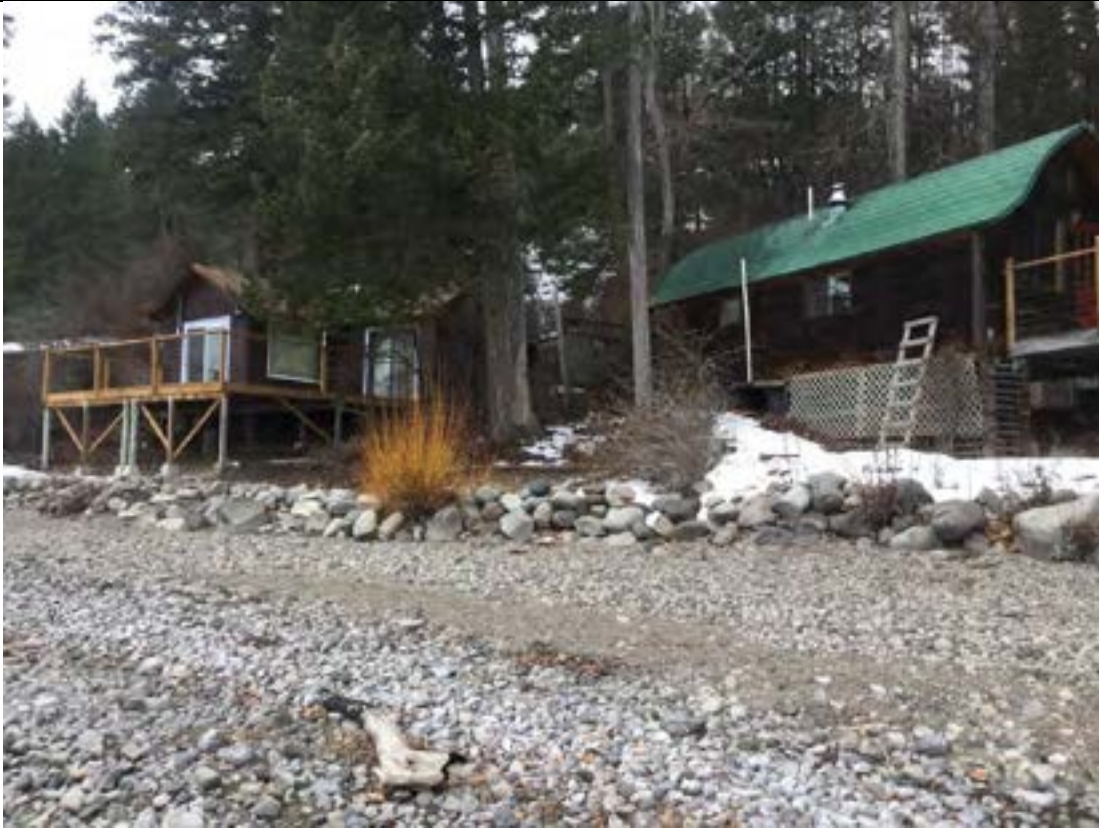
Photo 1: View of foreshore area at 90 Killarney Pl. Note two small dwellings along foreshore area.

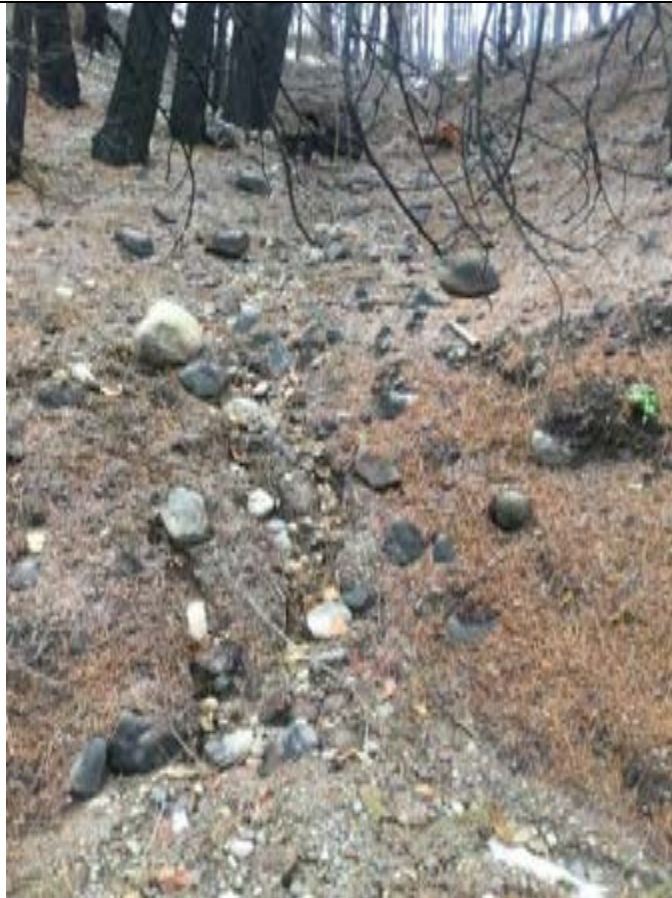
Photo 3: View of small gully situated along property line (from 81 Killarney Pl.) showing recent sediment transport through burned area

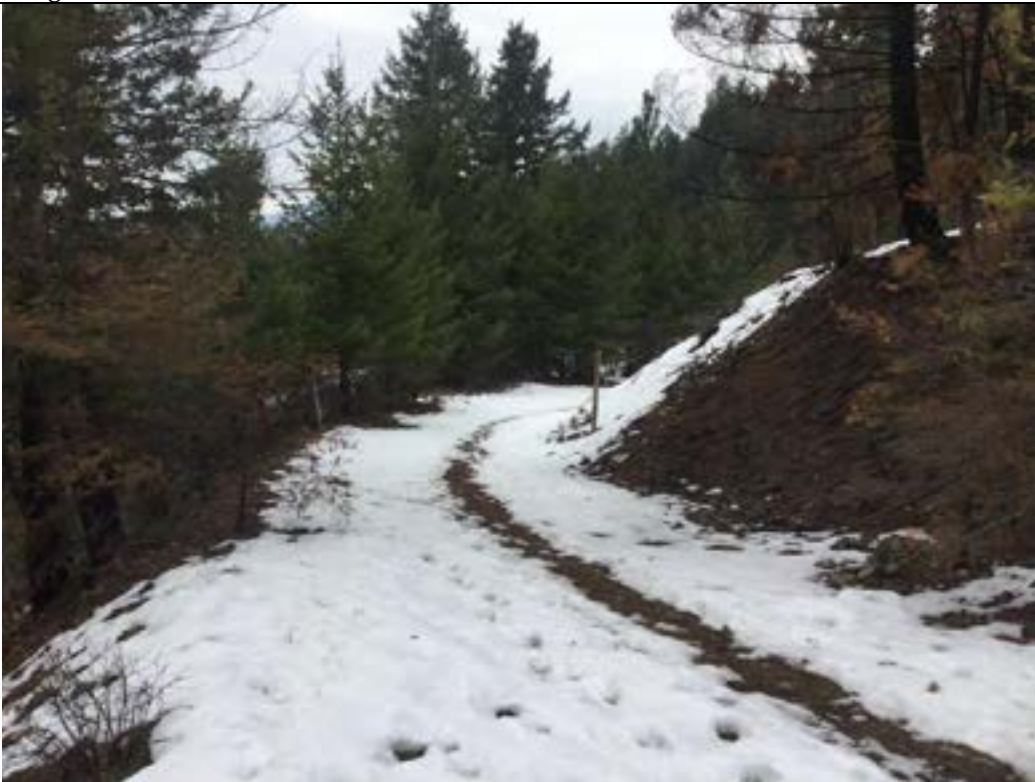
Photo 4: Unpaved access trail switchbacks off end of Killarney Pl. Minor raveling cutslopes and minor erosion along trail surface.

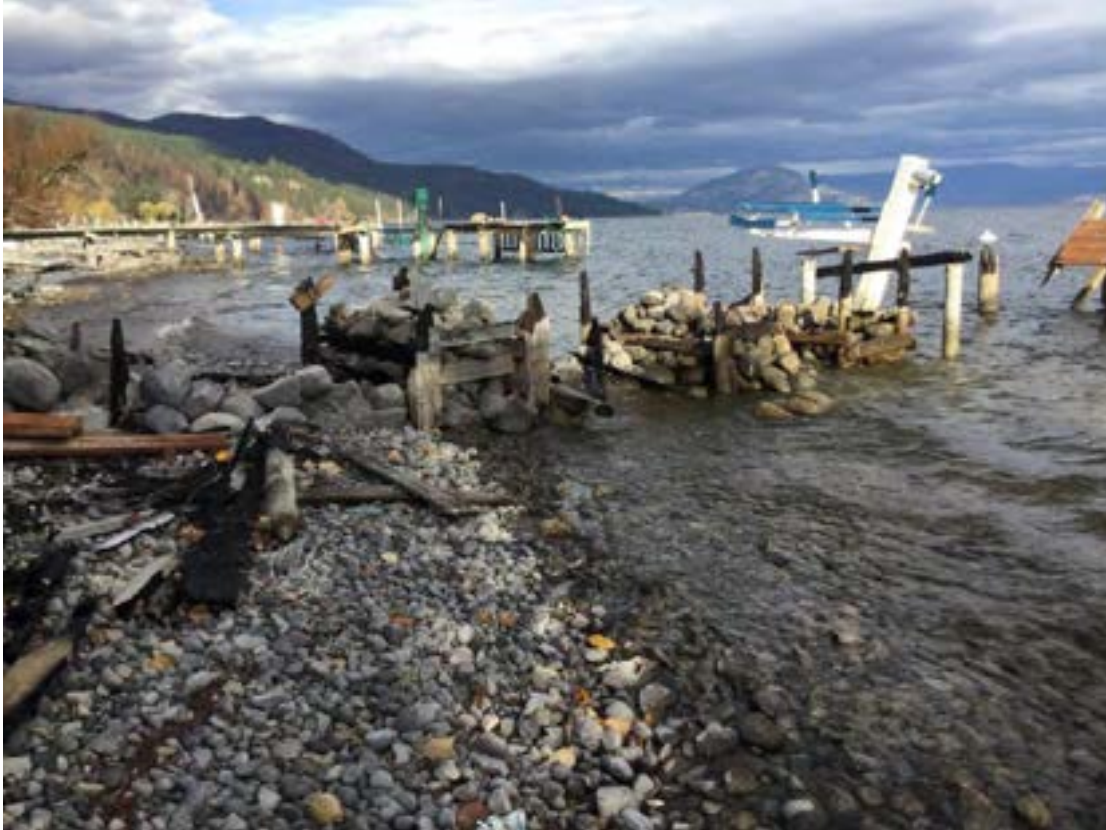
Photo 3: View of damaged dock with rock filled piling at 2 Nerie Rd.

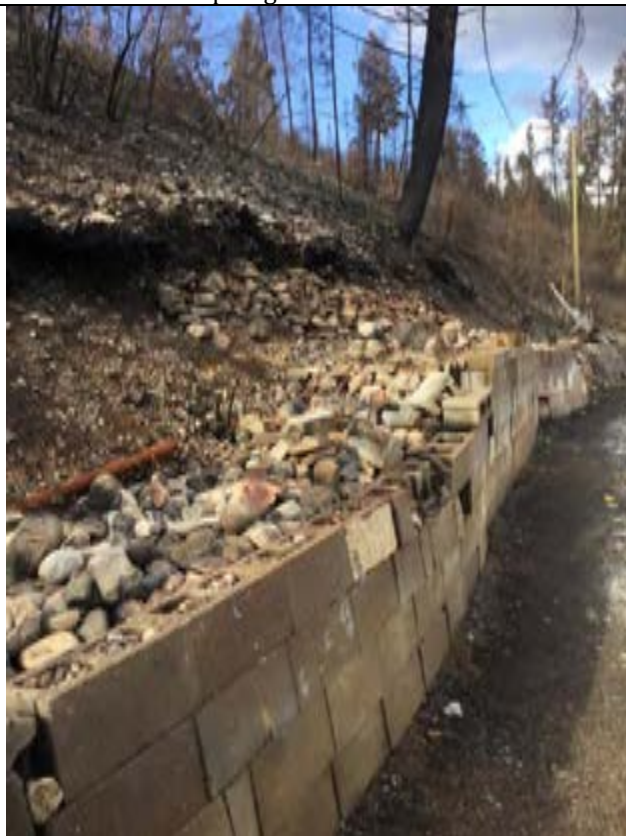
Photo 4: View of retaining wall and slope above lower property at 2 Nerie Rd.

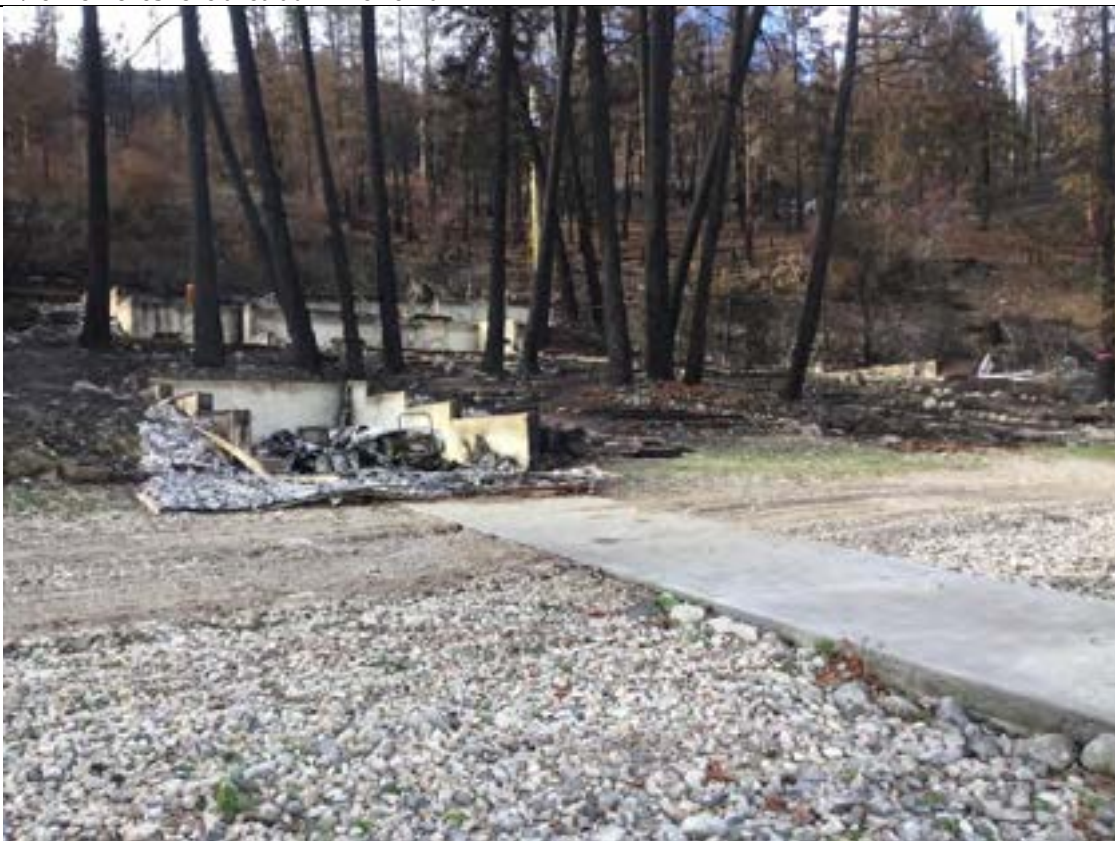
Photo 2: View from foreshore area at 11 Nerie Rd. with concrete boat ramp and burned boat house

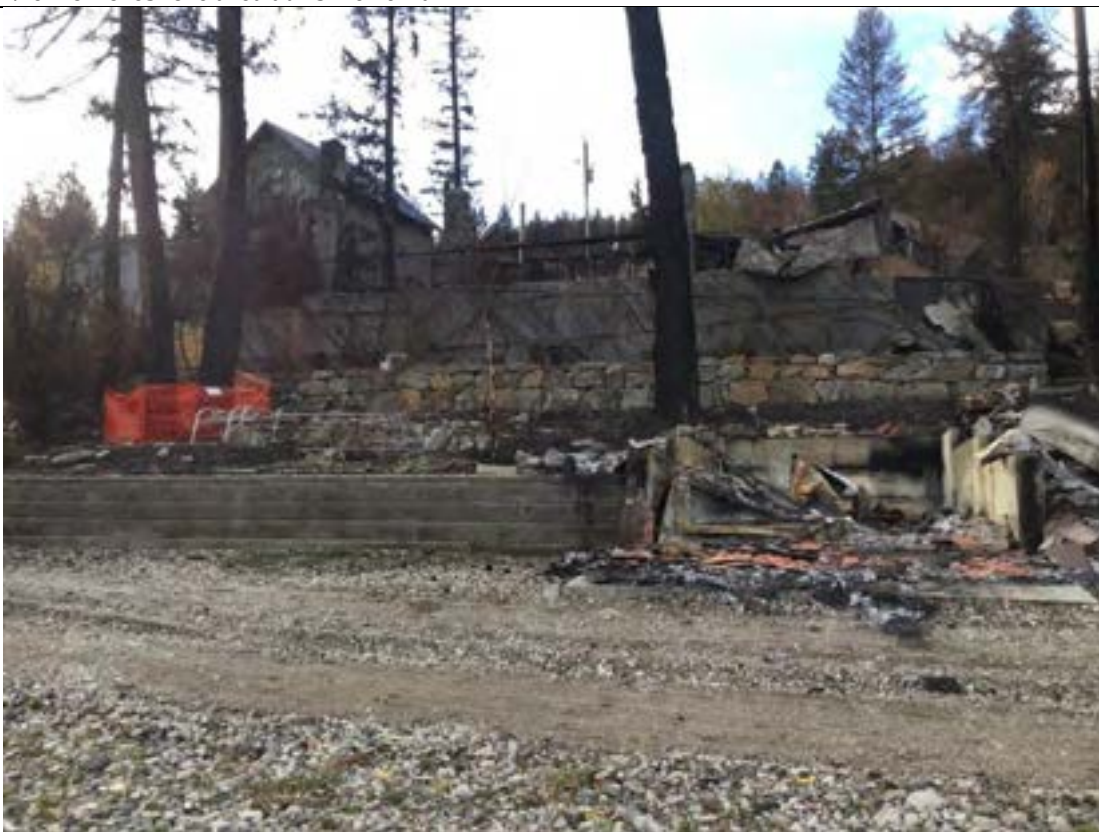
Photo 2: View from foreshore area at 13 Nerie Rd. with retaining wall and burned boat house

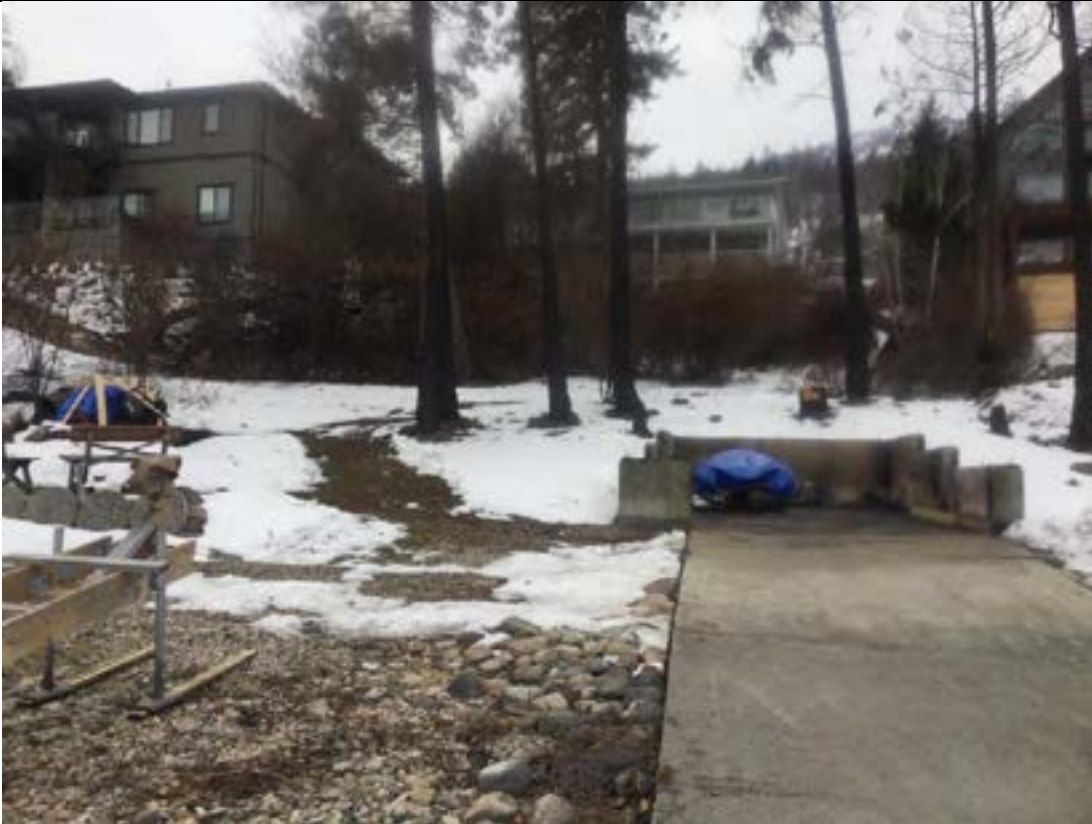
Photo 1: View upslope from foreshore area at 19 Nerie Rd. Note concrete boat ramp and burned boat house.

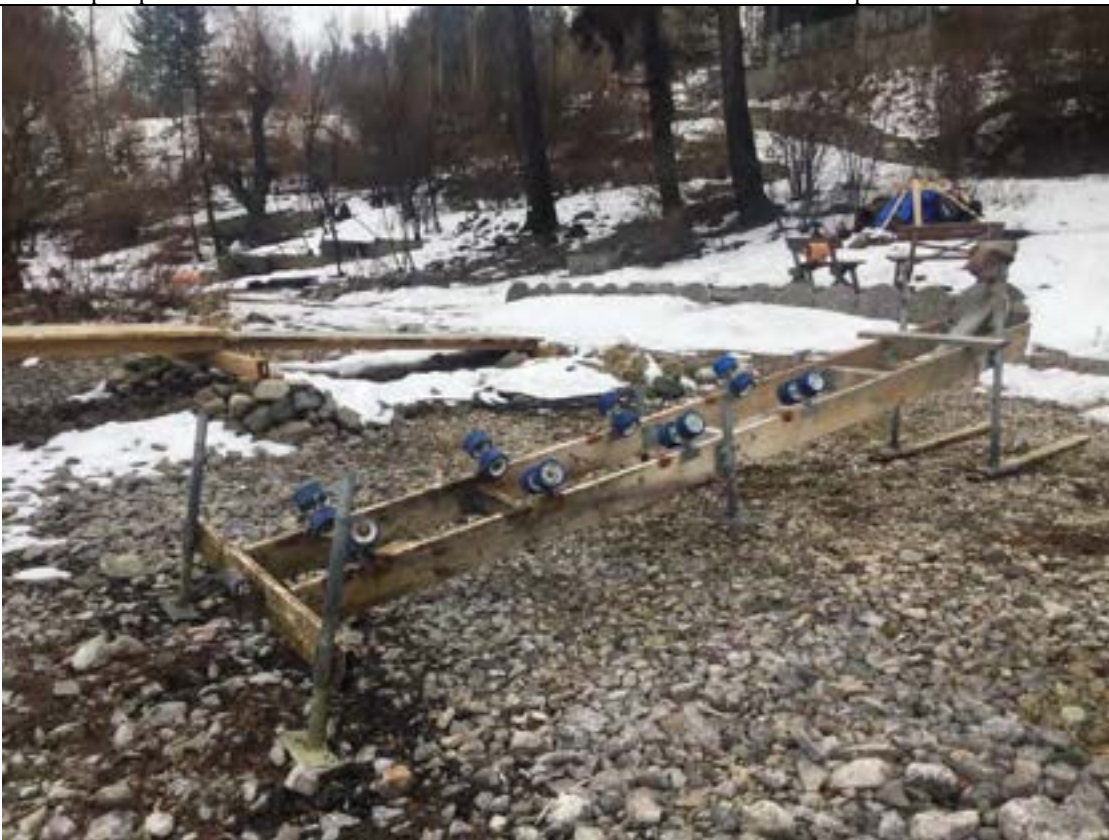
Photo 2: View of foreshore area at 19 Nerie Rd. End of dock is repaired.

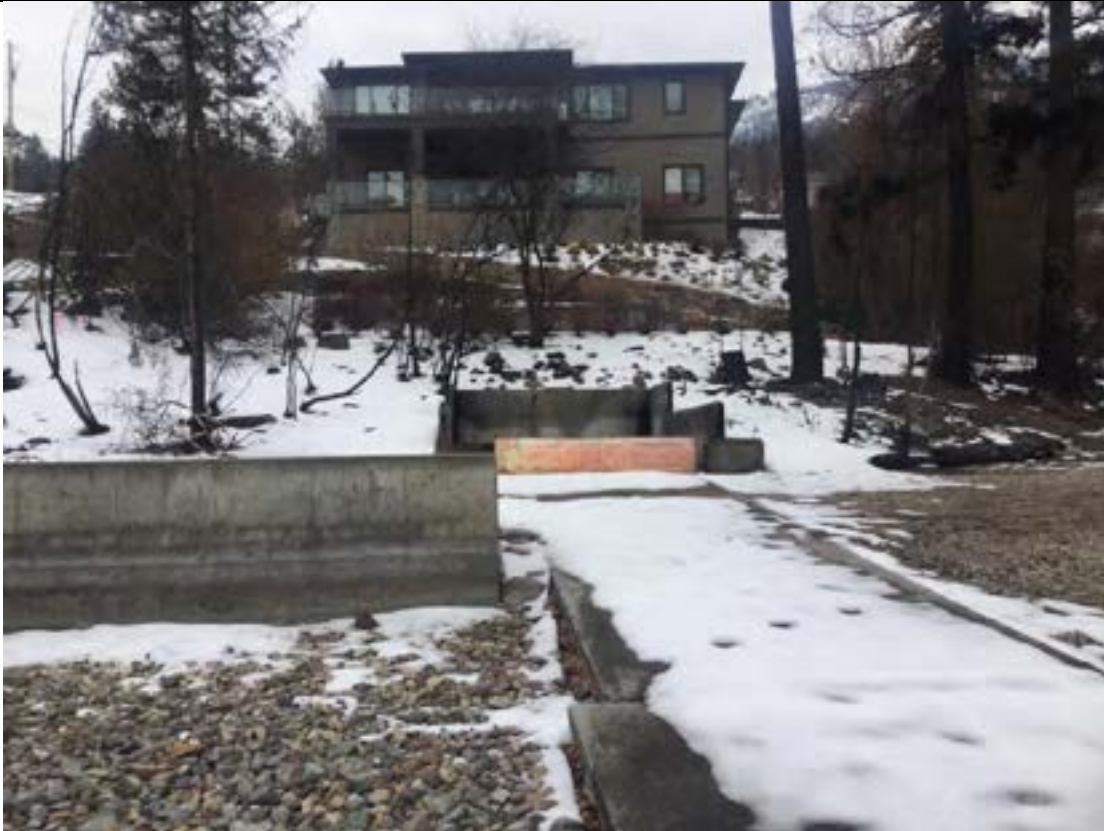
Photo 1: View upslope from foreshore area at 21 Nerie Rd. Note concrete retaining wall, boat ramp and burned boat house.

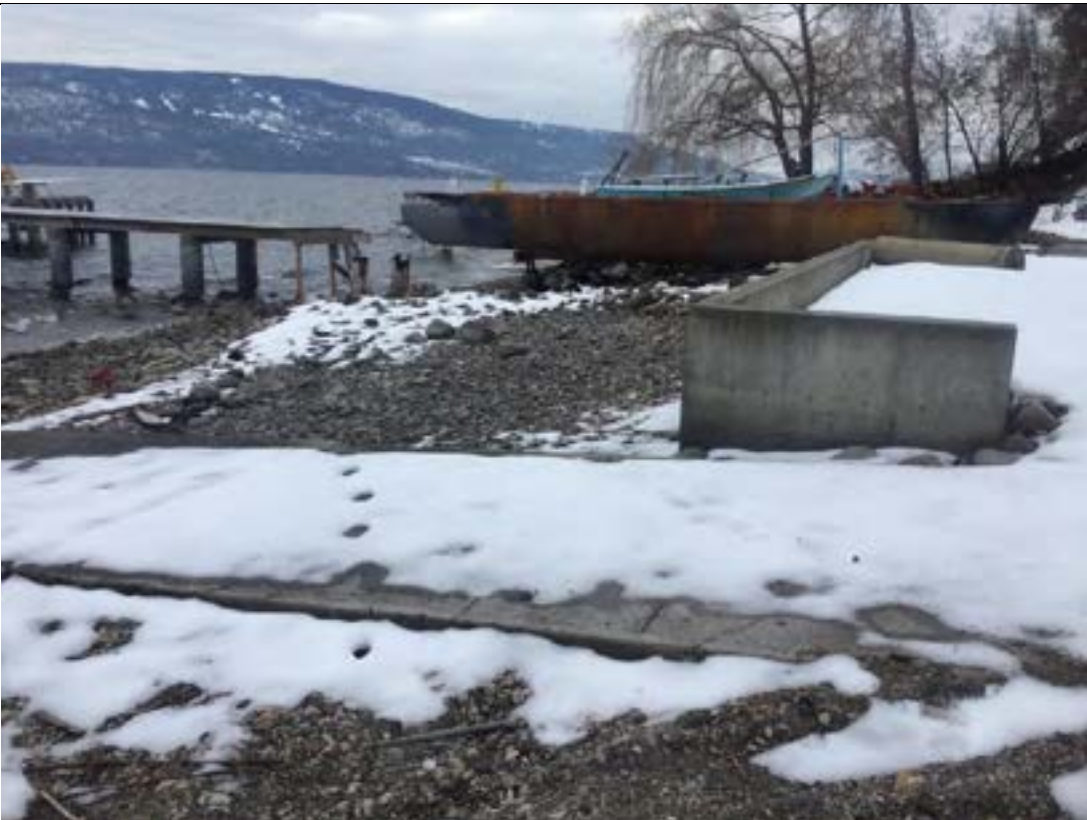
Photo 2: View of foreshore area at 21 Nerie Rd. Note retaining wall and damaged end of shared dock.

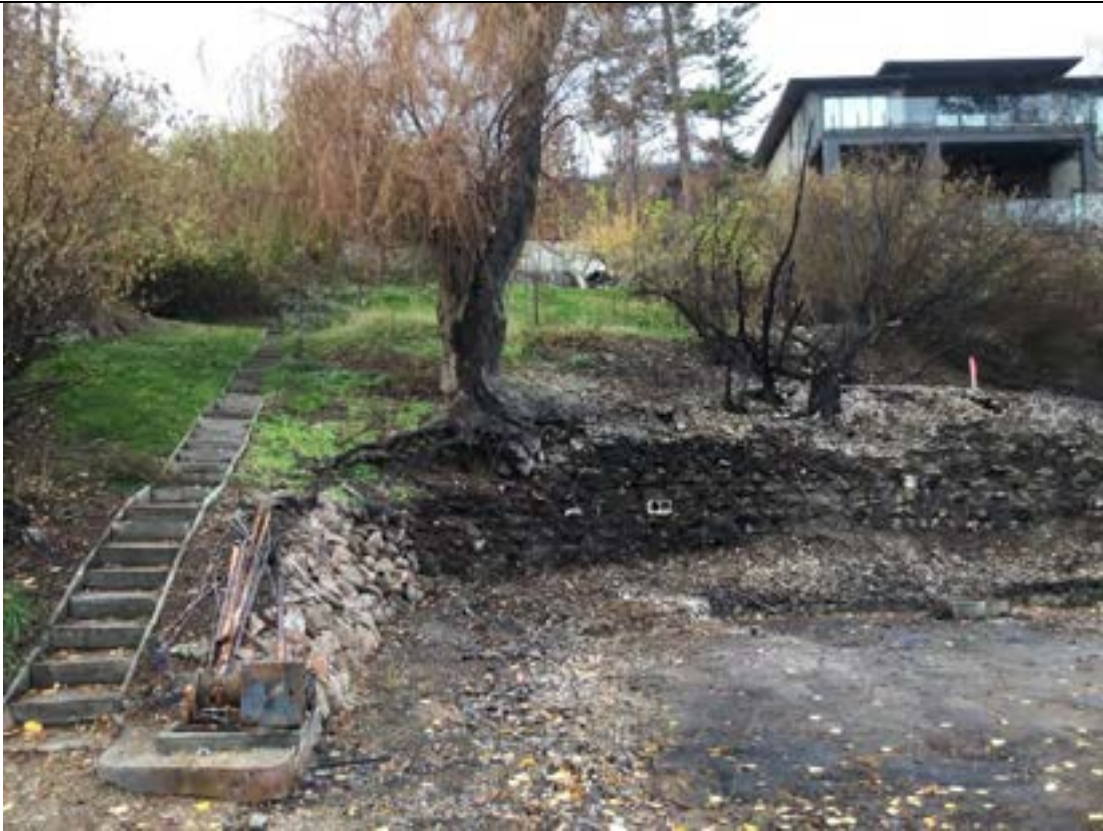
Photo 3: View of slope above foreshore area with burned garage and burned tire retaining wall

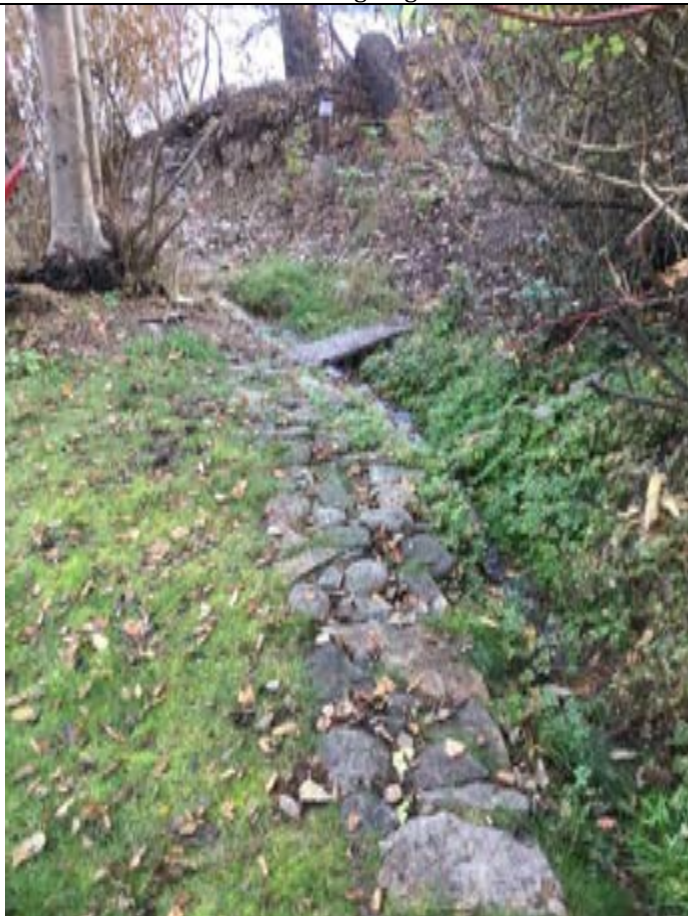
Photo 4: Small spring-fed stream flowing along south property line at 23 Nerie Rd.
