CLARKE GEOSCIENCE LTD.

POST-WILDFIRE ENVIRONMENTAL AND HAZARDOUS CONDITIONS ASSESSMENT OF THE NORTH WESTSIDE ROAD AREA

Dated:	February 23, 2022
Presented To:	Regional District of Central Okanagan
Attention:	Brittany Nichols, Environmental Planner
CGL Project # 21-0115	EOC #A21-674
Document Control:	Version Rev. 1 (corrected civic and legal property addresses for 3 properties)

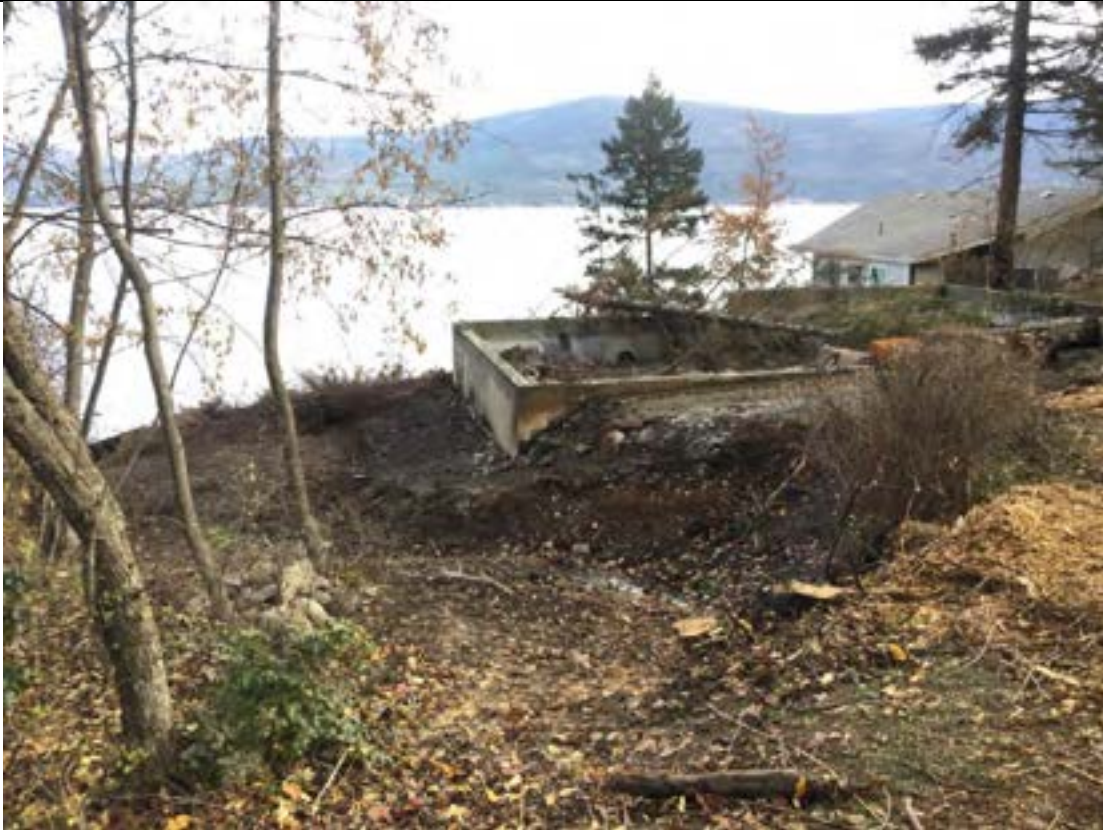
Photo 1: View of upper part of lot at 37 Nerie Rd, culvert outlet and stream flow in foreground

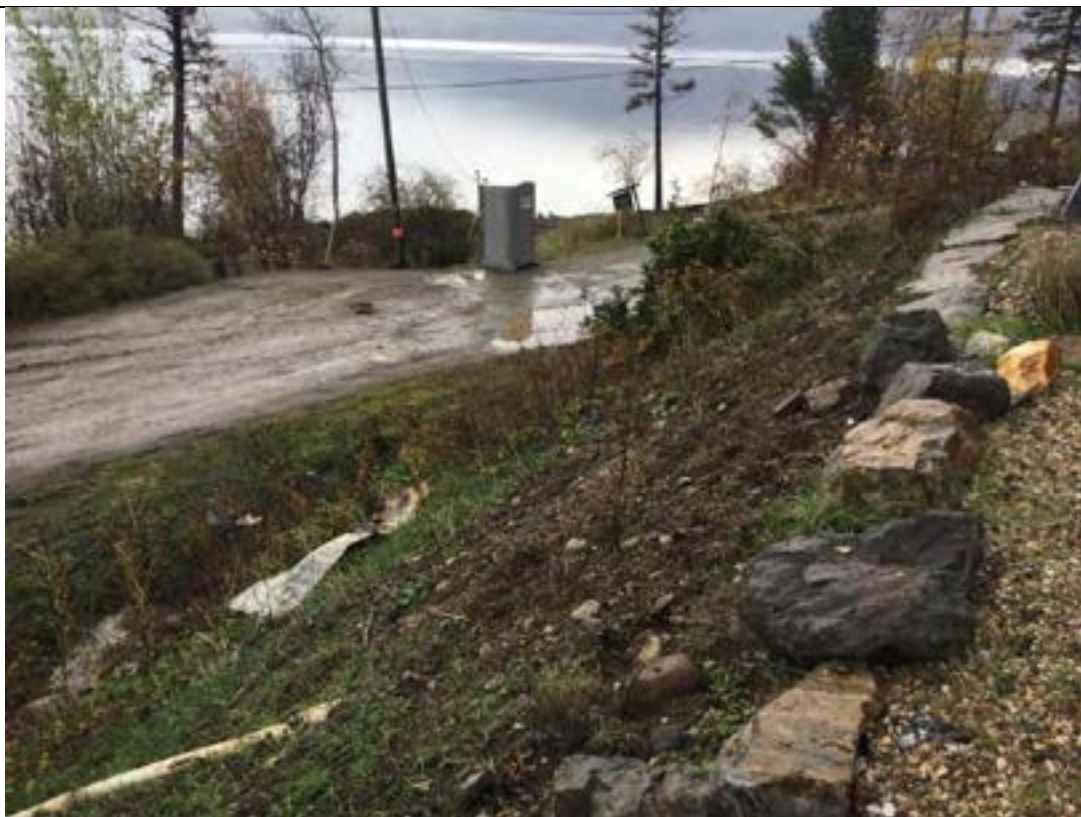
Photo 1: View of corner property at 104 Elliot Rd towards ditchline and culvert across Nerie Rd. Noted, two white PVC drain pipes along cutslope.

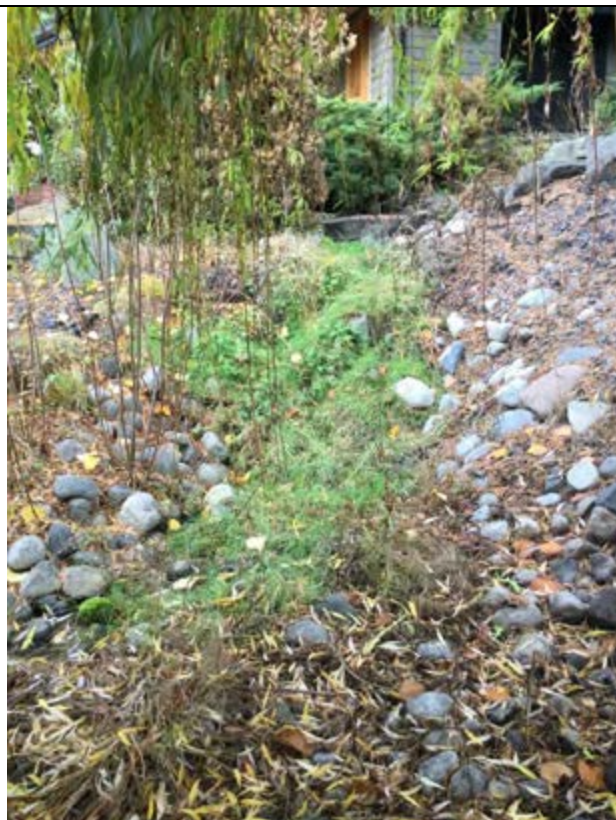
Photo 2: View of spring-fed stream along south property line at 104 Elliot Rd.

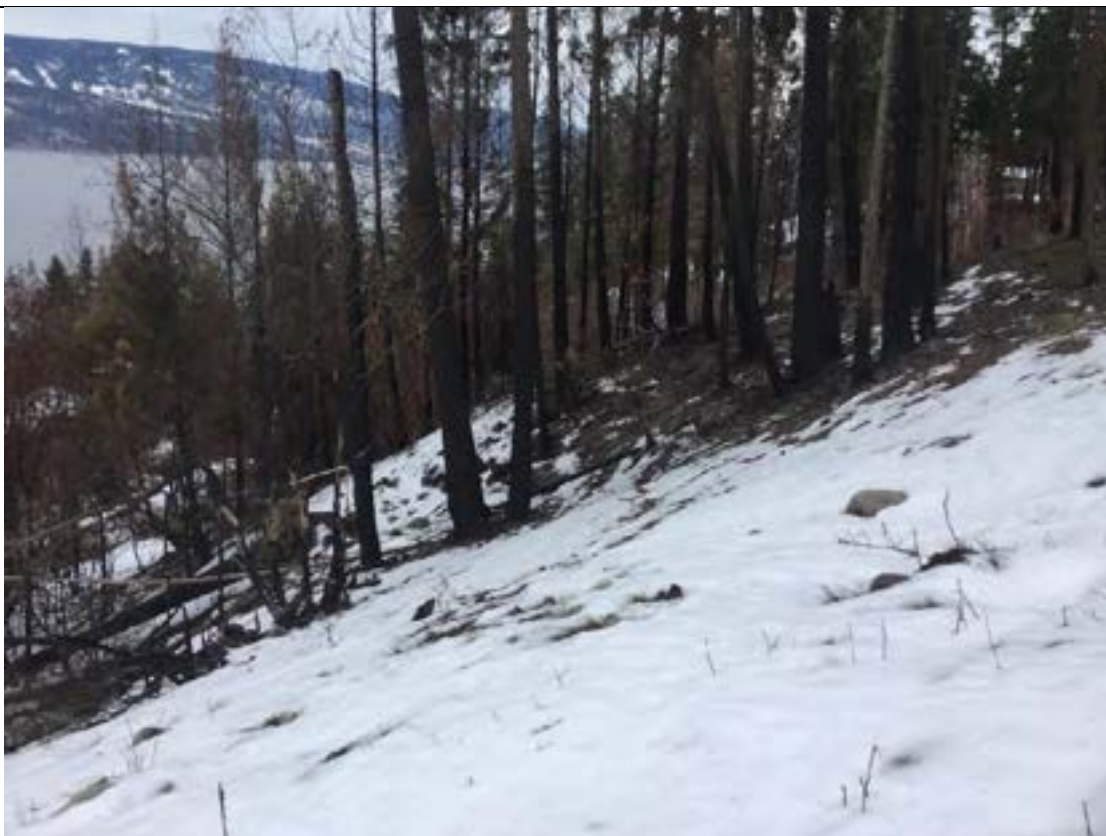
Photo 1: View of slopes along south side of 8715 N Westside Rd.
