Westside Regional Wastewater Treatment Plant Odour Assessment

Project number: 60667097

December 7, 2021

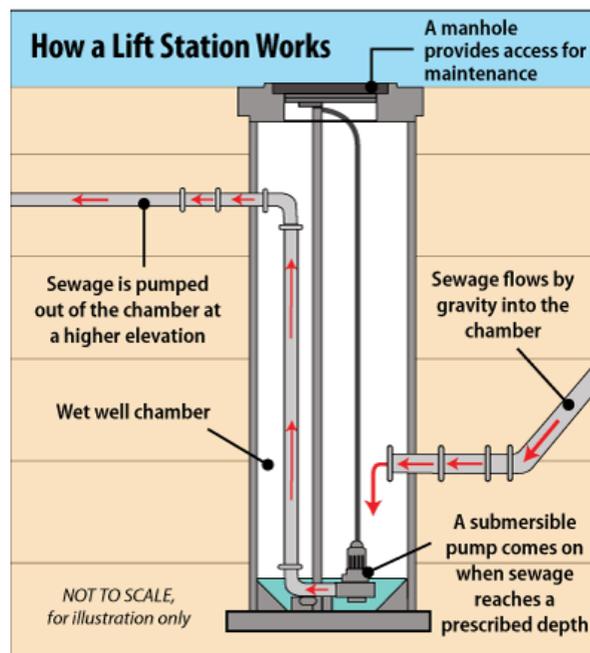
Figure 2-1: Typical Municipal Wastewater Lift Station Schematic

The anaerobic conditions that promote the formation of reduced sulphur compounds are typically associated with closed pipe systems like forcemains and siphons but can also occur in lift stations. Wastewater lift stations typically comprise of a submersible pump inside a wet well (tank). Wastewater flows by gravity into the wet well and the pump turns on when a pre-determined water level is reached. The wastewater is then pumped into a forcemain which provides ideal anaerobic conditions for wastewater decomposition. For smaller lift stations where flow rates are low, the pumps may operate infrequently (i.e., 2-3 times per day) which causes low turn-over rates and long detention times that can lead to high rate of reduced sulphur compounds in both the wet well and the forcemain.

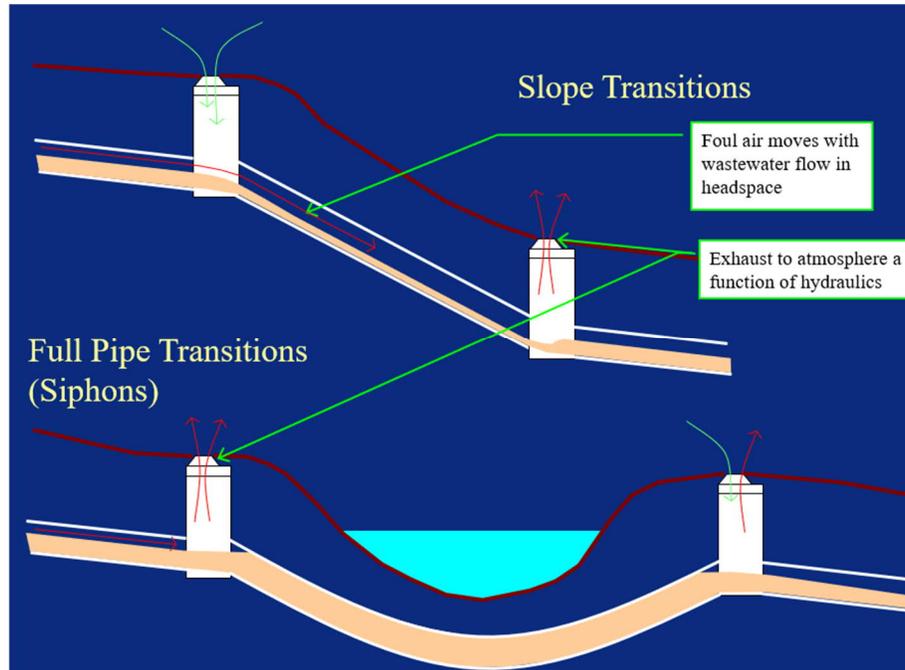
Figure 2-2: Illustration of Common Flow Transitions In Sewers That Cause Foul Air Emissions at the Surface

Once the reduced sulphur compounds have been formed in the water column, they occur as gases and are only slightly soluble and heavier than air. Any agitation will release the odours into the pipe or lift station headspace and since the gases are heavier than air they will tend to follow the water surface flow. The flow dynamics in the collection system will determine the degree to which these gases are forced above-ground as a detectable odour. Flow transitions are known mechanisms for release and transmission of reduced sulphur compounds and can include the following:

1. Steep to shallow slope pipe transitions – air in the headspace is accelerated through the steep pipe section and is forced out the manhole at the change to a shallow slope.
2. Partially full gravity pipe to full pipe transitions – foul air carried in the headspace of a partially full pipe is forced out the manhole at a transition to full pipe such as a siphon.
3. Forcemain transitions to gravity flow – turbulence associated with flow surges at pump start-up will release gases into the headspace of the gravity section and force foul air above-ground through the receiving manhole.

4. Lift station operation – gasses are released through turbulence and air displacement associated with wastewater entering the lift station or through the action of pumping. As the lift station tank fills, wastewater displaces volume which forces foul air to be vented to the surface.

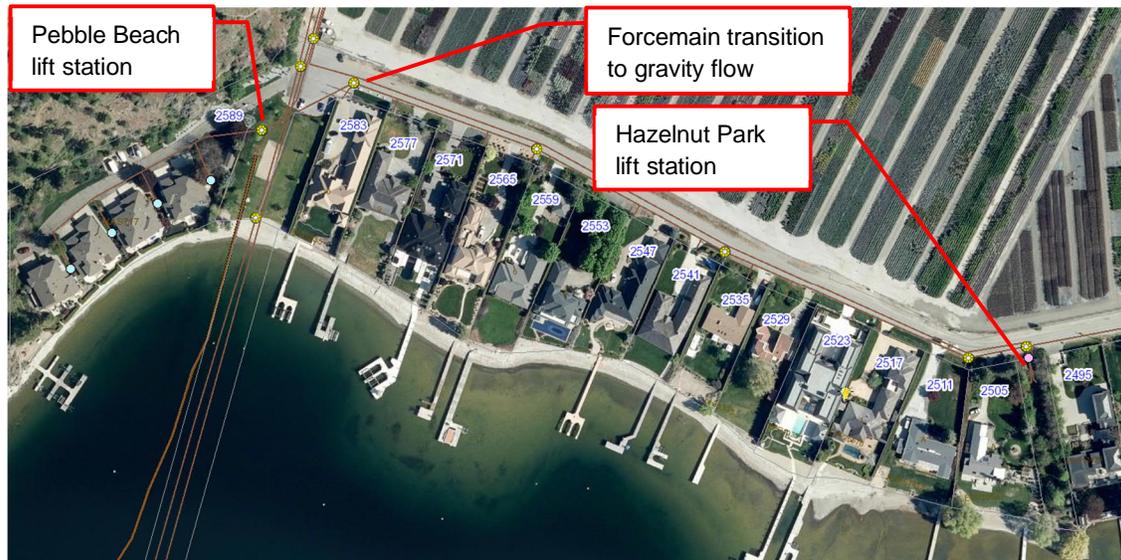
Figure 3-1: Location of H₂S Monitoring in Whitworth Road Area

H₂S loggers were installed at three locations on the wastewater collection system in the vicinity of Whitworth Road (**Figure 3-1**). The locations included:

1. Headspace of the Pebble Beach Lift Station
2. Manhole at the end of the Pebble Beach Lift Station forcemain where it transitions to gravity flow
3. Headspace of the Hazelnut Park Lift Station

The data output for each of the 3 sites is provided as graphs and included in **Appendix B**. The monitoring shows that all 3 sites exhibit transient emissions of high concentrations of H₂S in the lift station and pipe headspace.

The H₂S concentration in the Pebble Beach Lift Station is associated with the pumps starting up and is likely caused by turbulence. Based on information provided by the City of West Kelowna, who operates the lift station, the pumps typically operate 1-2 times per day. As a consequence, wastewater entering the station may stagnate for up to 24 hours, allowing for anaerobic conditions which promote nuisance odour generation. At pump start-up, the H₂S measured logger was 2 -13 ppm and typically abated after 9 -21 minutes. The lift station does not appear to have a ventilation exhaust or scrubber to manage the foul air generation. There is a possibility that odours generated in the station could be migrating up the gravity sewer trunk (i.e. returning to 2589 Whitworth Road). A ventilation fan and scrubber should be considered as an option to mitigate odours released to the atmosphere from the lift station headspace.

The Pebble Beach Lift Station pumps into a 200 mm diameter forcemain which discharges to the gravity sewer on Whitworth Road, a distance of 54 metres. The volume of the forcemain is 1.7 m³ which further increases the stagnation time of the wastewater by 6 – 12 hours, assuming a typical wastewater generation rates of 300 L/person/day. When the Pebble Beach pumps turn on, the H₂S concentration in the discharged manhole headspace spikes to a peak of 10 – 45 ppm with a detectable concentration (i.e., greater than 0.1 ppm) lingering for 5 to 70 minutes.

The Whitworth Road gravity sewer drains to the Hazelnut Park Lift Station. The headspace H₂S in the Hazelnut Park Lift Station exhibits transitory peaks of 3 – 16 ppm which may be associated with turbulence from pump operation or surges of flow from the Pebble Beach Lift Station. The waves of H₂S recorded in the Hazelnut Park Lift Station headspace can persist for hours.

The long residence time of the wastewater in the Pebble Beach Lift Station and forcemain appears to be contributing to the high levels of H₂S measured in the downstream sewer head space and remedial solutions should be investigated. As an interim measure, it may be possible to reduce residence time by adding a water source to the station inflow. The additional water would cause the lift station to cycle more frequently.

The Hazelnut Park Lift Station was designed with a ventilation pipe and is fitted with a carbon canister to mitigate odour. However, the size of carbon scrubber may be too small to control the odour generated and H₂S monitoring of the vent should be conducted to assess its efficacy.

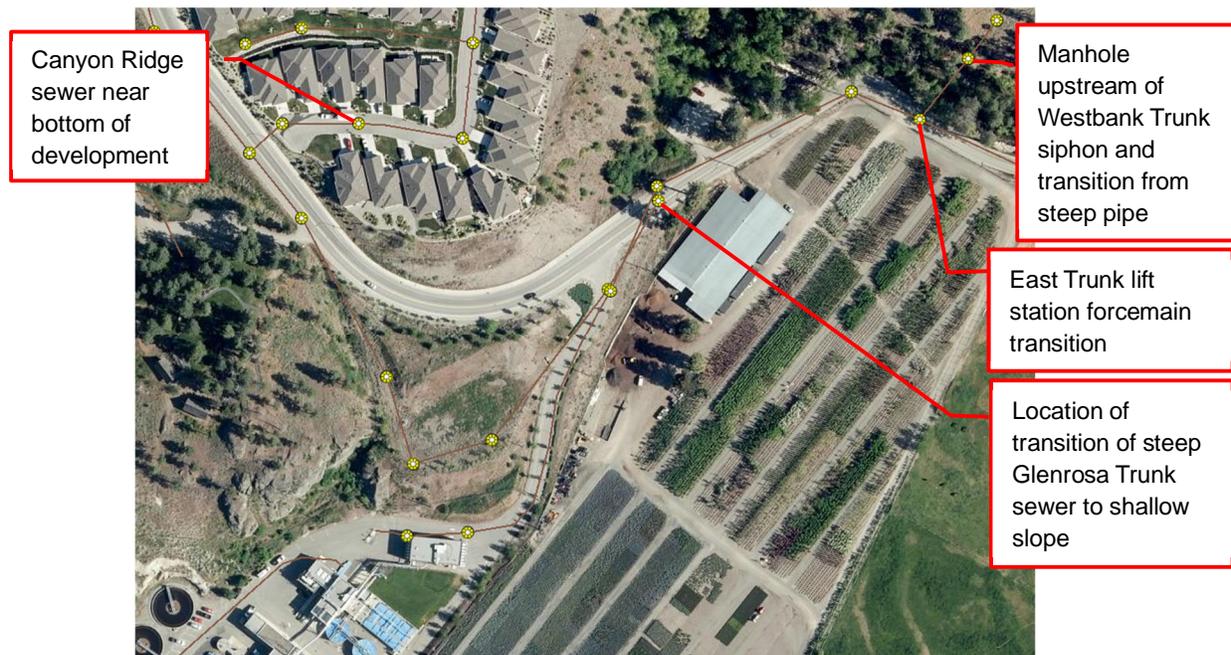
Figure 3-2: Location of H₂S Monitoring in the Canyon Ridge Area

H₂S loggers were installed at three locations in the wastewater collection system in the vicinity of the Canyon Ridge development and Flying Horse Drive areas. The three sites include:

1. Manhole located just upstream of the inverted siphon below Powers Creek on the Westbank Trunk
2. Manhole located at the transition of the East Trunk Lift Station forcemain to gravity flow
3. Manhole in the Canyon Ridge development near lower end of complex

Data from the H₂S logger installed upstream of the creek siphon and at the East Trunk Lift Station forcemain transition show high concentrations in the headspace which varies based on a diurnal pattern. In effect, the headspace in these sewers are potentially a constant source of odours in the area and likely contributes to the complaints documented in the vicinity of the fish ladders. It is expected that the Gellatly Road trunk exacerbates the potential for odour emissions given the transition from a steep slope to shallow slope pipe near the entrance to the WRWTP.

An H₂S logger was installed in a manhole at the bottom of the Canyon Ridge development, near where 2 residents have registered odour complaints. Two significant bursts of H₂S were measured on October 10 and 11, one of which lasted for 3 hours and registered a peak H₂S of 2.9 ppm. Additional monitoring is required to determine if these events were anomalous or are a regular occurrence. The bursts of H₂S are sufficiently large to be potential sources of odour.

5. The Westbank Trunk siphon is generating odour emissions due to the turbulence at the bottom of the slope near Powers Creek and is likely contributing to the complaints by residents on Flying Horse Drive. As a short-term solution, a new carbon scrubber should be installed prior to the summer, 2022. The carbon scrubber should allow for air venting to be unimpeded at the upstream end of the siphon. Furthermore, an H₂S logger should be installed on the carbon scrubber vent and operated continuously through the summer to assess performance and to determine a media replacement schedule.

6. The manhole where the East Trunk Lift Station manhole transitions to gravity flow is currently a source of odours in the immediate area and should be addressed in conjunction with long term solutions for the Westbank Trunk siphon emissions. As a short-term solution, a carbon scrubber in the manhole through the spring and summer of 2022 would help to reduce odour emissions. Following installation of the carbon scrubber, an H₂S logger should be installed on the vent and operated continuously through the summer to assess performance and to determine a media replacement schedule.

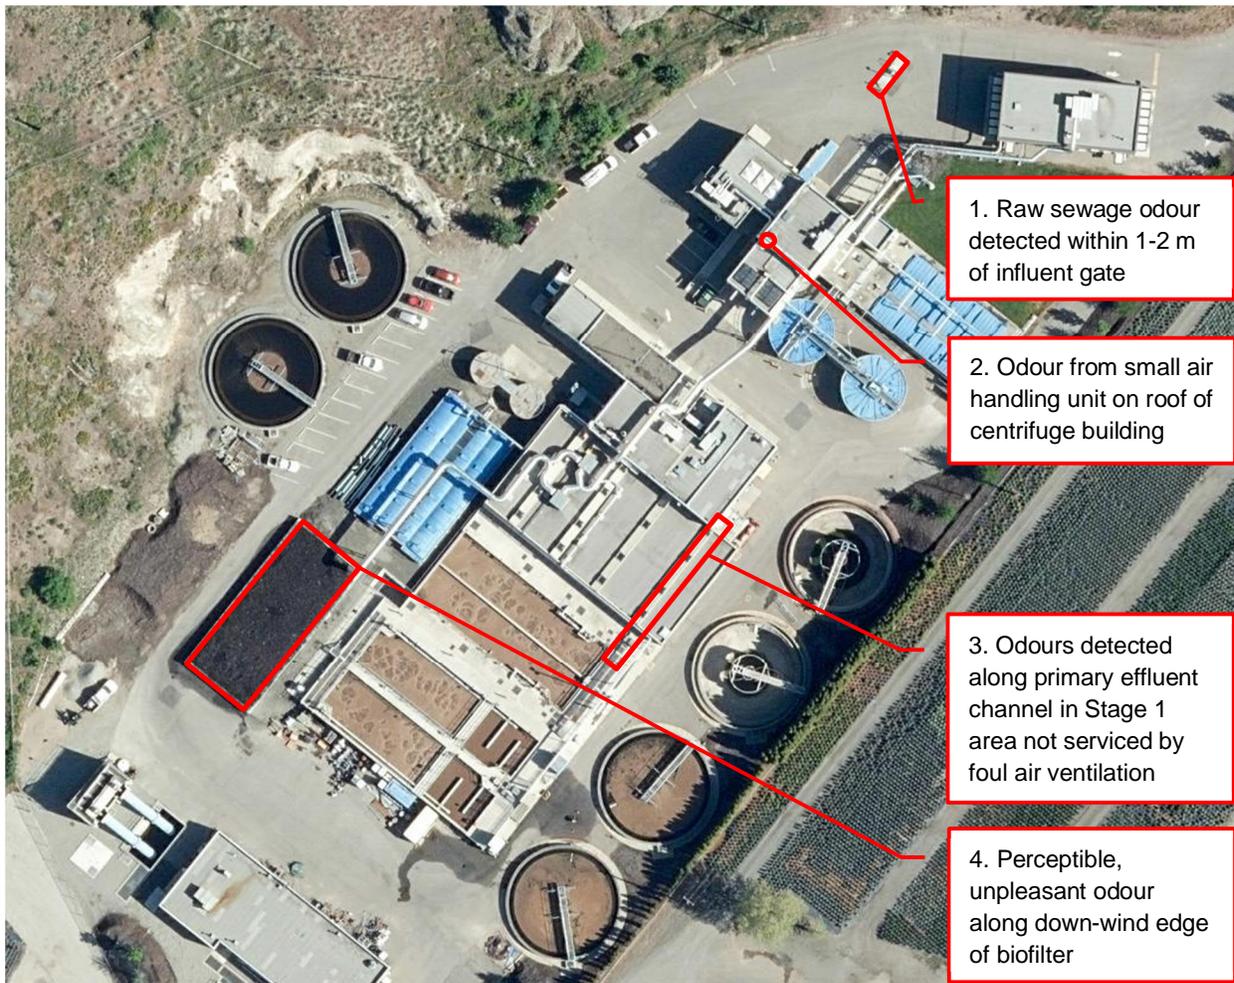
Figure 3-3: Sources of Odour Identified at the WRWTP

The biofilter media was replaced over the May 11 to May 17, 2021 period and it is not clear how this work has impacted treatment efficiency through the summer. Biofilters rely on developing a healthy population of various bacteria on the media to break-down the foul air constituents. The hot weather experienced through June and July may have prevented the media from staying fully saturated and did not allow the biofilter from reaching optimal performance. To address the performance issues observed, the design of the biofilter should be assessed under warm weather conditions to identify improvements. Upgrades that could provide better treatment and dispersion performance include:

at a negative pressure relative to atmosphere to ensure odour to not escape. The next plant-wide balancing should include confirmation of room pressures and room space air-changes.

- Covering the biofilter to reduce moisture loss
- Addition of an air stack to improve dispersion
- Replacing the organic media with an inorganic media
- Improvements to the humidification, pre-conditioning step
- Addition of a trickling filter, consisting of a fibreglass tank filled with plastic packing media through which the foul air is passed before entering the biofilter. The biofilter media is constantly wetted and allows sulphur-oxidizing bacteria to grow which attenuates loading to the biofilter.
- Partitioning the biofilter to allow for duty/standby operation and facilitate maintenance

- b. Regular H₂S measurements of the biofilter performance should be conducted using the Jerome meter to assess treatment performance and proactively address any foul air break-through. The testing should be started as soon as possible with air samples taken as close to the middle of the biofilter surface as possible. Samples should be taken at least 5 days per week or when the centrifuge is operating to reflect the worst-case operating conditions.

- c. It is suspected that short-circuiting is occurring through gaps in the lock block containment. The leaks should be confirmed through site investigations and local sampling using the Jerome meter and sealed as required.

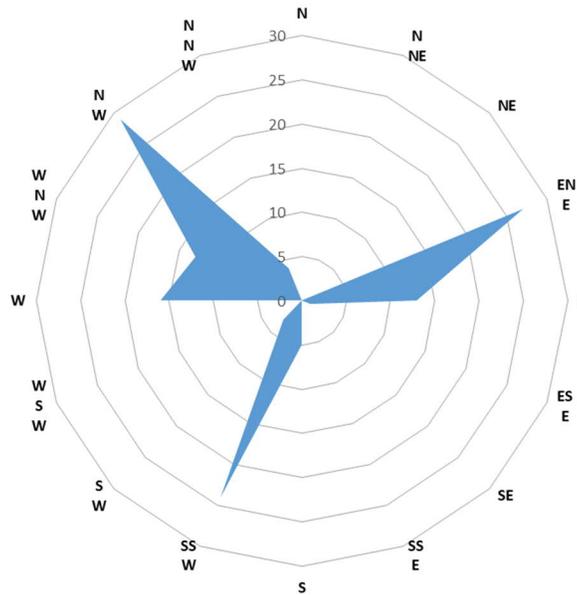
Figure 3-4: Dominant Daily Average Wind Direction Plot (June 1 to October 14, 2021)

Figure 3-4 provides a plot of the wind direction for the period of June 1 to October 14, 2021. The predominant wind direction during this period is from the north-west, east-north-east and west.

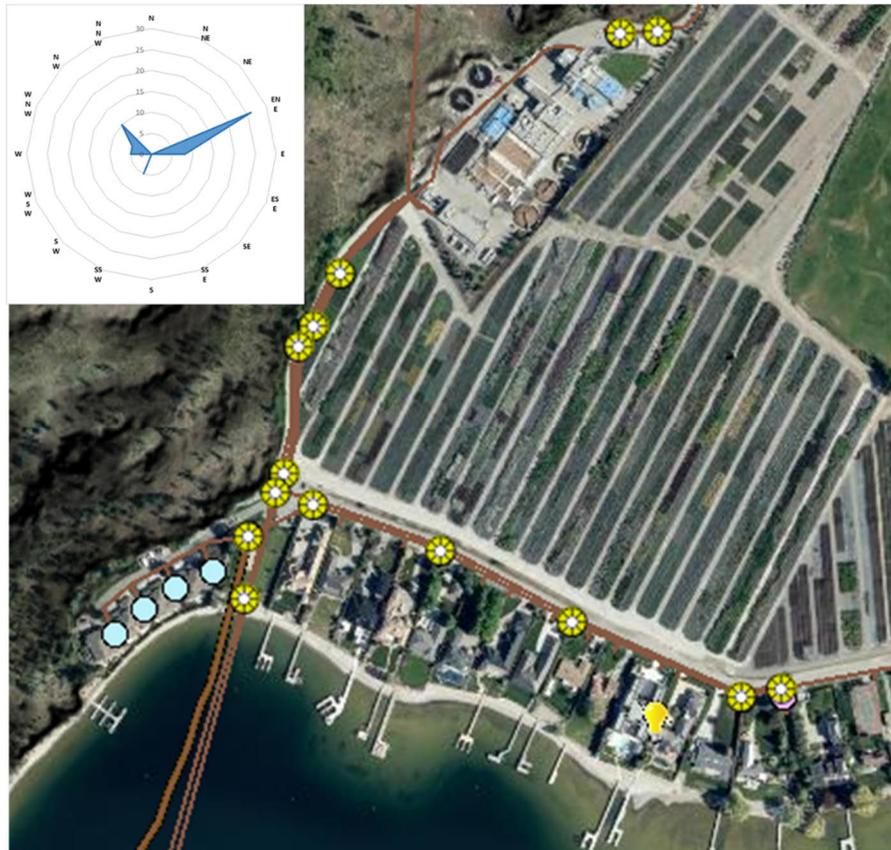
Figure 3-5: Daily Average Wind Direction on Days When Odour Complaints Were Received for Whitworth Road Area

For 26 of the 59 days when odour complaints were documented for the Whitworth Road area, the predominant wind direction was from the east-north-east direction. While this implicates the WRWTP as a

source, for 20 of 59 complaints the predominant wind direction on those days was away from the Whitworth Road area.

The wind direction data averaged over the day may be too coarse to assist identification of odour sources. The data also does not allow for assessing conveyance of odours in the evening and mornings when there is little air movement. Under these conditions, passive diffusion and density gradients may be more important for transmission. The weather station should be updated to log data over more smaller time increments (i.e., 5-10 minutes) to allow for more detailed assessment and allow for a dispersion model to be developed which accounts for possible transmission mechanisms. The dispersion model would allow for developing foul air treatment design objectives based on achieving a maximum H₂S threshold for residents in the Canyon Ridge, Flying Horse Drive and Whitworth Road subdivisions. It is further recommended that assessment of the biofilter performance be informed by the dispersion model output.

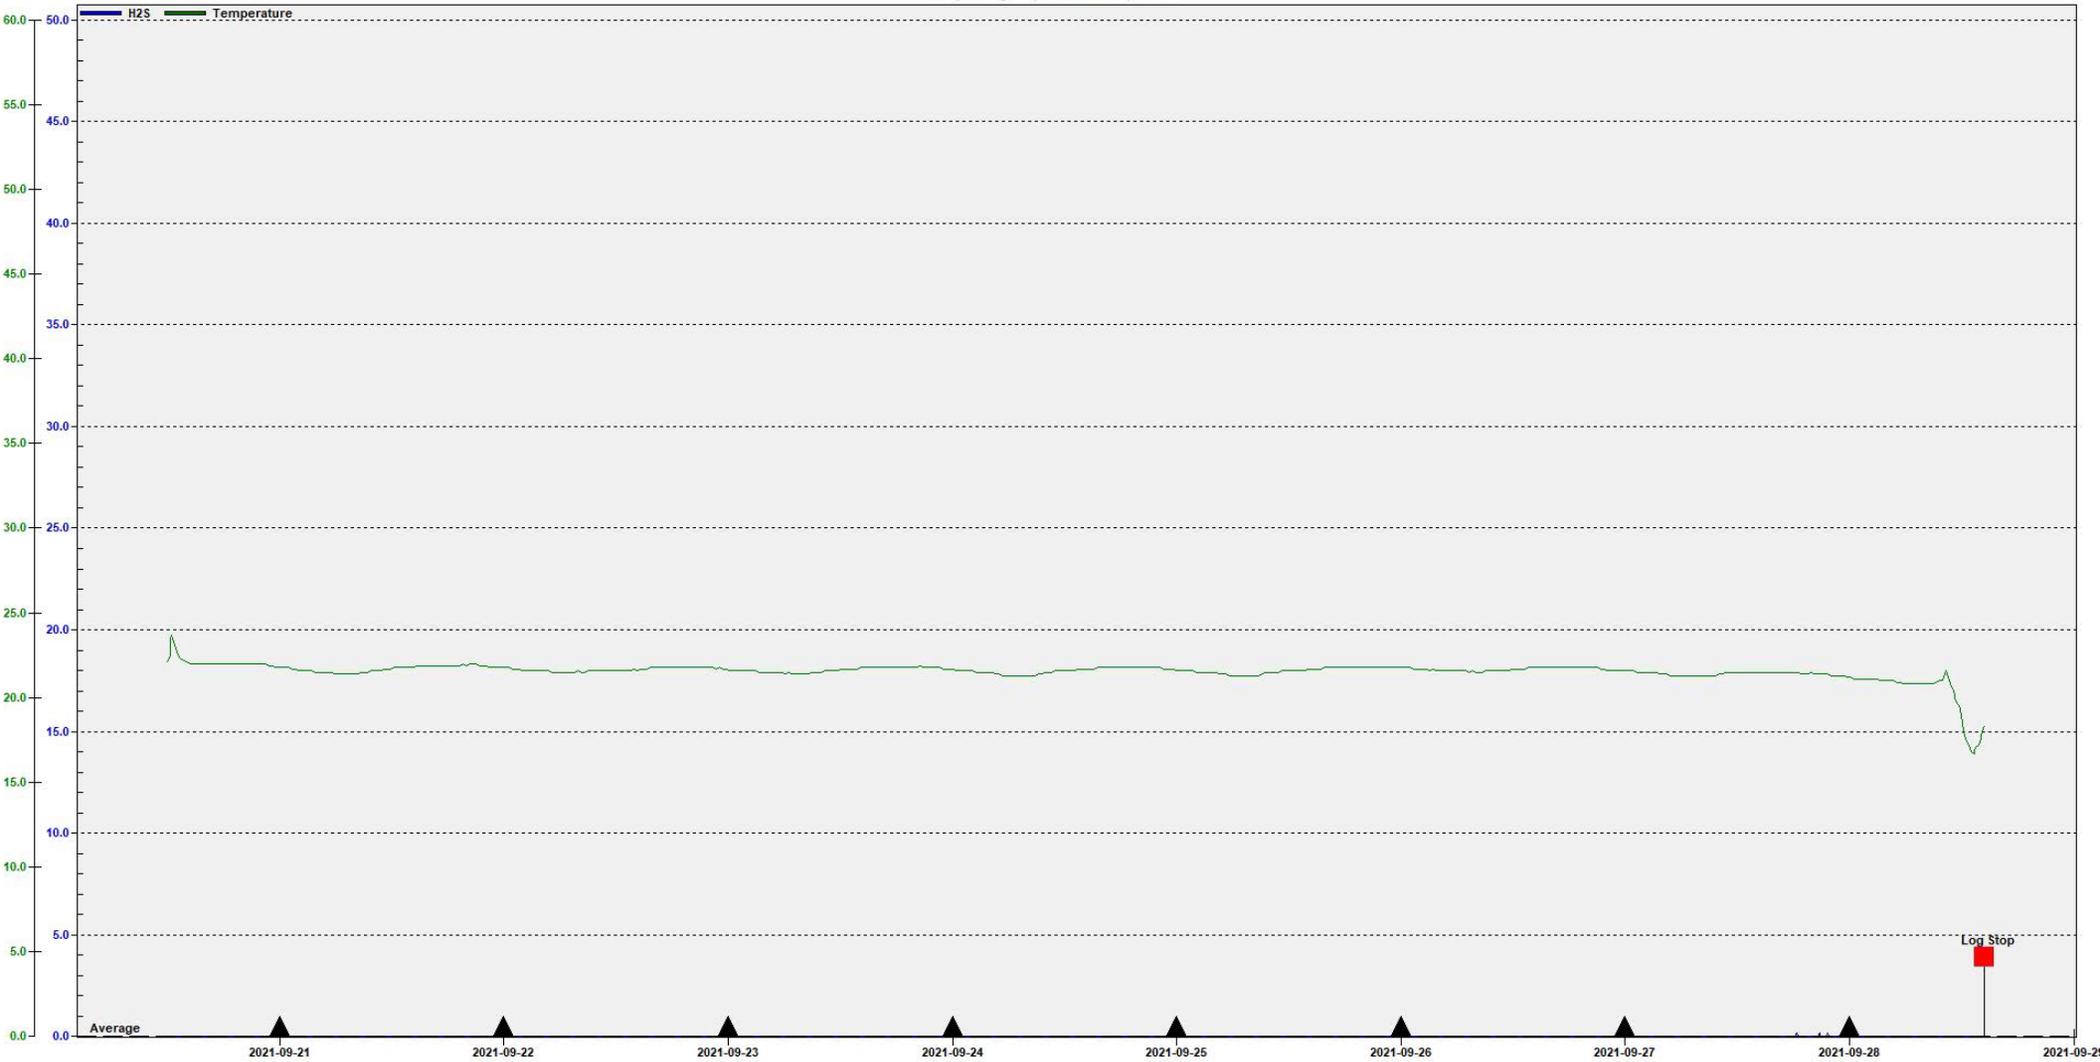
Canyon Ridge September 20 - 28, 2021

Period Displayed: 2021-09-20 - 2021-09-29 (Oda File: 20210929_05710087_01.oda -- Serial Number: Odialog Type L2-RTx 05710087 Instrument Range 0-0PPM)

Average 0.0 ▲ Month Transition Min 0.0 Max 0.3 (Use Screen Data Only)

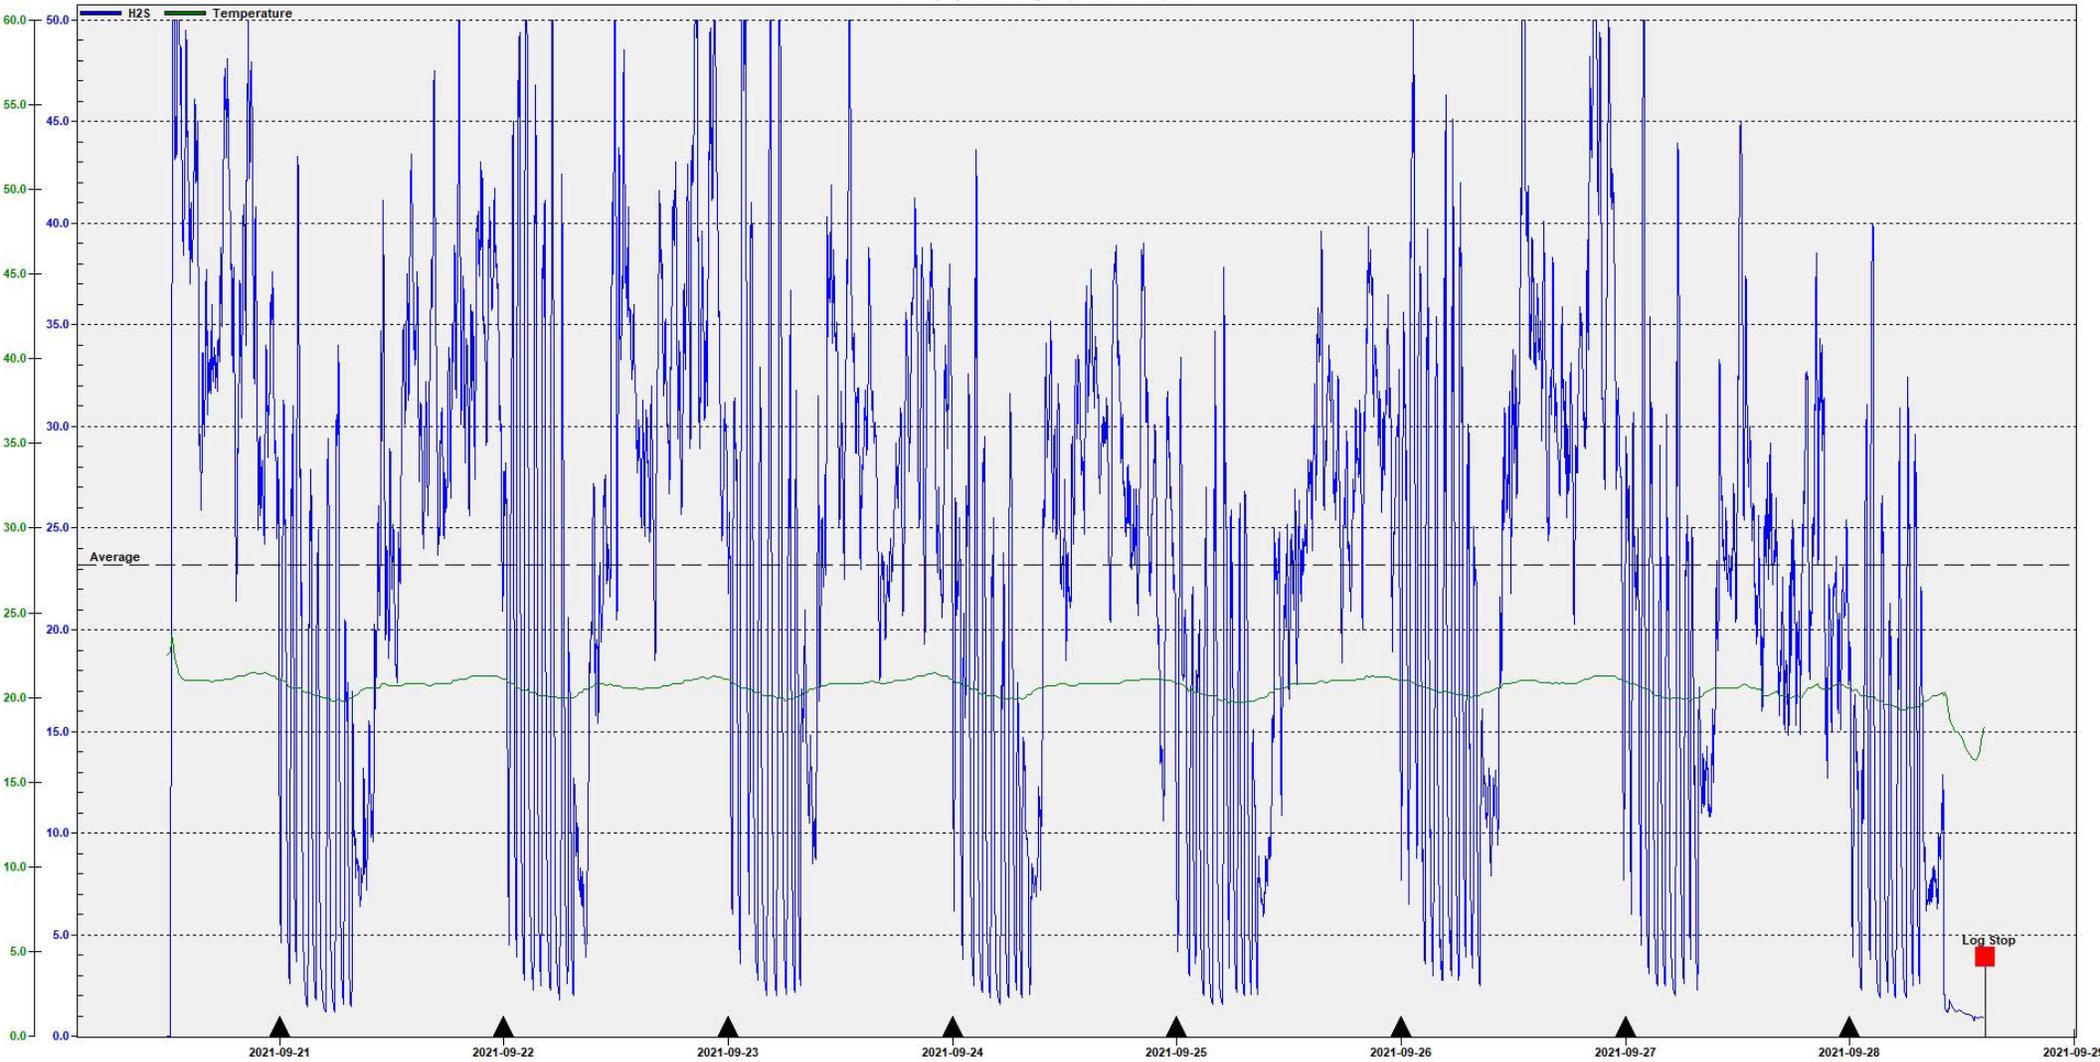
Gellatly Siphon Discharge September 20 - 28, 20221

Period Displayed: 2021-09-20 - 2021-09-29 (Oda File: 20210929_09507851_01.oda -- Serial Number: Odialog Type L2-RTx 09507851 Instrument Range 0-0PPM)

— Average 23.2 ▲ Month Transition Min 0.0 Max 62.2 (Use Screen Data Only)

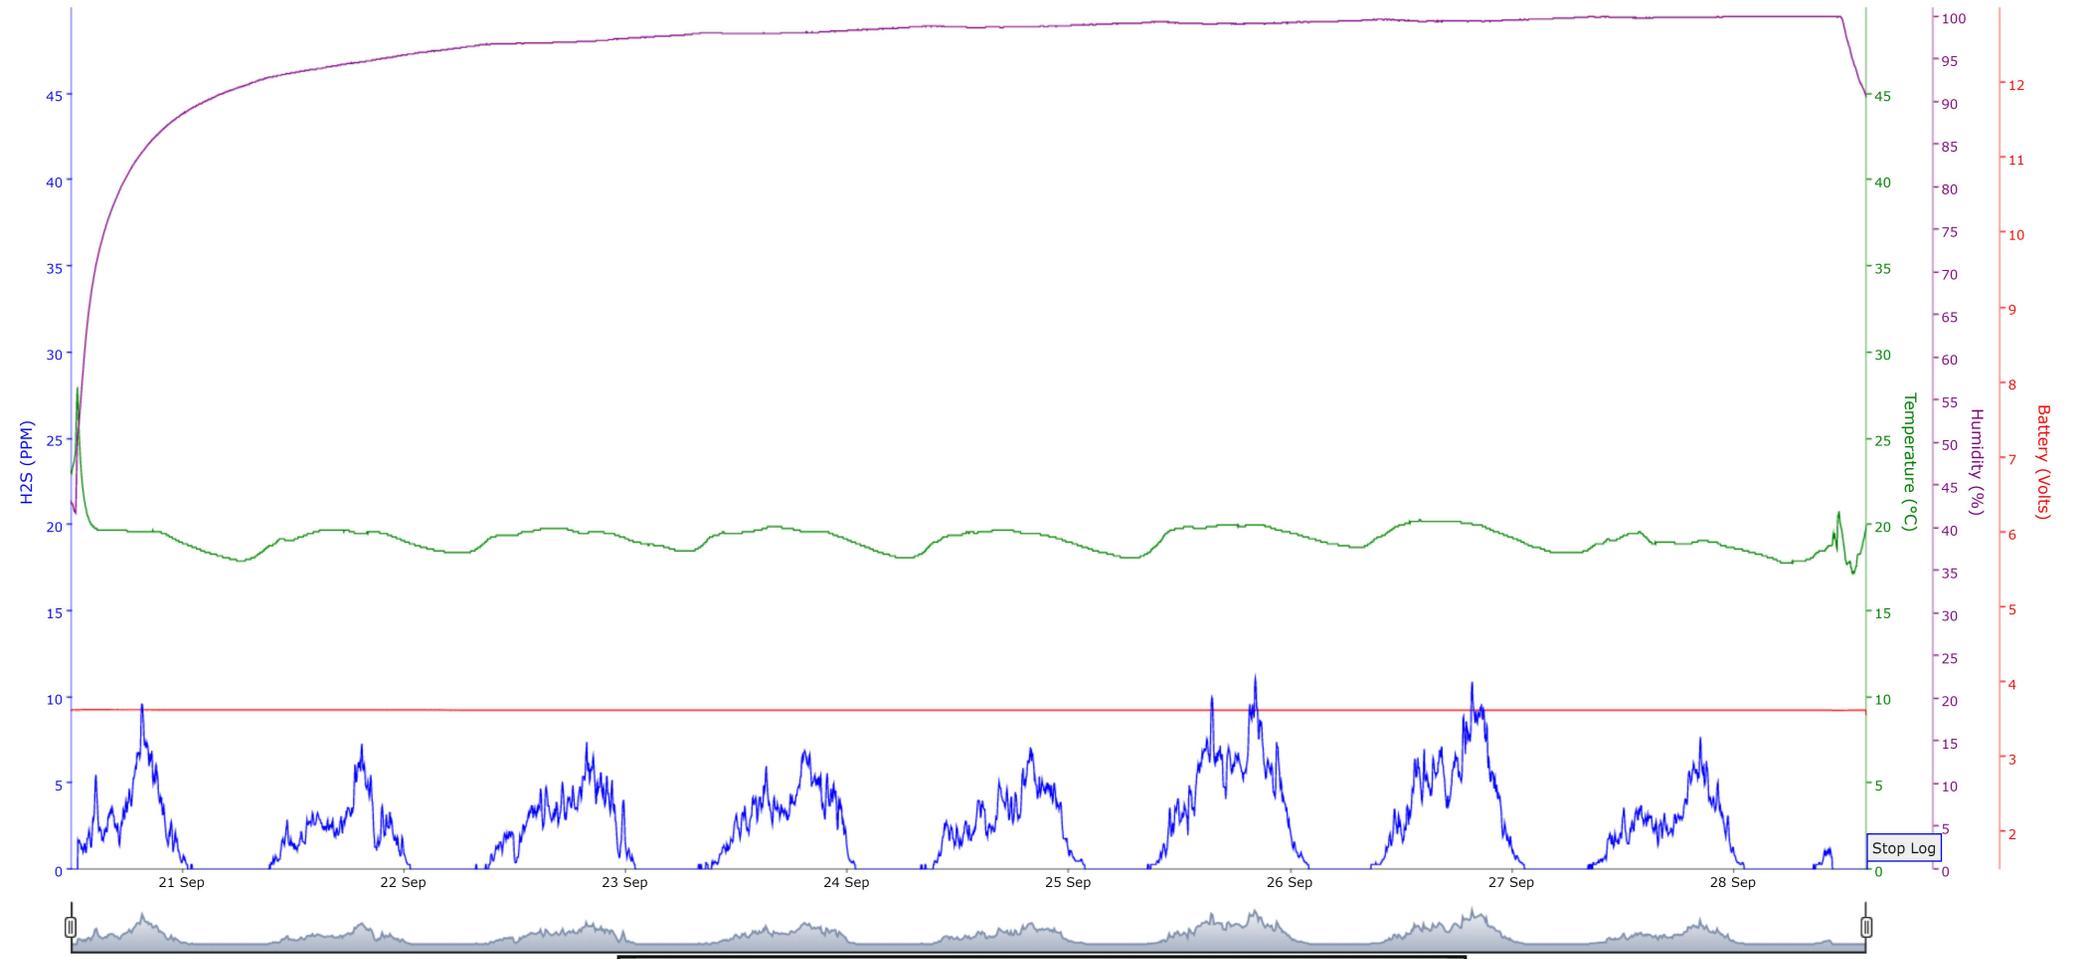
Gellatly Siphon H2S-210504331_9_20_2021, 11_59_19 AM --- 9_28_2021, 2_29_19 PM:[Regional District of Central Okanagan]

Average: 2.18 PPM; Minimum: 0 PPM; Maximum: 11.1 PPM [9/20/2021, 11:59:19 AM --- 9/28/2021, 2:29:19 PM]

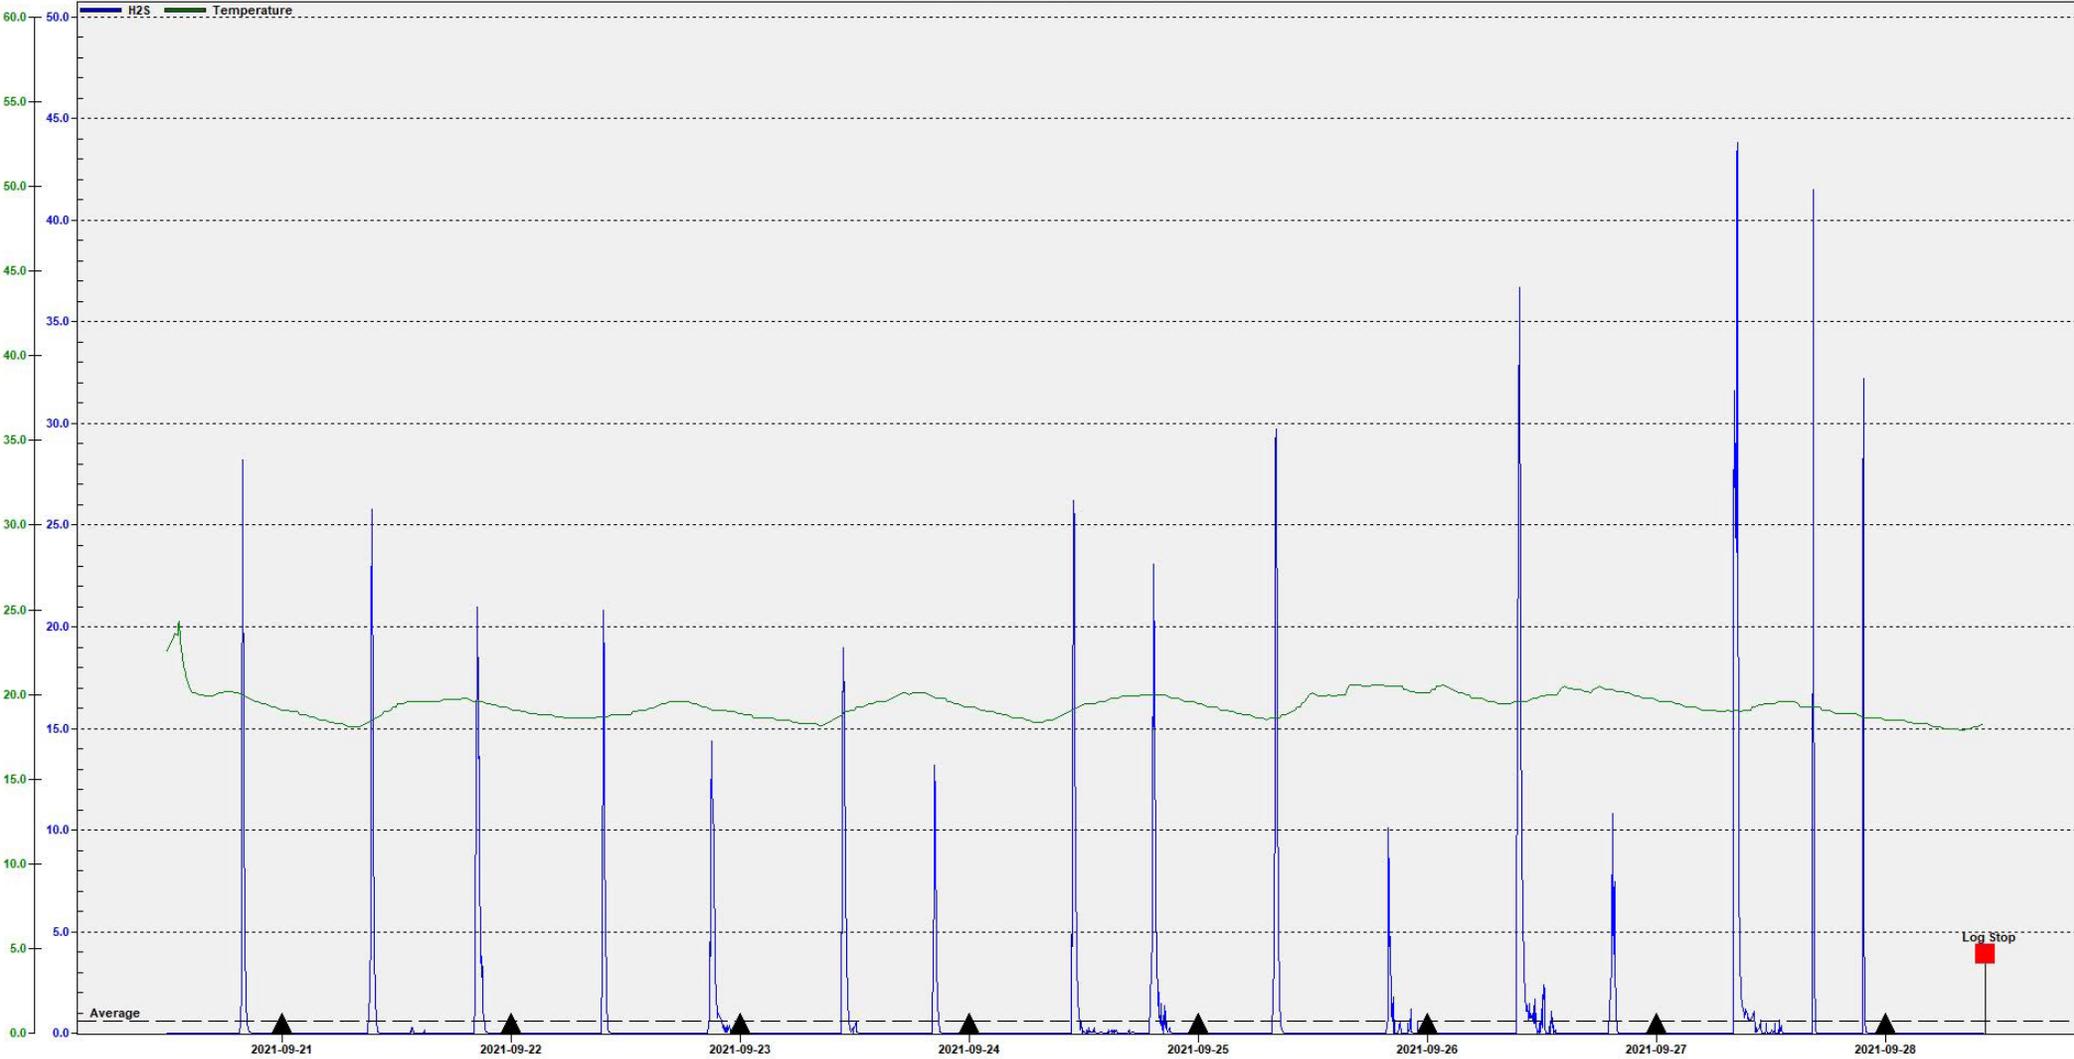
Pebble Beach Discharge September 20 - 28, 2021

Period Displayed: 2021-09-20 - 2021-09-28 (Oda File: 20210929_05203916_01.oda -- Serial Number: Odalog Type L2-RTx 05203916 Instrument Range 0-0PPM)

Average 0.6 ▲ Month Transition Min 0.0 Max 43.8 (Use Screen Data Only)

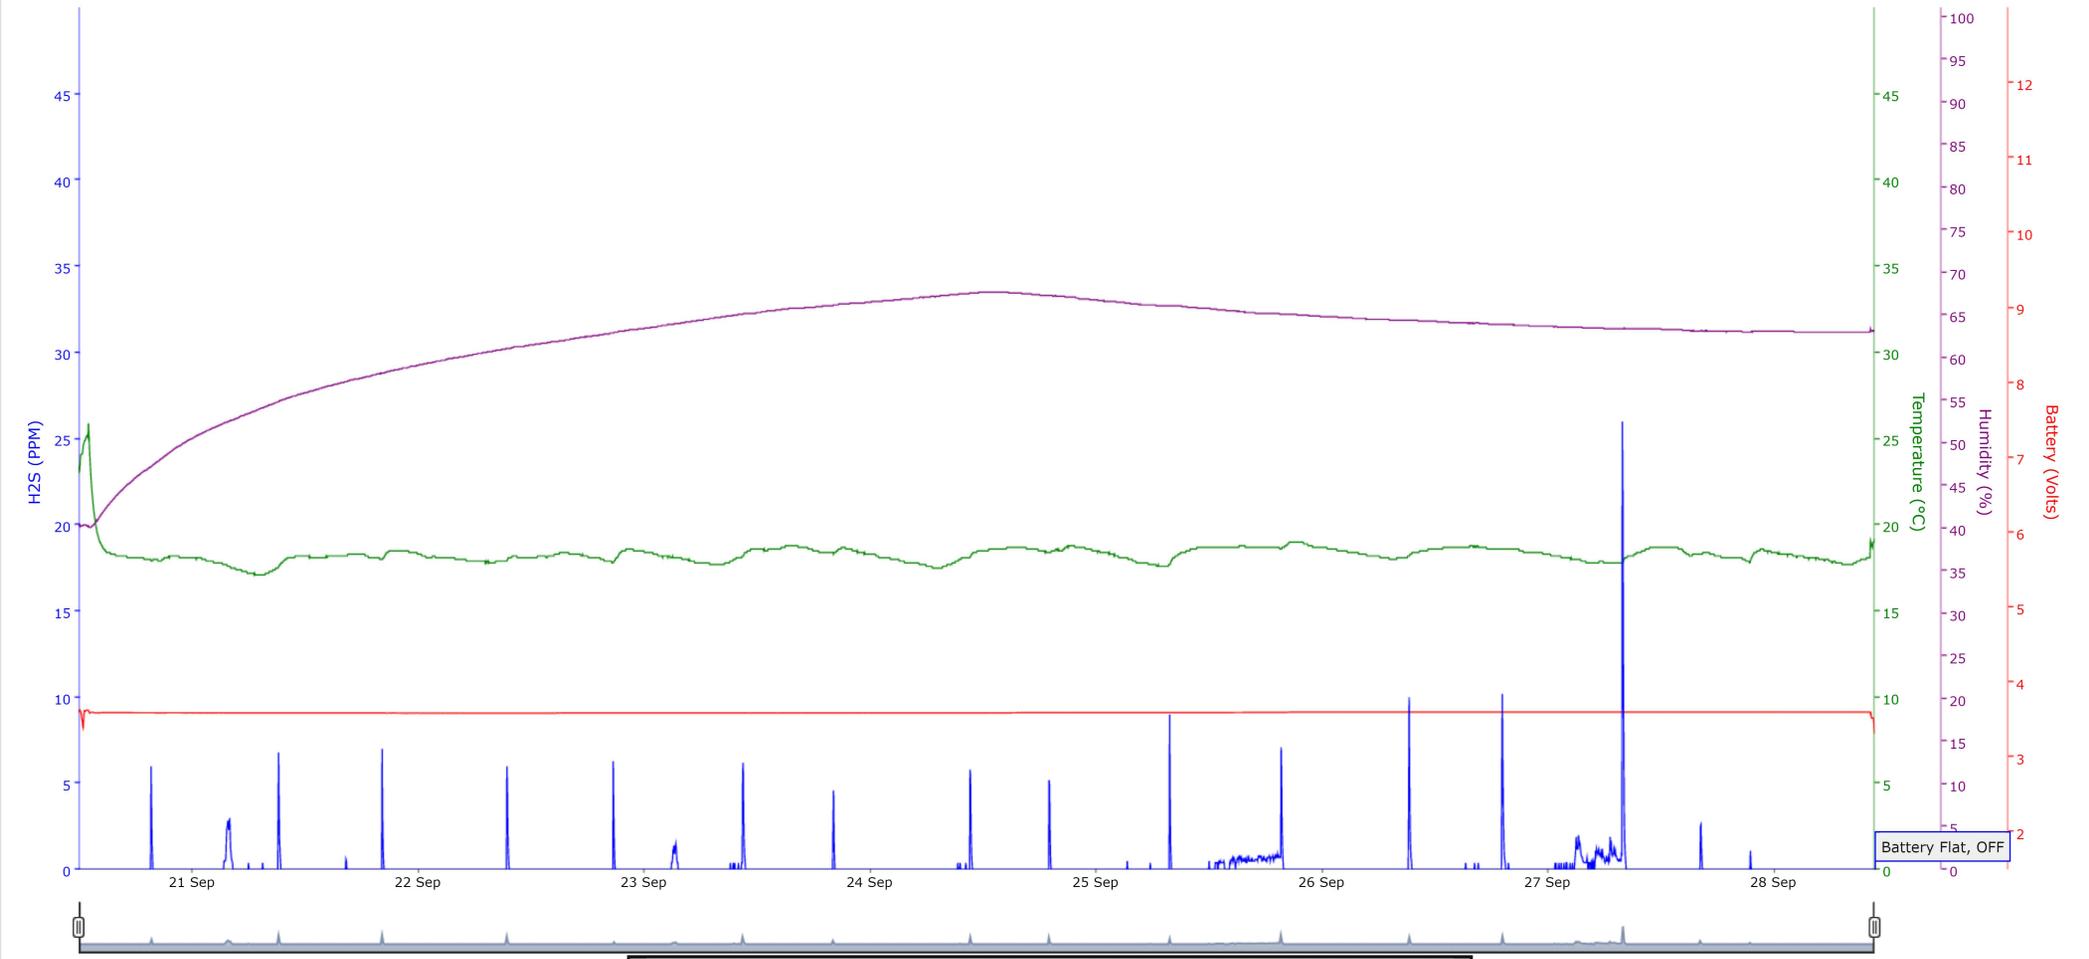
Pebble Beach Lift Station H2S-210504333_9_20_2021, 11_59_03 AM --- 9_28_2021, 10_47_03 AM:[Regional District of Central Okanagan]

Average: 0.13 PPM; Minimum: 0 PPM; Maximum: 26 PPM [9/20/2021, 11:59:03 AM --- 9/28/2021, 10:47:03 AM]
