POST-WILDFIRE NATURAL HAZARDS RISK ANALYSIS OF THE 2023 MCDOUGALL CREEK WILDFIRE (K52767)

Dated:	January 4, 2024
Presented To:	Ministry of Forests – BC Wildfire Service
Attention:	Mr. Gareth Wells, P.Geo.
CGL Project #	23-0106
Version:	Final - Issued for Use

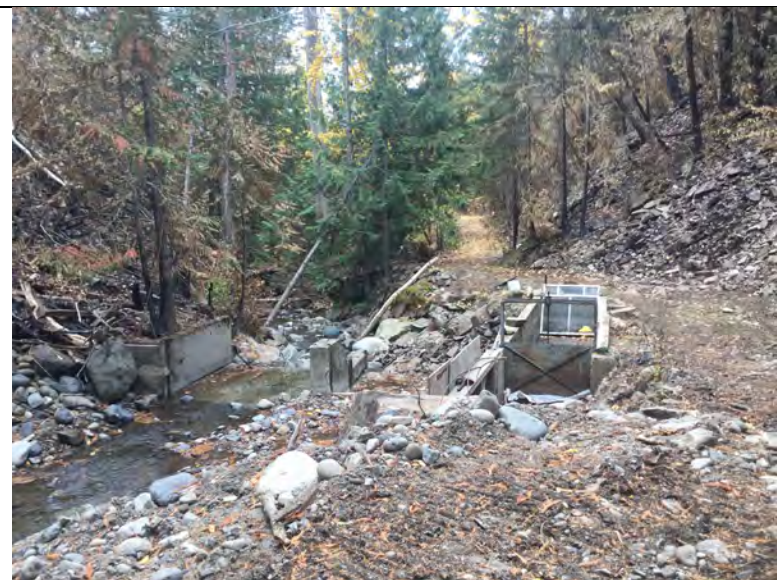
Photo 3: Water intake structure on McDougall Creek within lower canyon (view downstream) (McDougall-1).

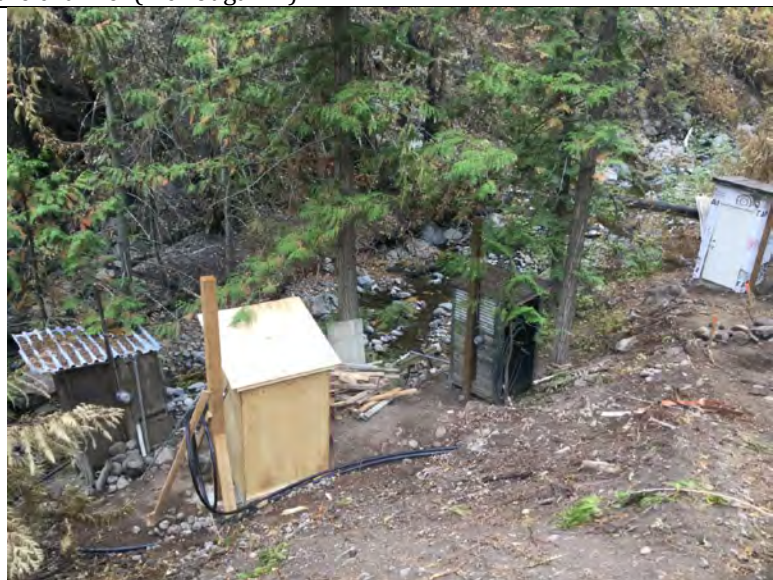
Photo 4: Water intakes accessed off the end of Bartley Road on lower McDougall Creek.

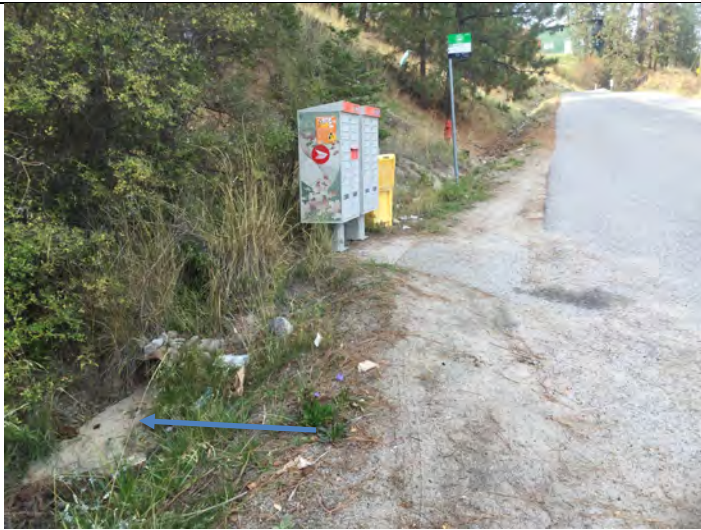
Photo 5: Shallow ditch along Bear Creek Rd (at McNaughton) with small culvert under mailbox. Note recent sediment in ditch (arrow) (Keefe-1)

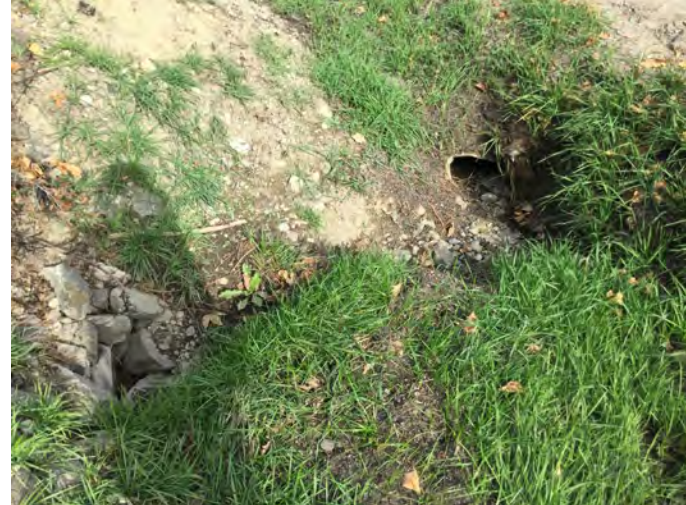
Photo 8: Partly-plugged 400 mm and 250 mm culverts under Bear Creek Road (Keefe-3)

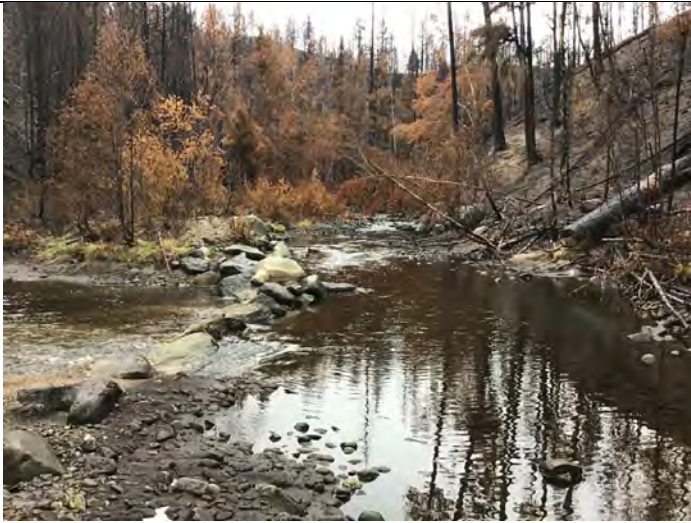
Photo 12: Lambly Creek, view upstream from diversion (Lambly-6)

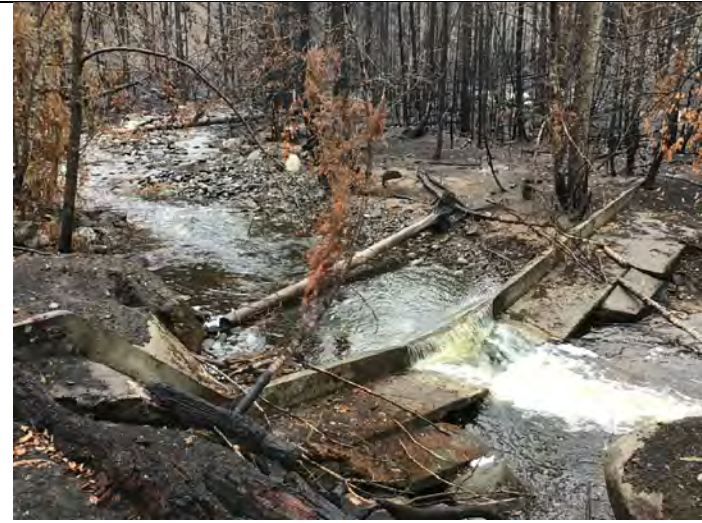
Photo 13: Lambly Creek channel upstream of diversion, view of old weir structure. Note burned riparian forest in floodplain (Lambly-7)

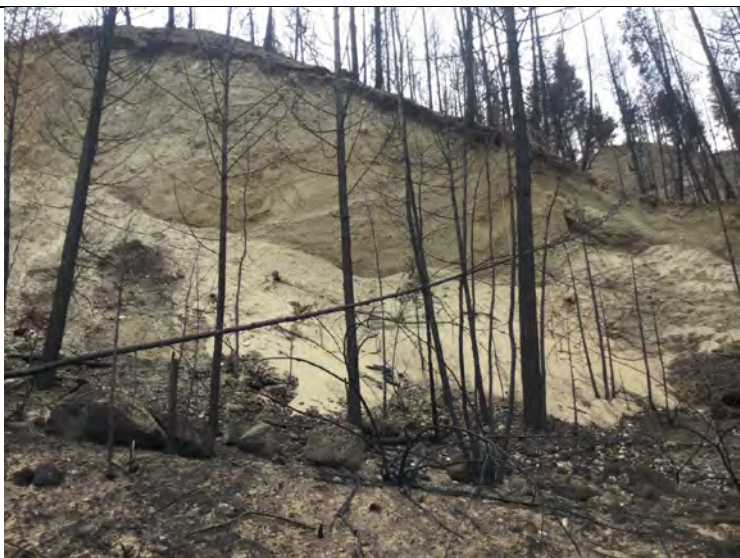
Photo 16: Stratified glaciofluvial and glaciolacustrine sediments exposed along side slopes above water pipeline and Lambly Creek (Bear Ck Rd-2)

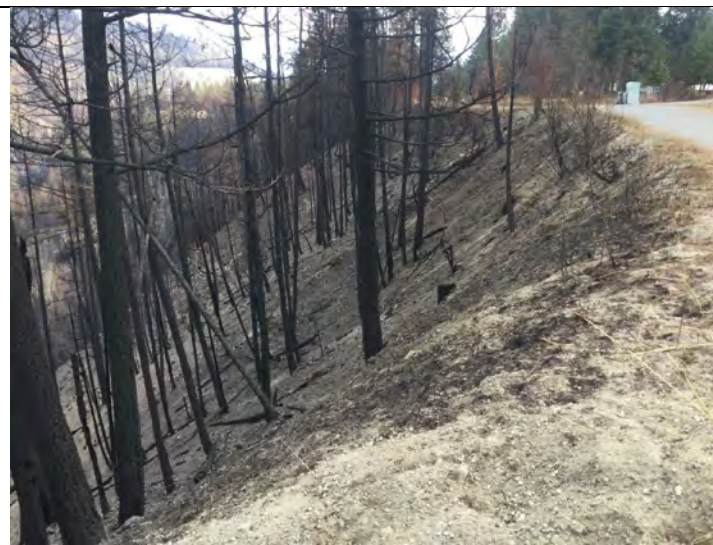
Photo 17: View along edge of burned steep slopes below Bear Creek Road (Bear Ck Rd-1)

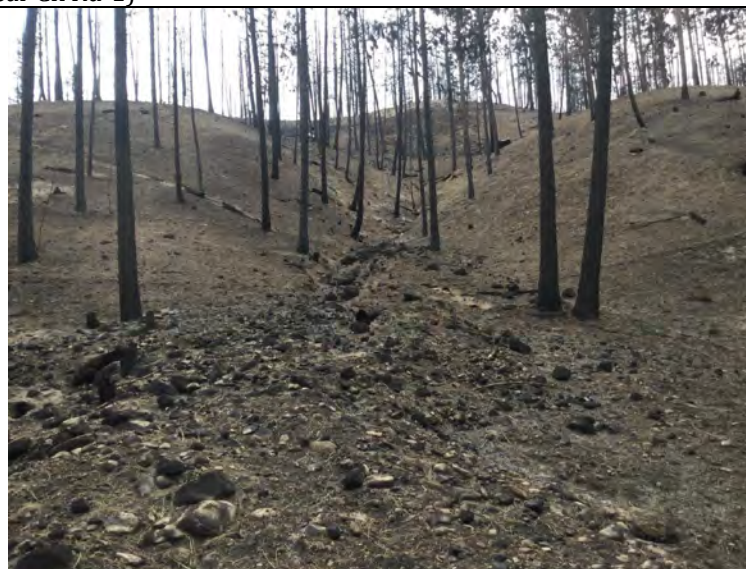
Photo 19: View of small debris-flow gully upslope of Bear Creek Rd (Bear Ck Rd-3)

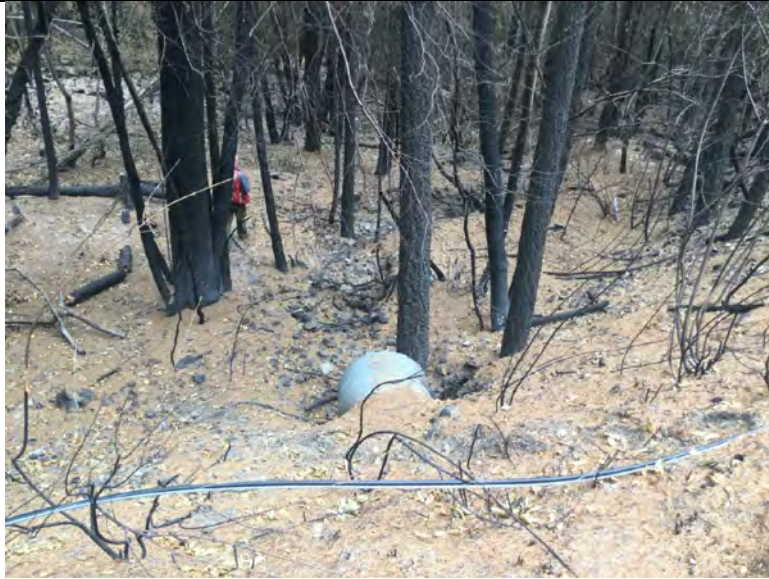
Photo 28: View downstream from Bear Creek Road at culvert crossing. Note abundant colluvium, and hummocky terrain indicative of past flood events. (Cedar-4)

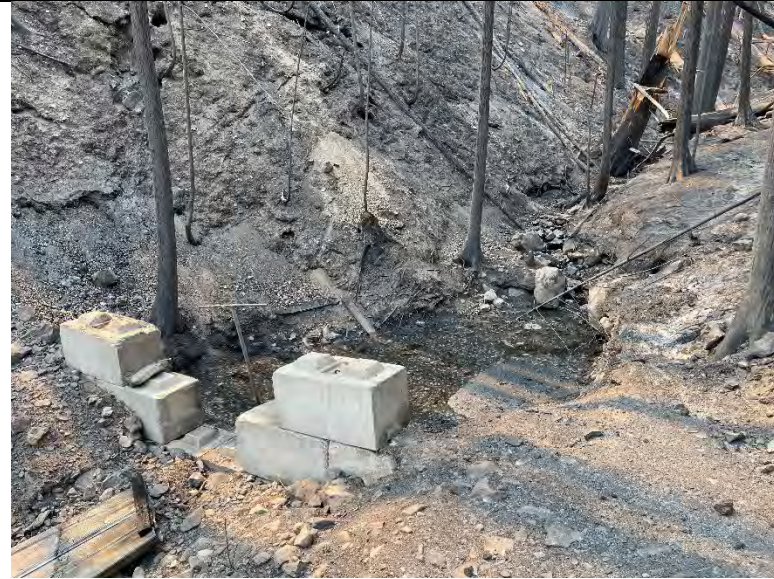
Photo 29: Domestic Water Intake on Cedar Creek (photo provided by L. Jensen 910 Bear Ck Rd) (Cedar-5)

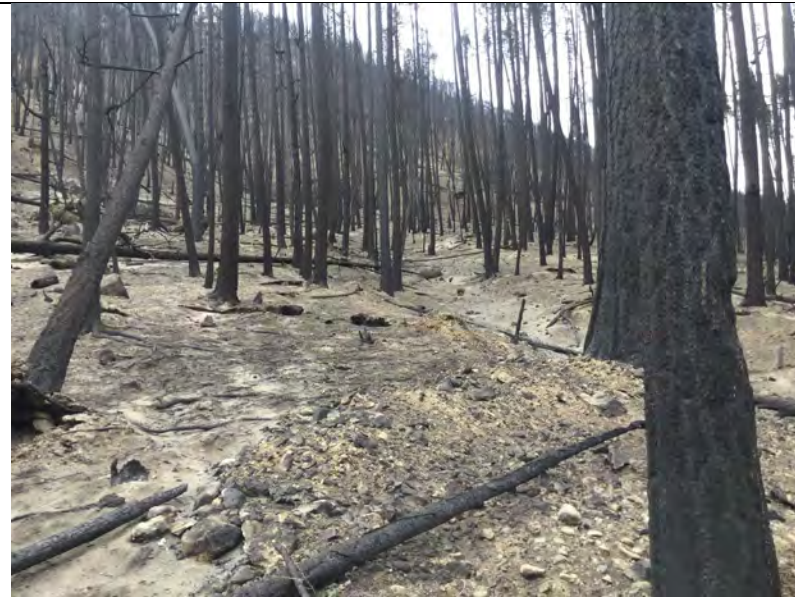
Photo 31: Lower end of colluvial fan on Lambly Tributary 2 (no visible channel) located south of 524 Bear Creek Road (Lambly Trib2-1)

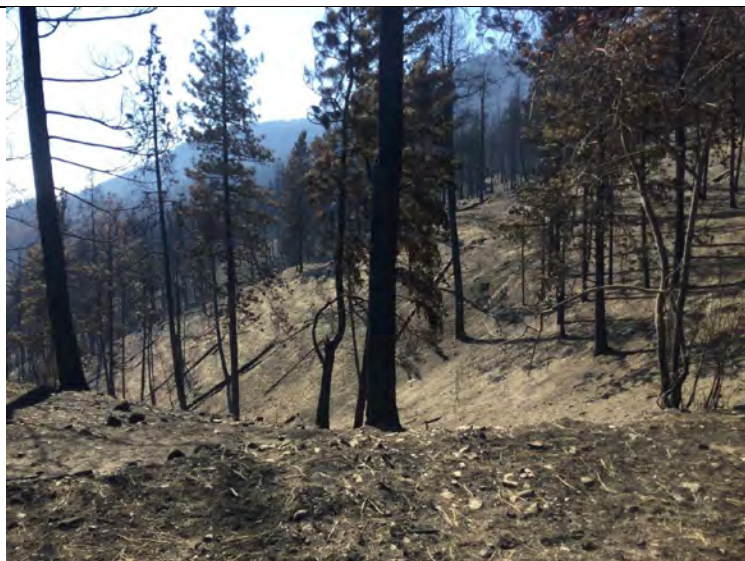
Photo 13: Slopes at ~600 m elevation showing benched slopes and upper slope breaks at gully headwalls (north of Wilson Creek) (Wilson-4)

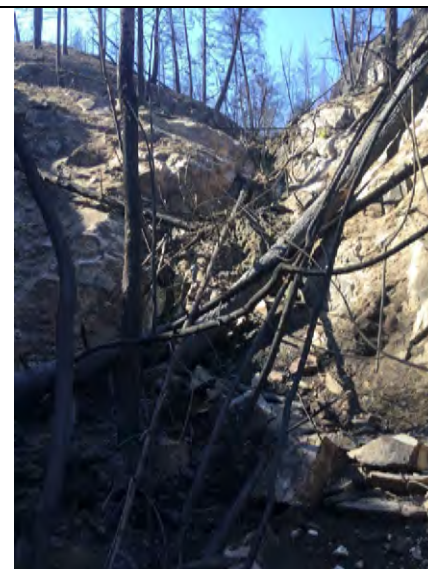
Photo14: View upslope along bedrock-controlled reach of Wilson Creek. Abundant rockfall and exposed soils available to the channel (Wilson-5).

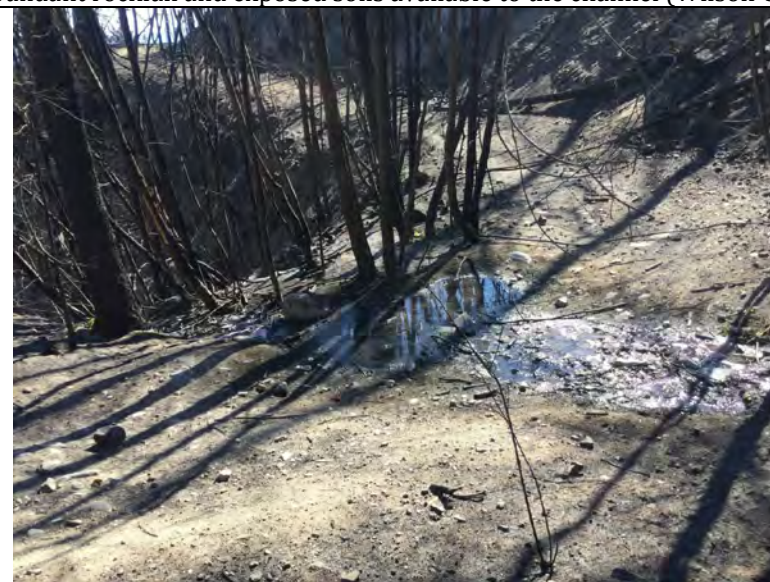
Photo16: Water flowing across old trail crossing on Wilson Creek, mid-watershed (Wilson-6)

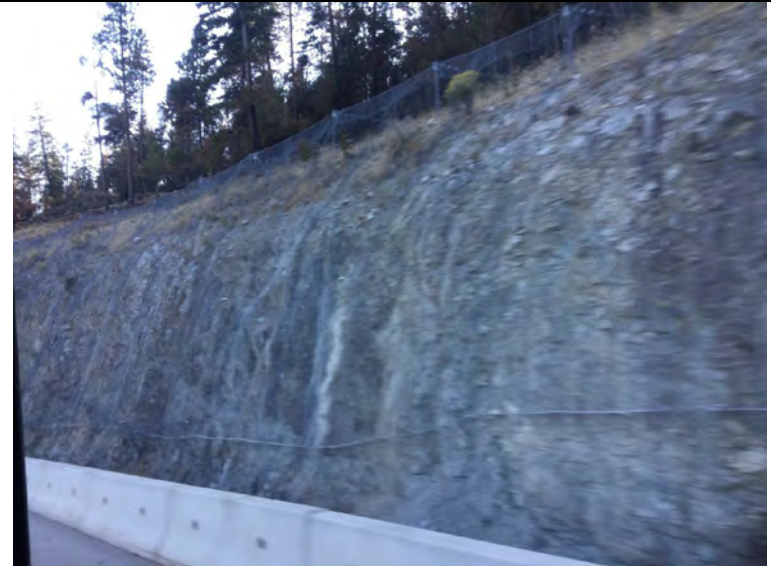
Field observations along Westside Road (Waypoint Westside-1) noted that wide ditches can capture and detain sediment-laden runoff from burned slopes above. An example of this is shown in Photo 4 (Appendix C-7). Sections of Westside Road have upgraded drainage structures, such as the 1200 mm diameter culvert with concrete baffles and rock-lined ditches (at Waypoint Westside-2; Photo 19). These newer structures may be able to accommodate post-wildfire runoff, but not moderate-sized debris flows. A section of Westside Road has been improved, with stabilized rock cuts and installed rockfall mitigation fencing (Westside-3; Photo 20). This structure will reduce the likelihood of rockfall reaching the road.

Photo 20: Rock cut with rockfall protection fencing along Westside Road.
