CLARKE GEOSCIENCE LTD.

POST-WILDFIRE ENVIRONMENTAL AND HAZARDOUS CONDITIONS ASSESSMENT OF THE NORTH WESTSIDE ROAD AREA

Dated:	February 23, 2022
Presented To:	Regional District of Central Okanagan
Attention:	Brittany Nichols, Environmental Planner
CGL Project # 21-0115	EOC #A21-674
Document Control:	Version Rev. 1 (corrected civic and legal property addresses for 3 properties)

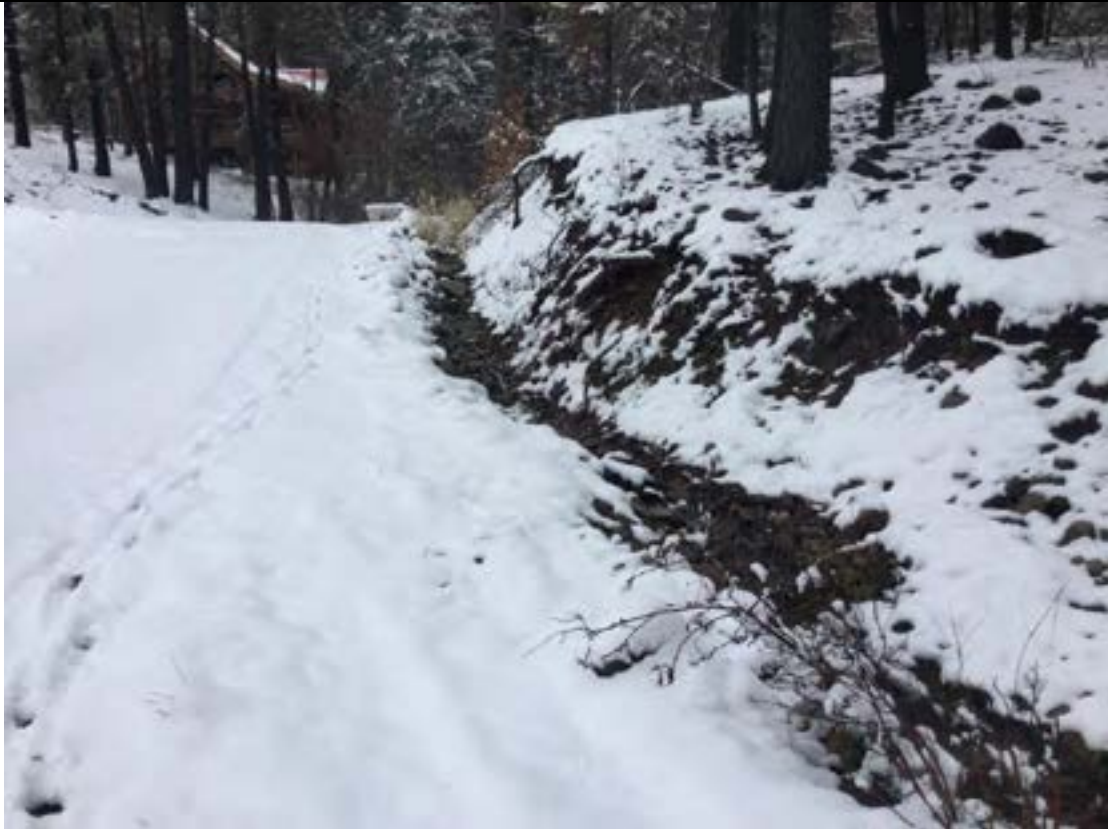
Photo 2: View of stream that flows along the north property boundary of 9344 Westside Rd.

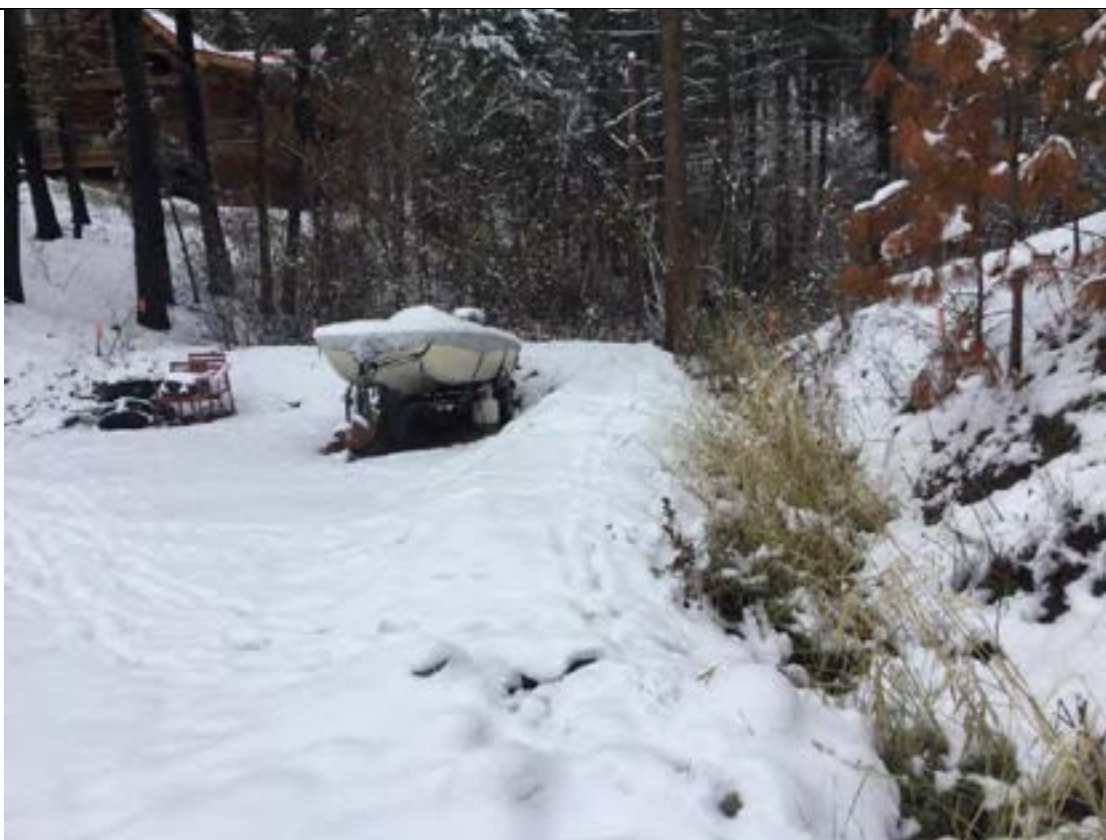
Photo 3: View of berm surrounding small pond located just upslope of 9344 Westside Rd.

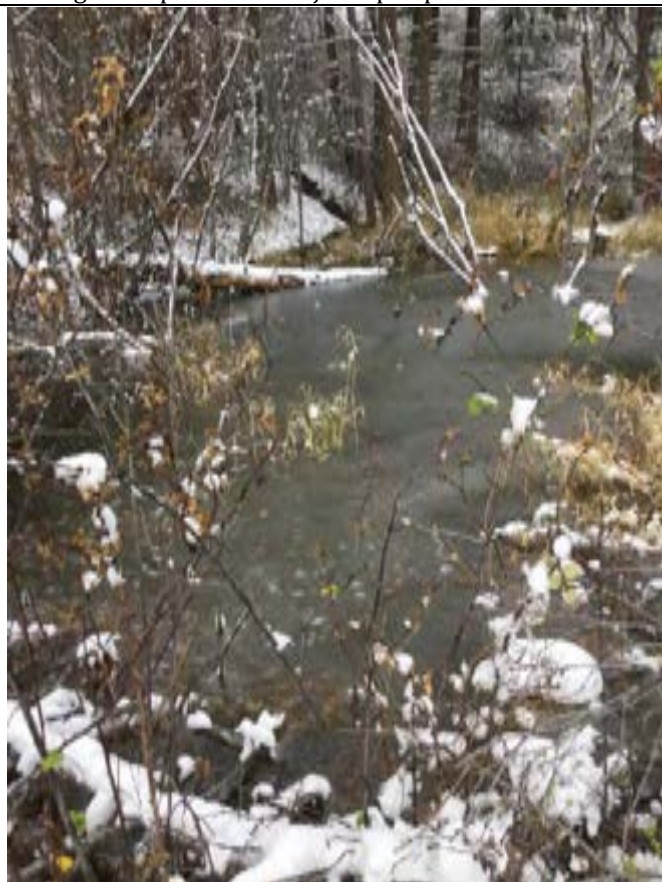
Photo 4: View of small pond located upslope of 9344 Westside Road. Water level controlled by elevation of outlet.

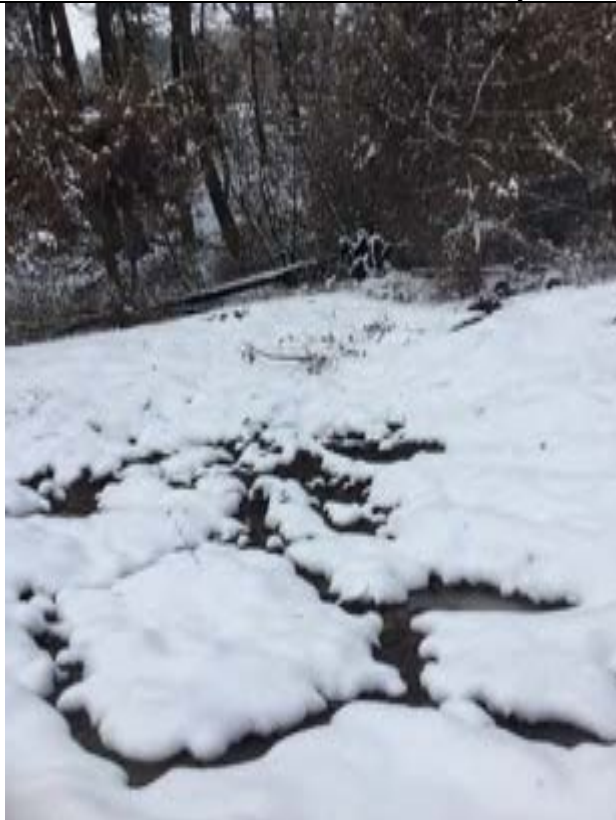
Photo 2: View of seepage across property and view towards stream (Norris Creek) in background along south property line.

Recommended Recovery Response and Considerations for Future Development:	Short term (pre-freshet): Ensure full clearance of culvert under Udell Road. Monitor and be prepared to respond to overflow and/or blockage.

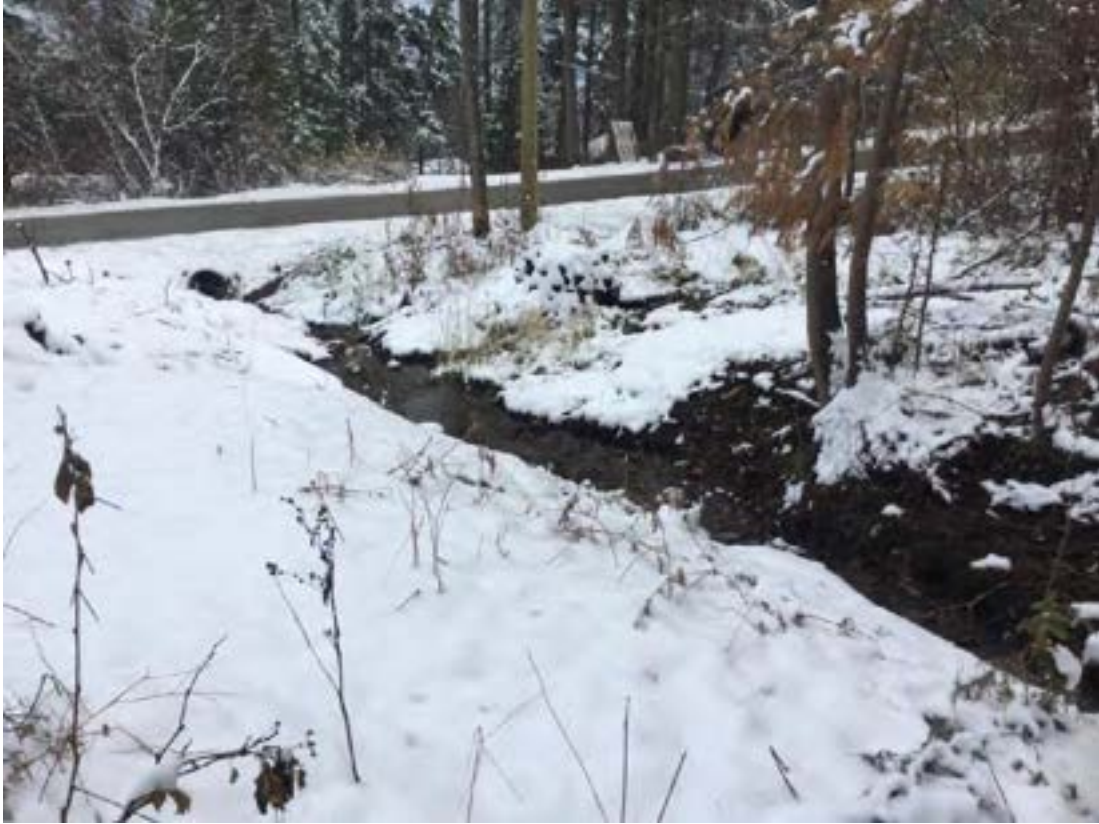
Photo 3: View of stream that flows along the south property boundary of 654 Udell Rd to culvert under Udell Rd..

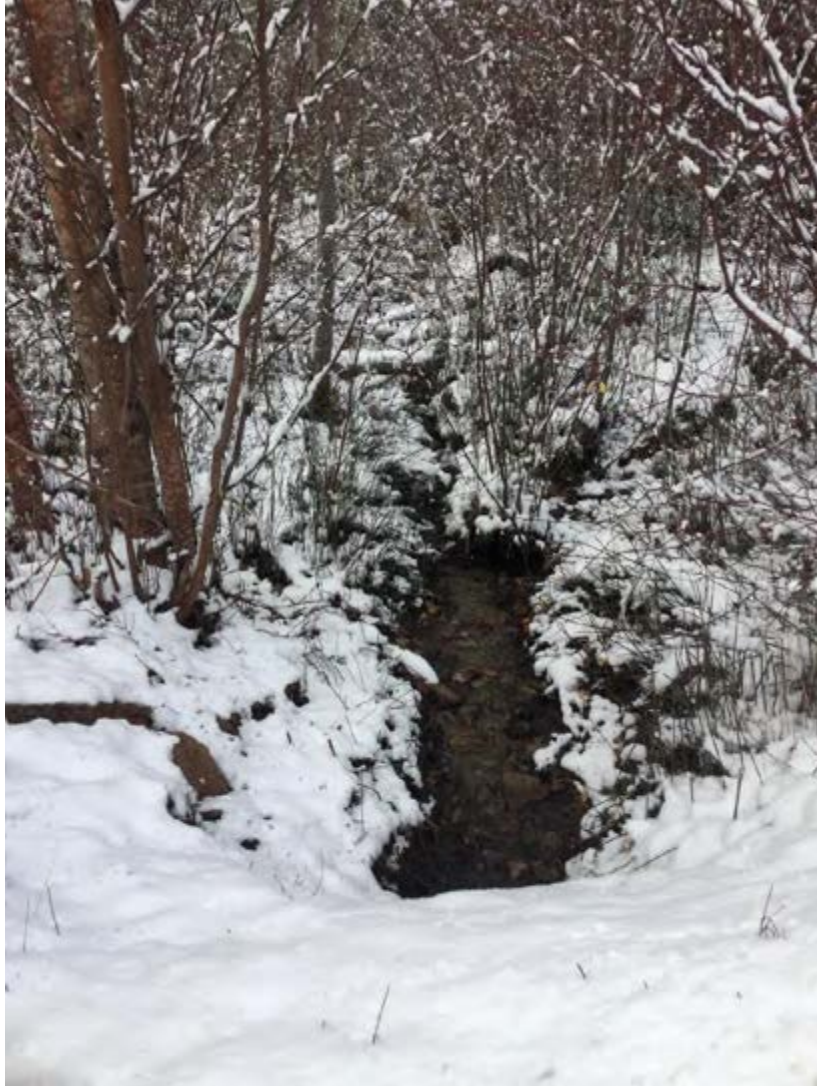
Photo 1: View downstream along stream that flows along north boundary of 9325 Keithley Rd, from culvert under Keithley Rd.

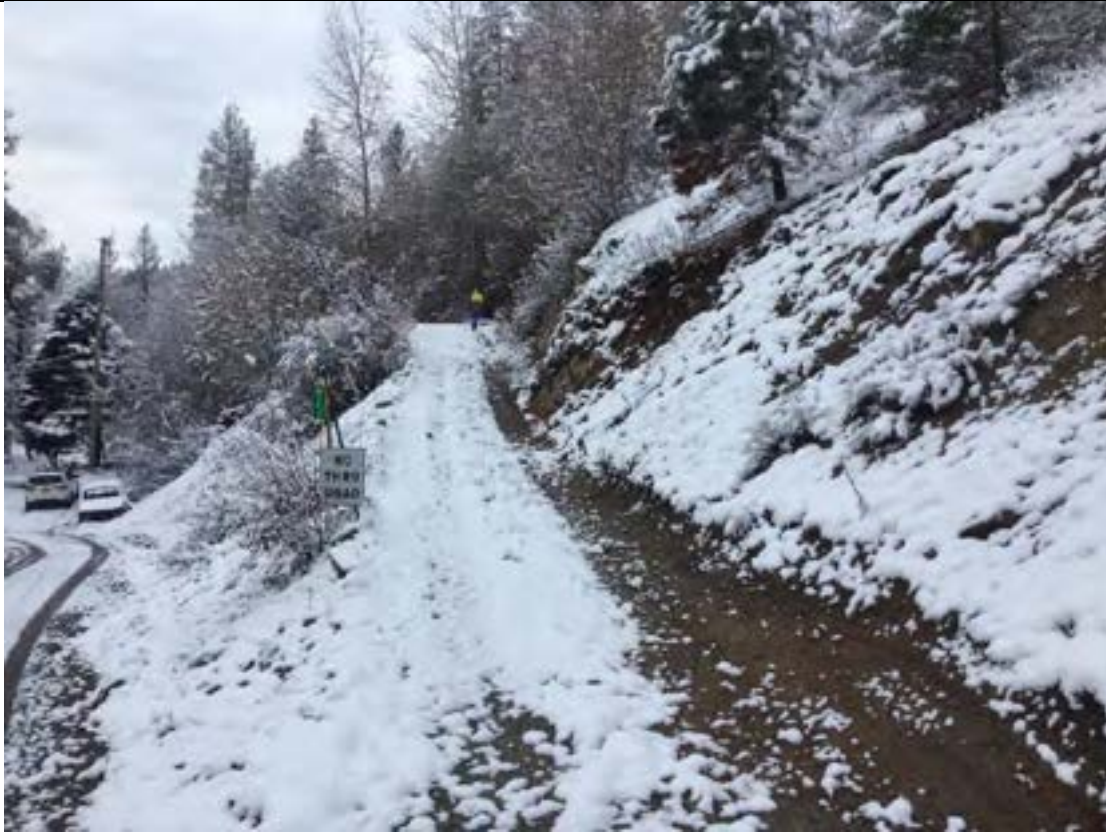
Photo 1: View of driveway access from Hodges Road (at 9304 Hodges Rd)

Recommended Recovery Response and Considerations for Future Development:	Short term (pre-freshet): Ensure full clearance of driveway culvert and ditch along Hodges Road and culvert under Hodges Road. Monitor and be prepared to respond to overflow and/or blockage.
	Long term: Consider groundwater seepage assessment and soils/geotechnical assessment for future development.

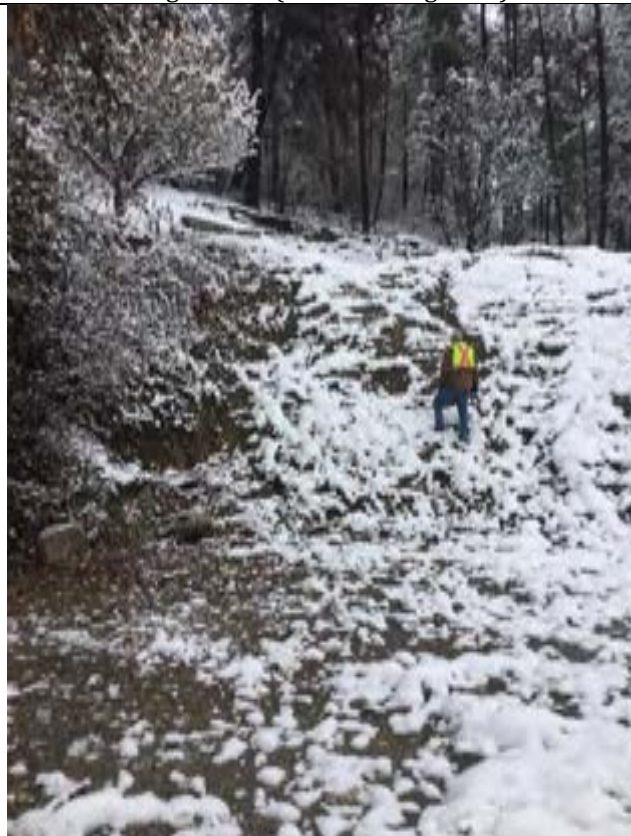
Photo 2: View towards upper part of lot from driveway at 9304 Hodges Rd.

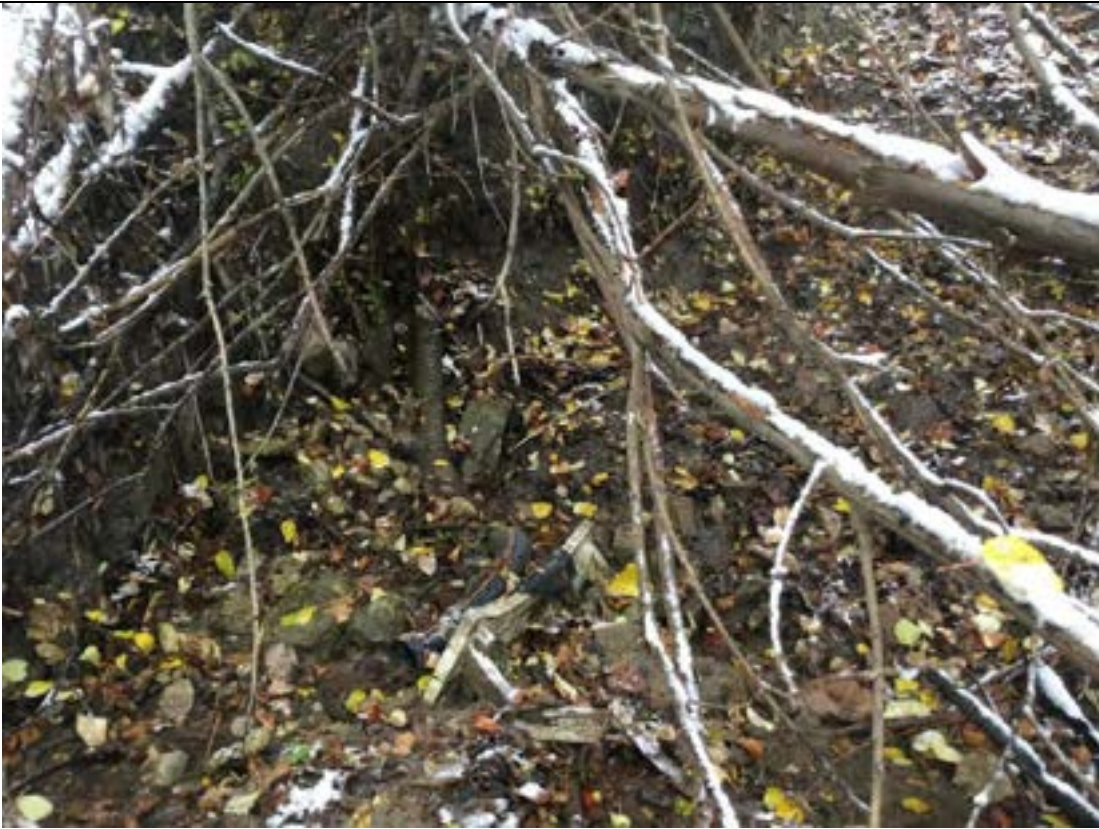
Photo 3: View of water course (Norris Creek) along south boundary of 9304 Hodges Rd.

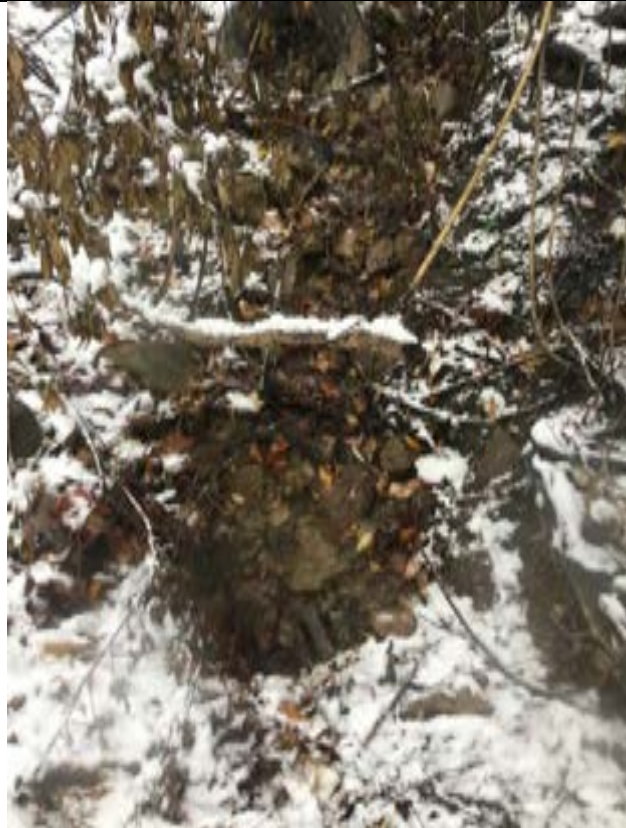
Photo 2: View of partly obstructed culvert inlet under driveway access (Norris Creek) below 9294 Hodges Rd.

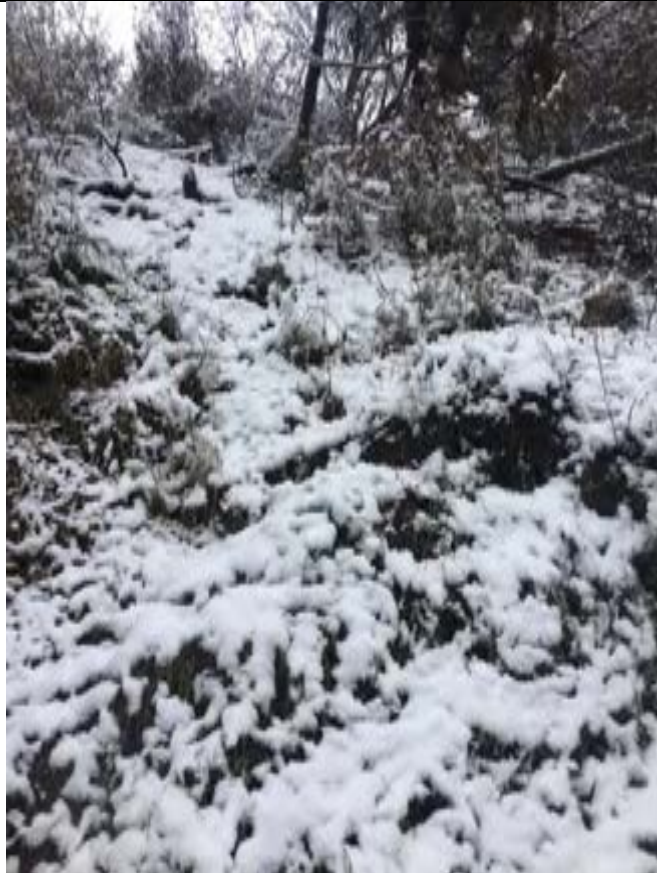
Photo 1: View upslope from driveway access right of way at 9284 Hodges Rd.

Recommended Recovery Response and Considerations for Future Development:	
	Long term: Consider soils/geotechnical assessment for future development.

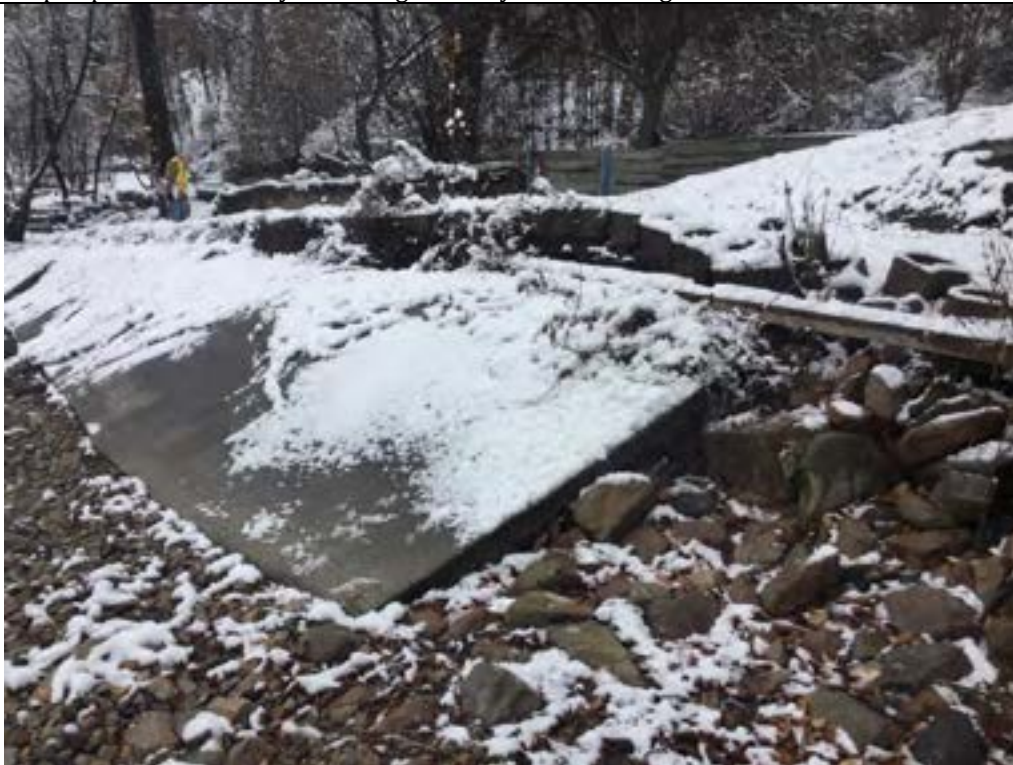
Photo 2: View of concrete apron along foreshore, with wood retaining wall in background of photo at 9284 Hodges Rd.

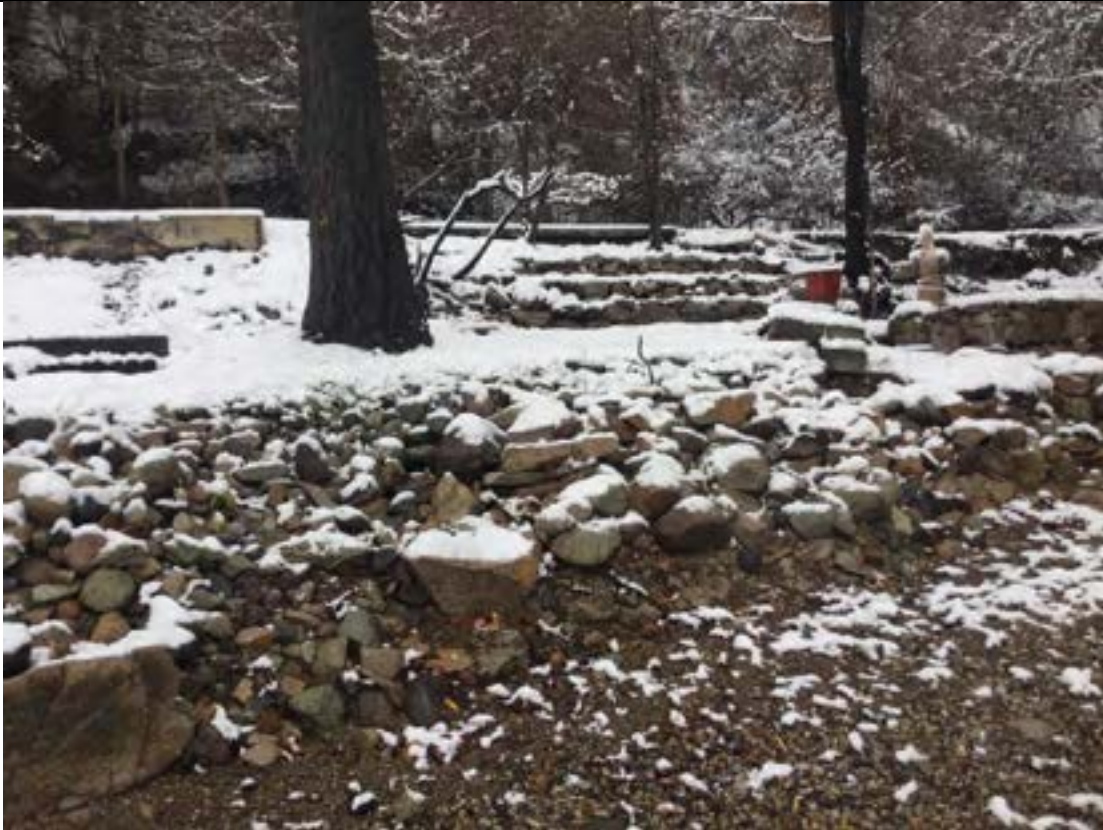
Photo 1: View upslope of foreshore area and low rock wall from the lake

Recommended Recovery Response and Considerations for Future Development:		
	Long term: Consider soils/geotechnical assessment and drainage plan along access driveway for future development.

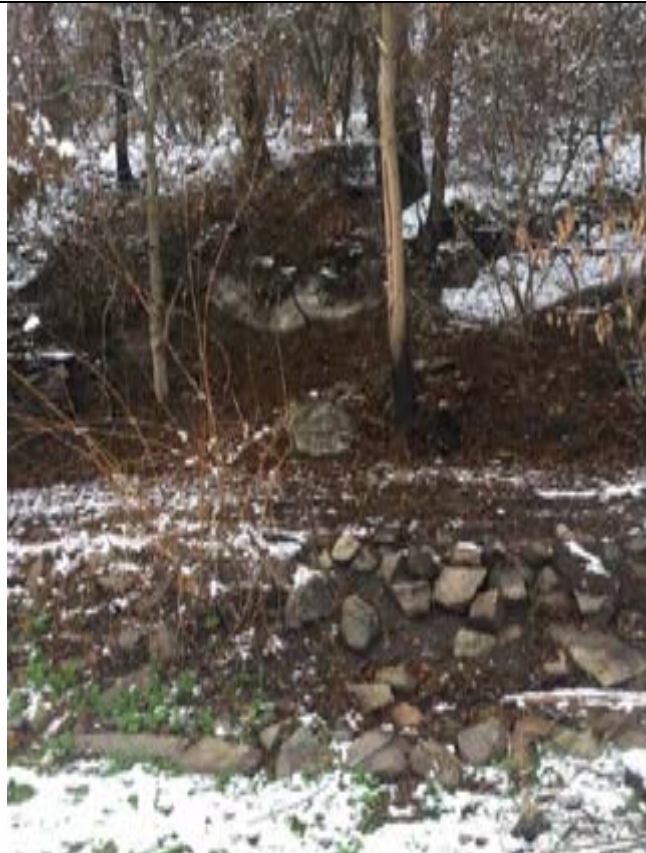
Photo 2: View of slope above foreshore area with rock retaining wall and driveway access trail above.

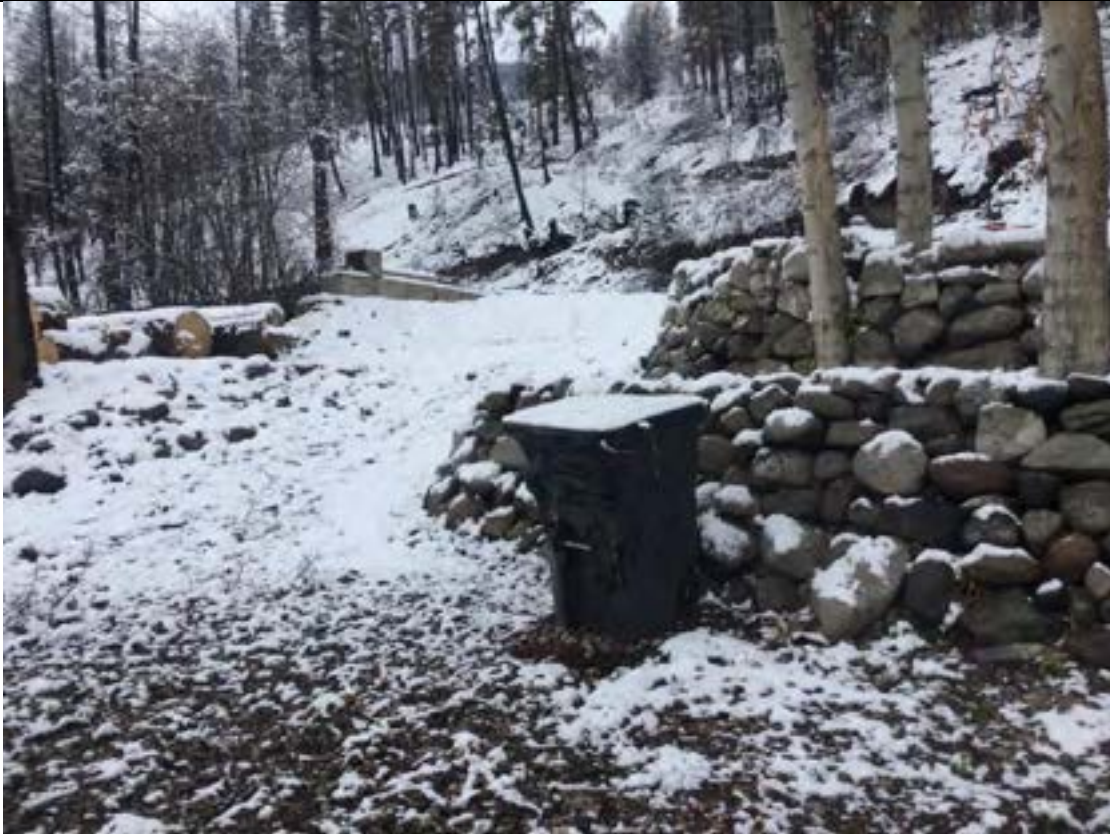
Photo 1: View of stepped rock walls from the foreshore at 58 Killarney Pl

Recommended Recovery Response and Considerations for Future Development:	
	Long term: Consider soils/geotechnical assessment along access driveway for future development.

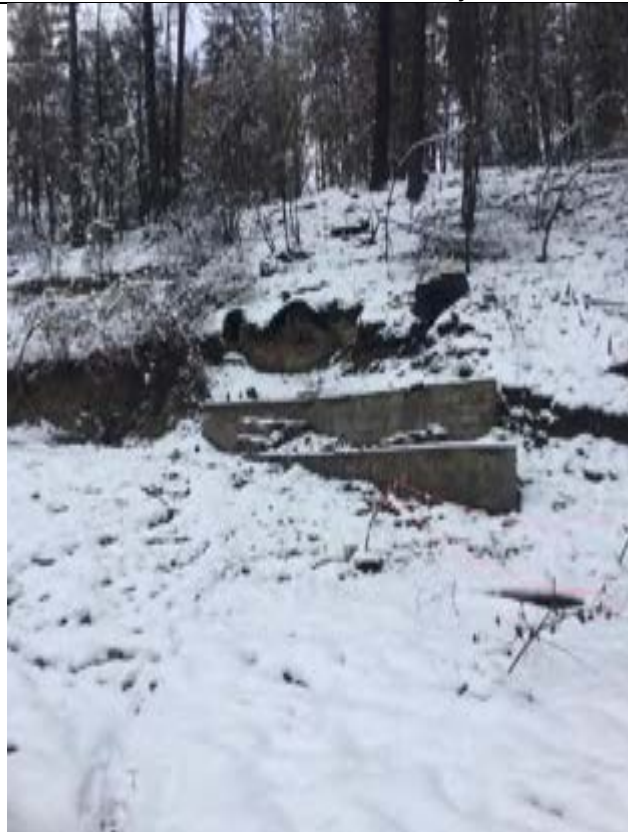
Photo 2: View of slope above foreshore area with block retaining wall along toe of slope

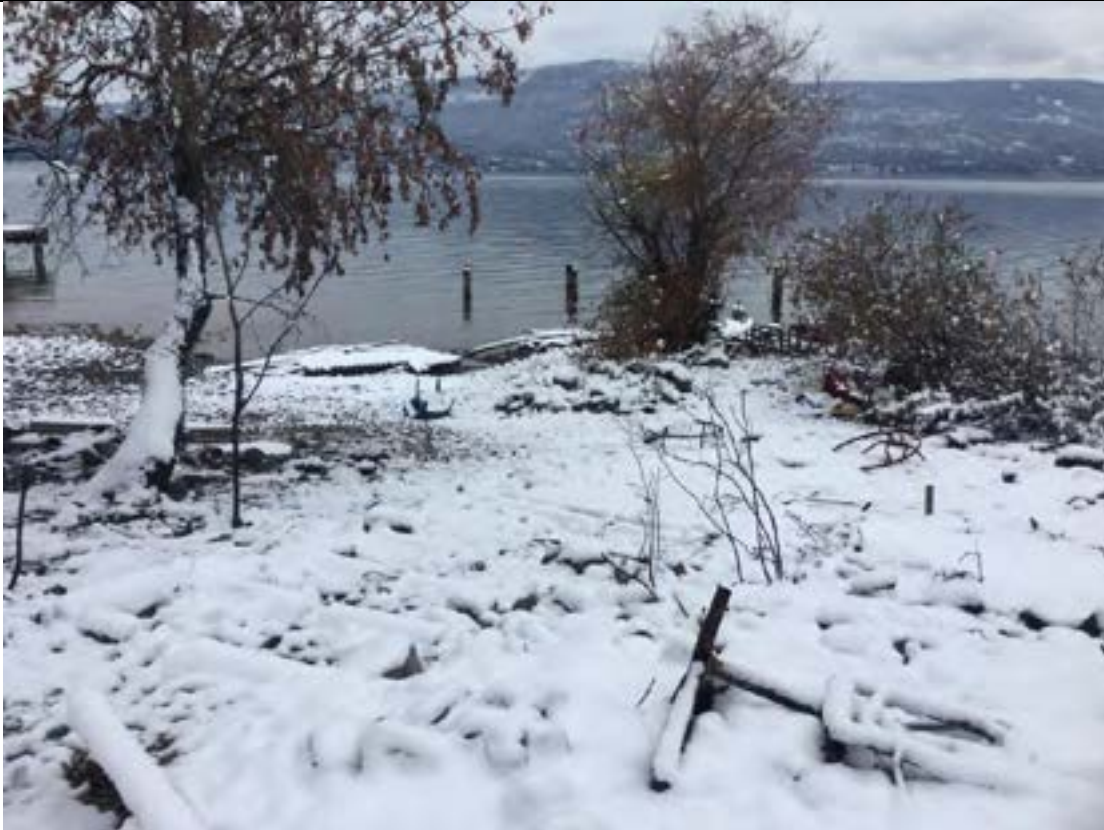
Photo 1: View towards Okanagan Lake 66 Killarney Pl.

Recommended Recovery Response and Considerations for Future Development:	
	Long term: Consider soils/geotechnical assessment along access driveway for future development.

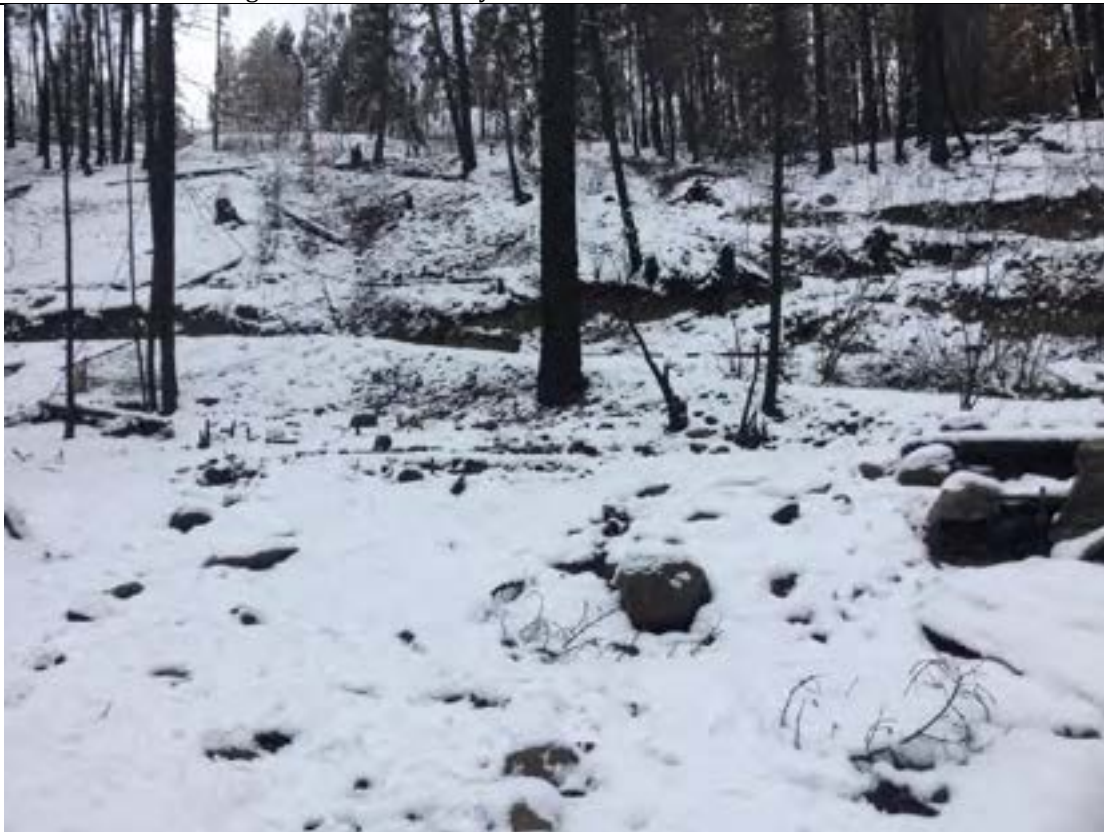
Photo 2: View of slope above foreshore area at 66 Killarney Pl.

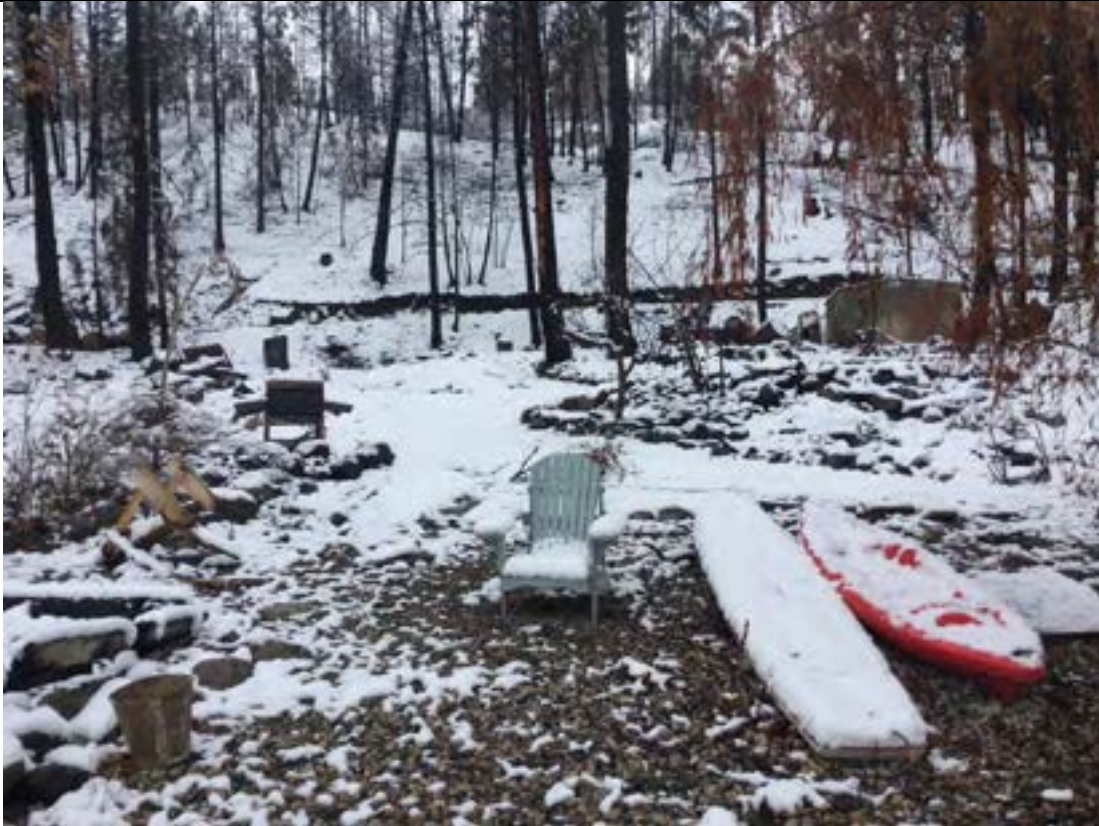
Photo 1: View of foreshore area towards slope at 75 Killarney Pl.

Recommended Recovery Response and Considerations for Future Development:		
	Long term: Consider drainage plan for driveway access.

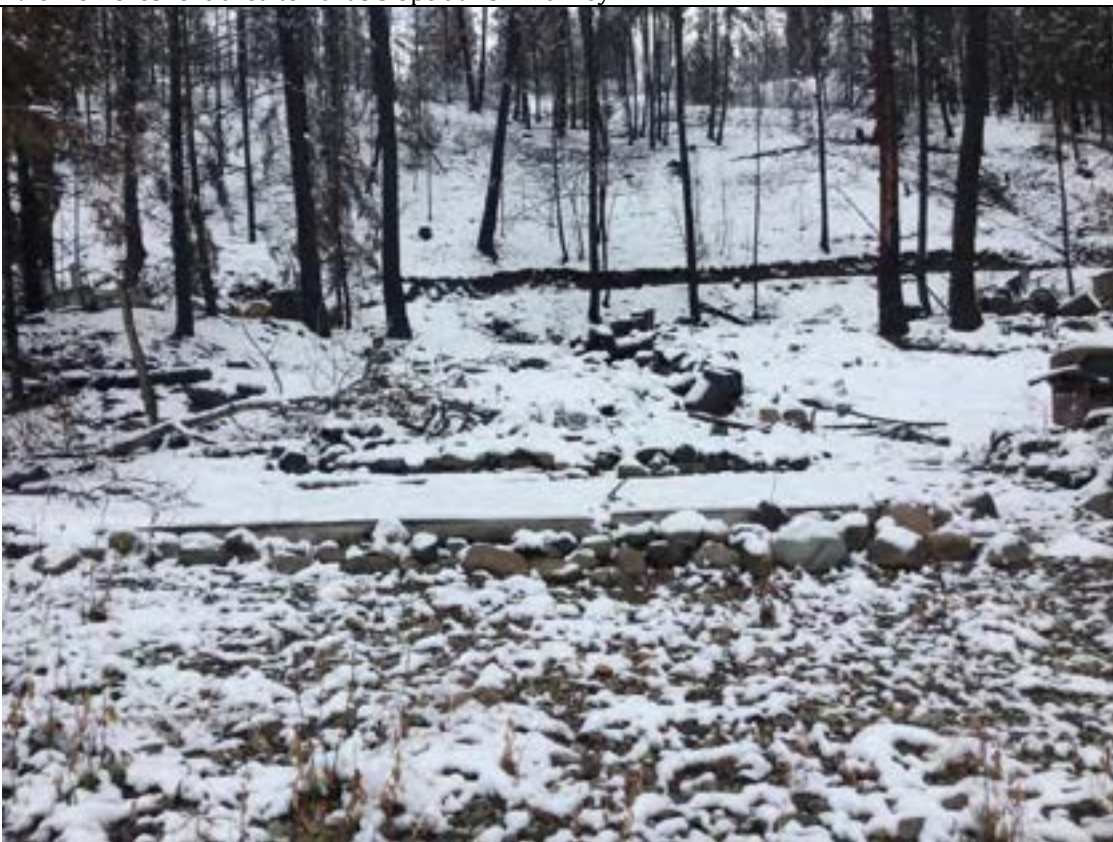
Photo 2: View of slope above foreshore area at 75 Killarney Pl.

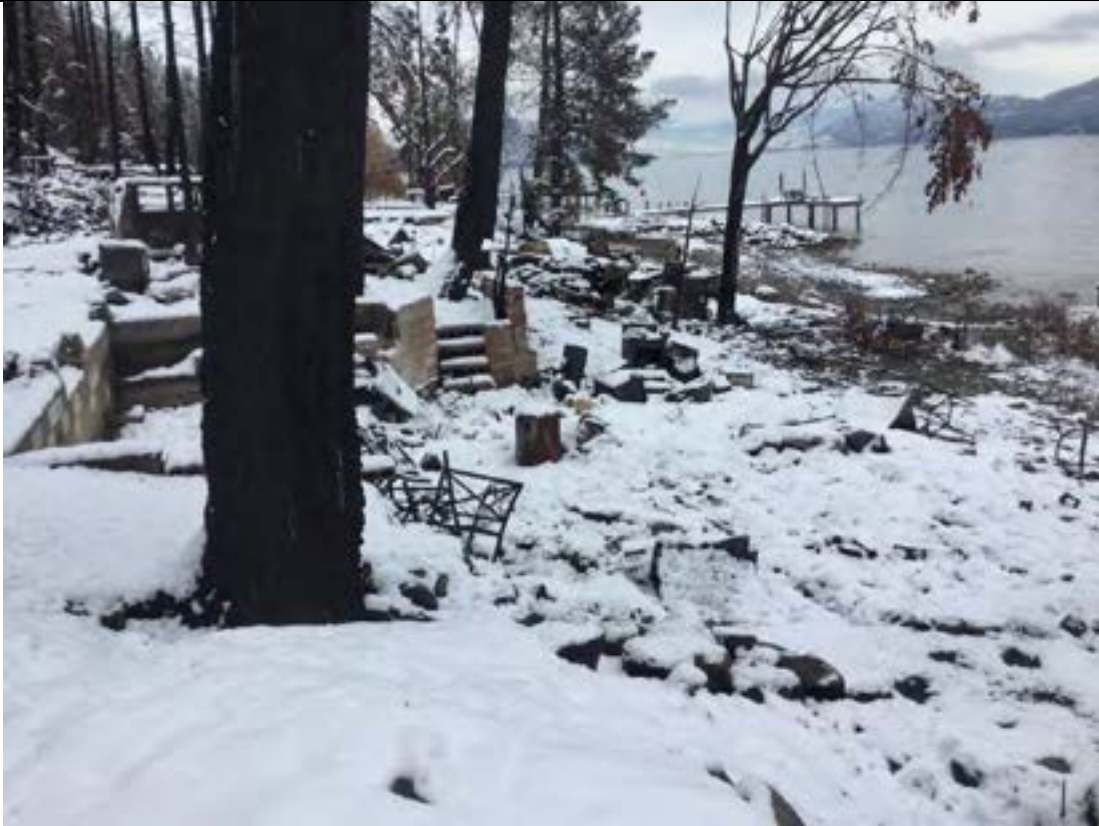
Photo 1: View of foreshore area at 81 Killarney Pl.

Recommended Recovery Response and Considerations for Future Development:	Short term: Be prepared for higher than usual runoff and associated soil erosion from slopes above.	
	Long term: Consider geotechnical assessment and drainage plan for access trail.

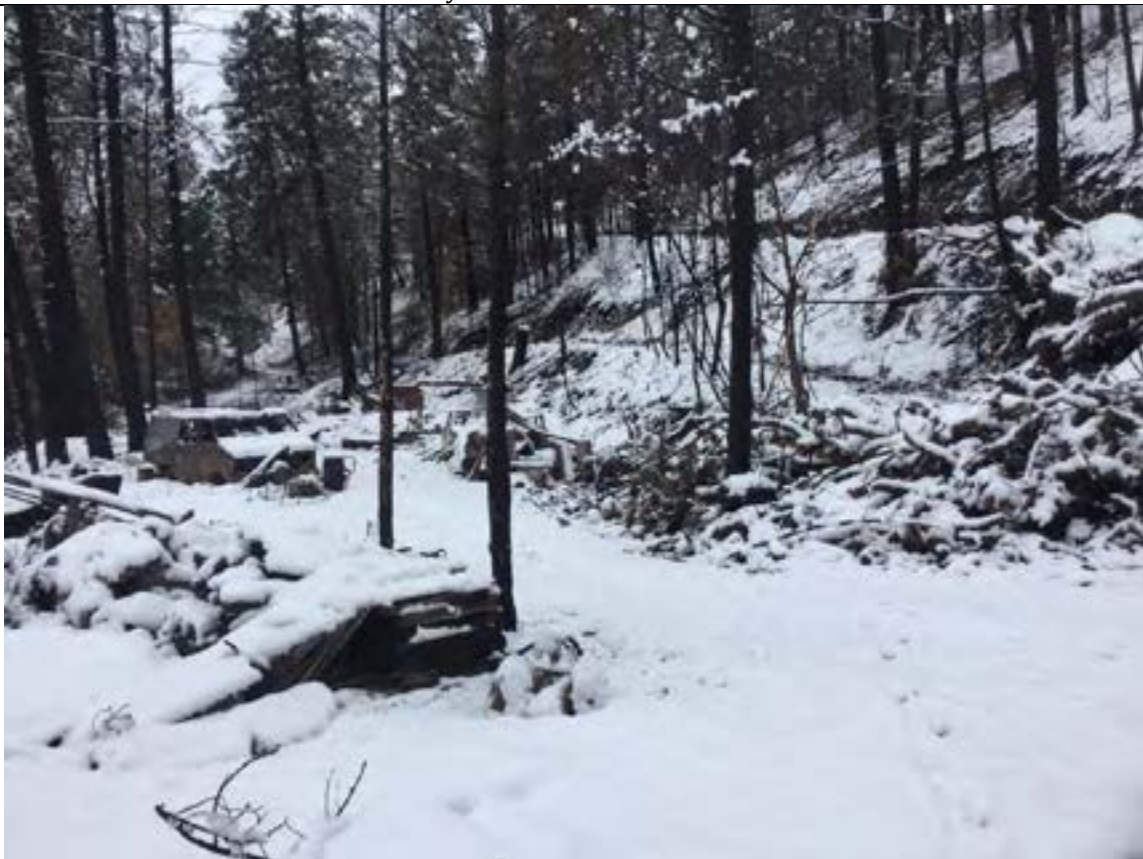
Photo 2: View of slope above foreshore area at 81 Killarney Pl.

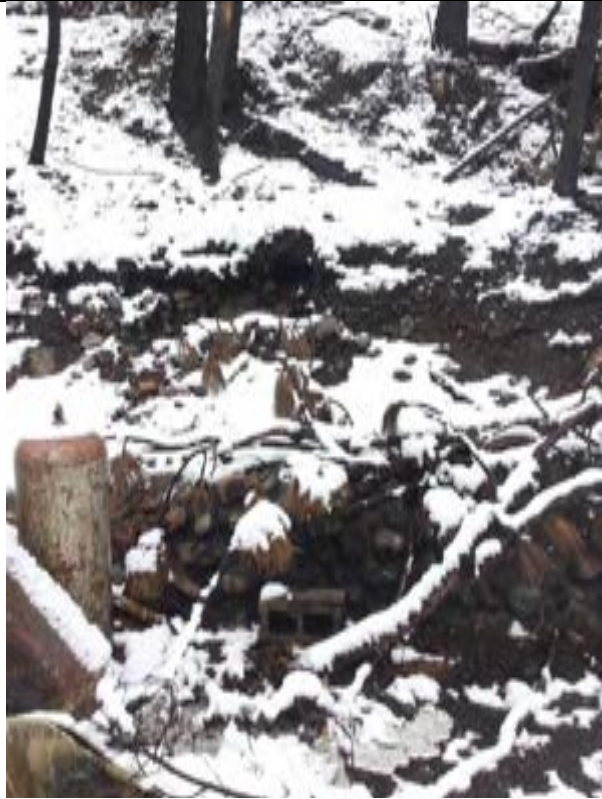
Photo 3: View of slope above foreshore area at 81 Killarney Pl.

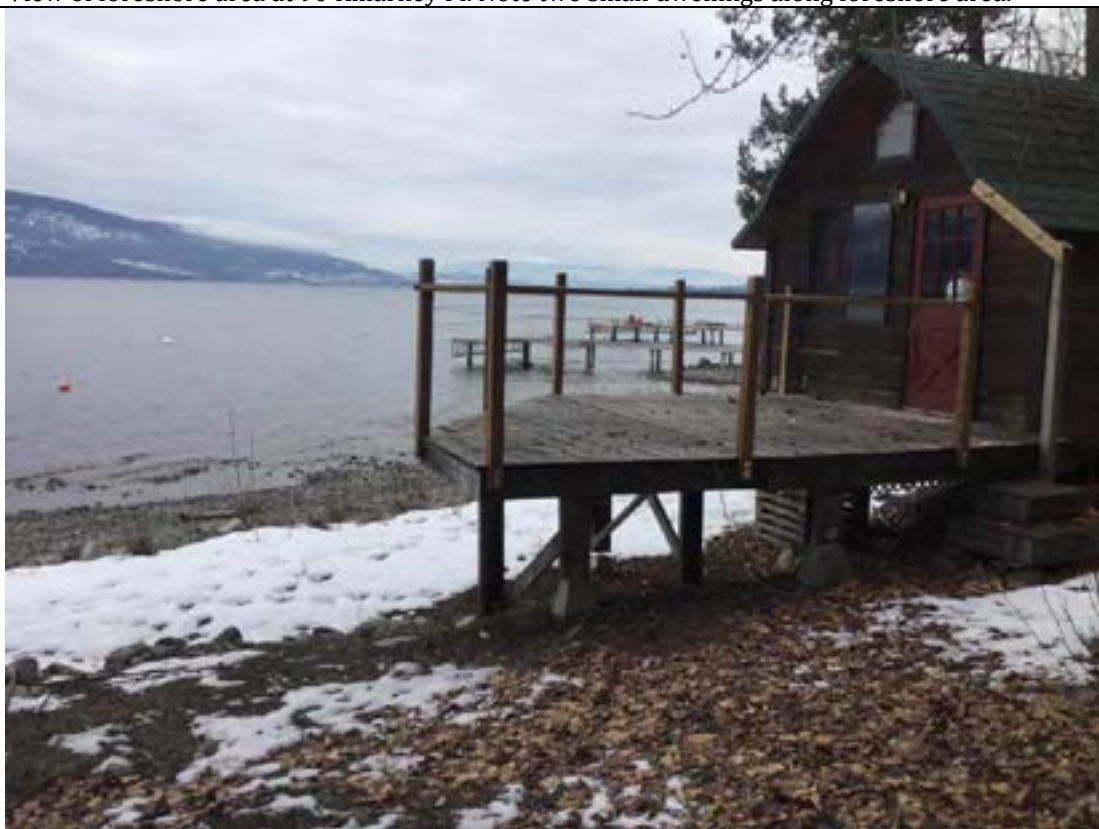
Foreshore Conditions:	Two small cottages on piled wood foundations at the lakeshore. No damages to building apparent. No dock. Beach area relatively natural.		
Setback Distance & Elevation from HWM* or Top of Bank (SHIM):	Current cabins <15 m setback from lake; elevation to be confirmed.		
Wildfire Effects Upslope/Upstream:	Mod to severe burn severity, burned gully shows recent sediment transport but very limited runout at toe of slope. Fire affected catchment areas upslope.

Hazards Noted:	Potential runoff effects, sediment-laden runoff along gully and runoff and soil erosion on moderately sloped areas upslope.	
Spatial Likelihood:	Low potential for sediment delivery to Okanagan Lake	
Hazard Level: MODERATE	Spatial Likelihood: LOW	Risk Level: LOW

Photo 2: View of foreshore area at 90 Killarney Pl.

Recommended Recovery Response and Considerations for Future Development:	Short term: Be prepared for higher than usual runoff and associated soil erosion from slopes above.	
	Long term: Consider geotechnical assessment and drainage plan for access trail.

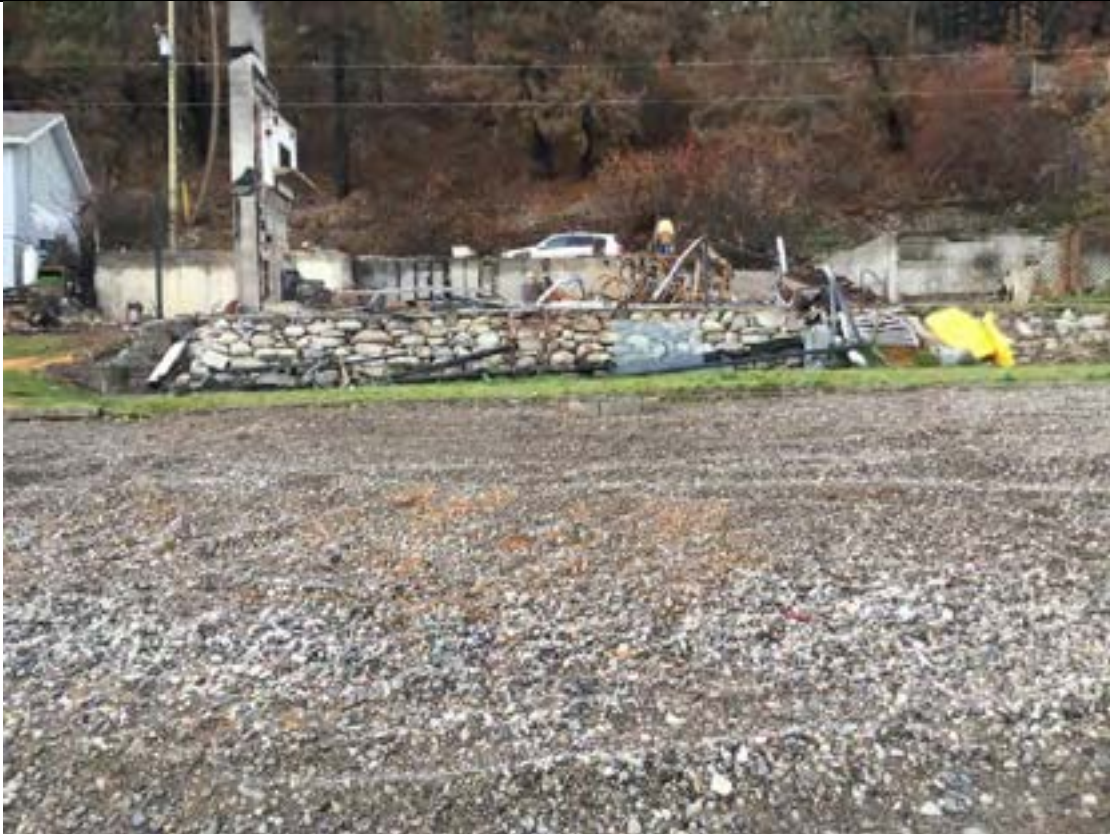
Photo 1: View of 43 Beachwood from Okanagan Lake

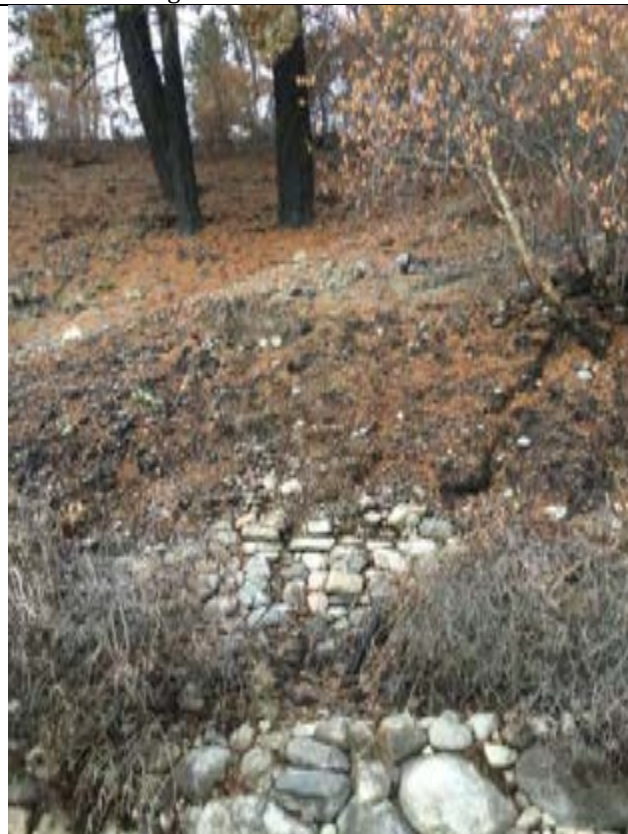
Wildfire Effects Upslope/Upstream:	Vegetation burn severity is moderate, small green shoots visible. Middle lot is steep with exposed mineral soils, signs of surface erosion.

Hazards Noted:	Observed soil erosion and shallow soil slump/landslide.	
Spatial Likelihood:	Potential sediment delivery to Beachwood Rd and downslope properties.	
Hazard Level: MODERATE	Spatial Likelihood: HIGH	Risk Level: HIGH

Photo 2: View upslope from lower part of Beachwood Rd.

Recommended Recovery Response and Considerations for Future Development:	Short term: Be prepared for higher than usual runoff and associated soil erosion from slopes above. Maintain ditches along Beachwood Road.	
	Long term: Consider restoration plan for burned slopes.

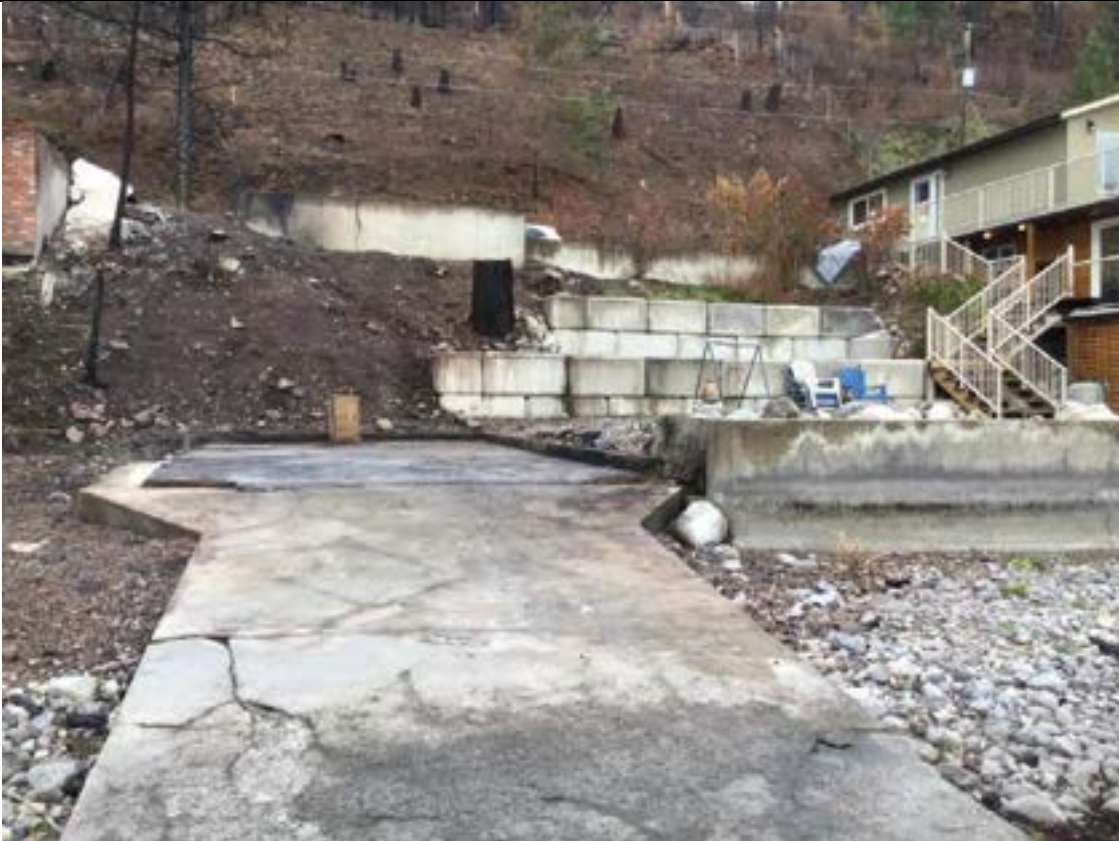
Photo 1: View of 67 Beachwood from Okanagan Lake
