CLARKE GEOSCIENCE LTD.

POST-WILDFIRE ENVIRONMENTAL AND HAZARDOUS CONDITIONS ASSESSMENT OF THE NORTH WESTSIDE ROAD AREA

Dated:	February 23, 2022
Presented To:	Regional District of Central Okanagan
Attention:	Brittany Nichols, Environmental Planner
CGL Project # 21-0115	EOC #A21-674
Document Control:	Version Rev. 1 (corrected civic and legal property addresses for 3 properties)

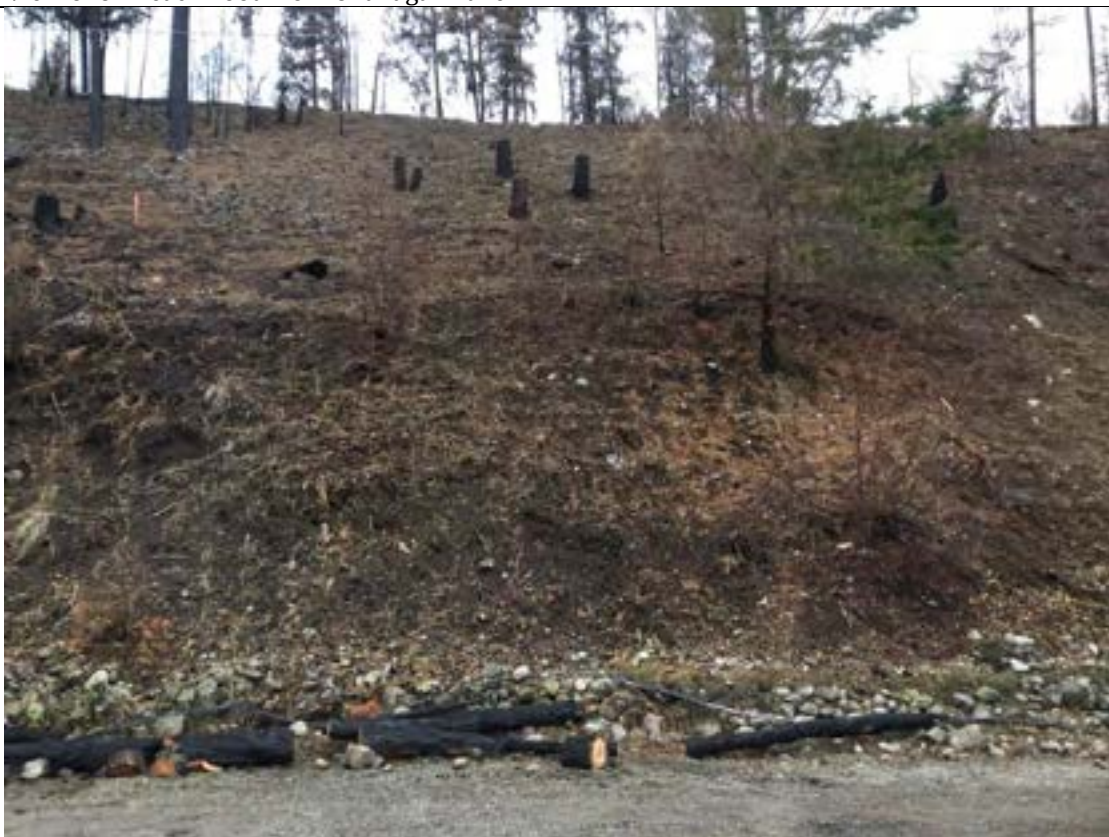
Wildfire Effects Upslope/Upstream:	Burned open forest, trees removed, mineral soil exposed, steep slopes, ravelling disturbed soils observed.

Hazards Noted:	Observed soil erosion and shallow soil slump/landslide.		
Spatial Likelihood:	Potential sediment delivery to Beachwood Rd and downslope properties.		
Hazard Level: MODERATE	Spatial Likelihood: HIGH	Risk Level: HIGH

Photo 2: View upslope from lower part of Beachwood Rd.

Recommended Recovery Response and Considerations for Future Development:	Short term: Be prepared for higher than usual runoff and associated soil erosion from slopes above. Maintain ditches along Beachwood Road.		
	Long term: Consider restoration plan for burned slopes.

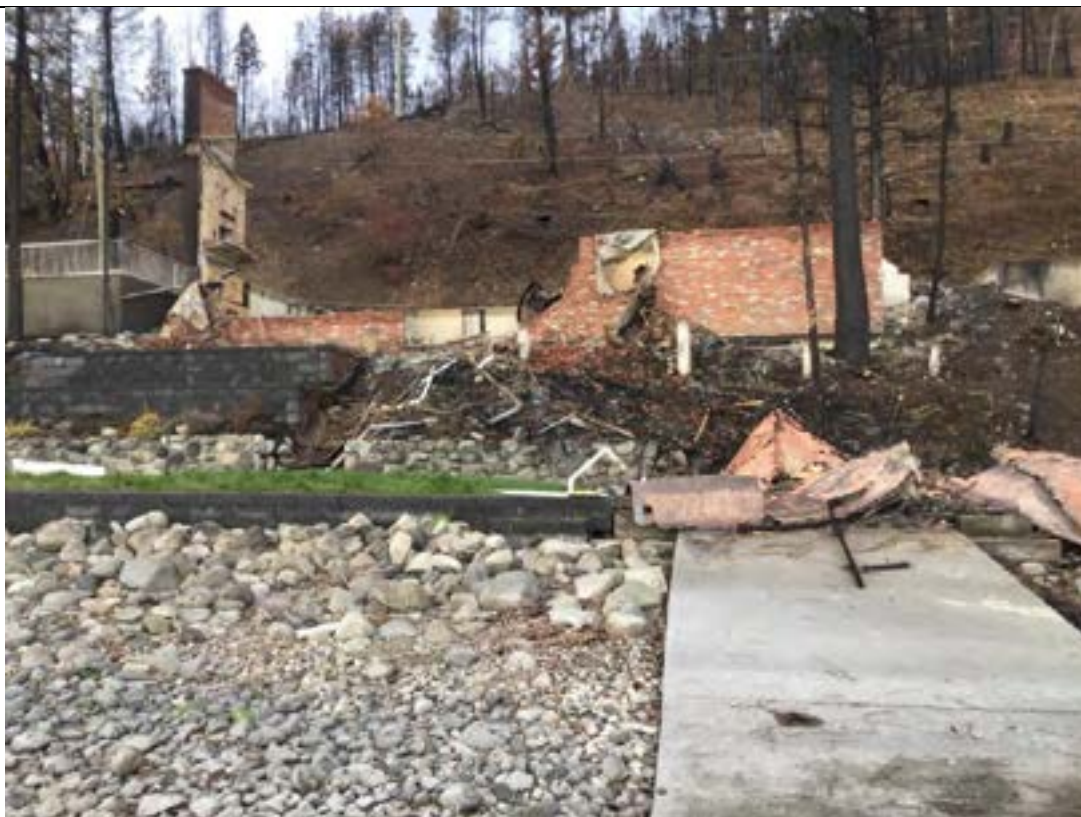
Photo 1: View of 73 Beachwood from Okanagan Lake

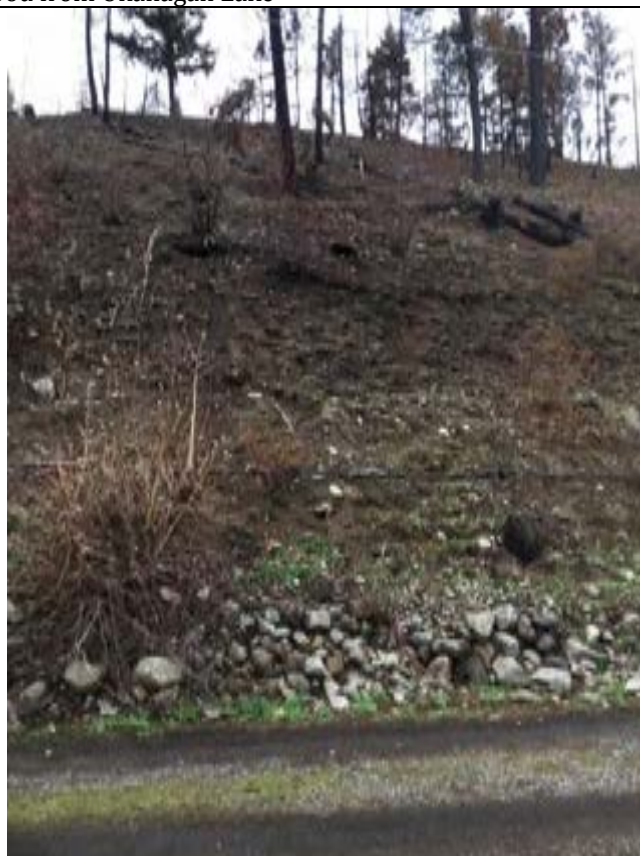
Wildfire Effects Upslope/Upstream:	Burned and cleared upslope, 70% slope above lot, exposed sands and gravels, shallow soil ravelling observed.

Hazards Noted:	Observed soil erosion and shallow soil slump/landslide.	
Spatial Likelihood:	Potential sediment delivery to Beachwood Rd and downslope properties.	
Hazard Level: MODERATE	Spatial Likelihood: HIGH	Risk Level: HIGH

Photo 2: View upslope from lower part of Beachwood Rd.

Recommended Recovery Response and Considerations for Future Development:	Short term: Be prepared for higher than usual runoff and associated soil erosion from slopes above. Maintain ditches along Beachwood Road.
	Long term: Consider restoration plan for burned slopes.

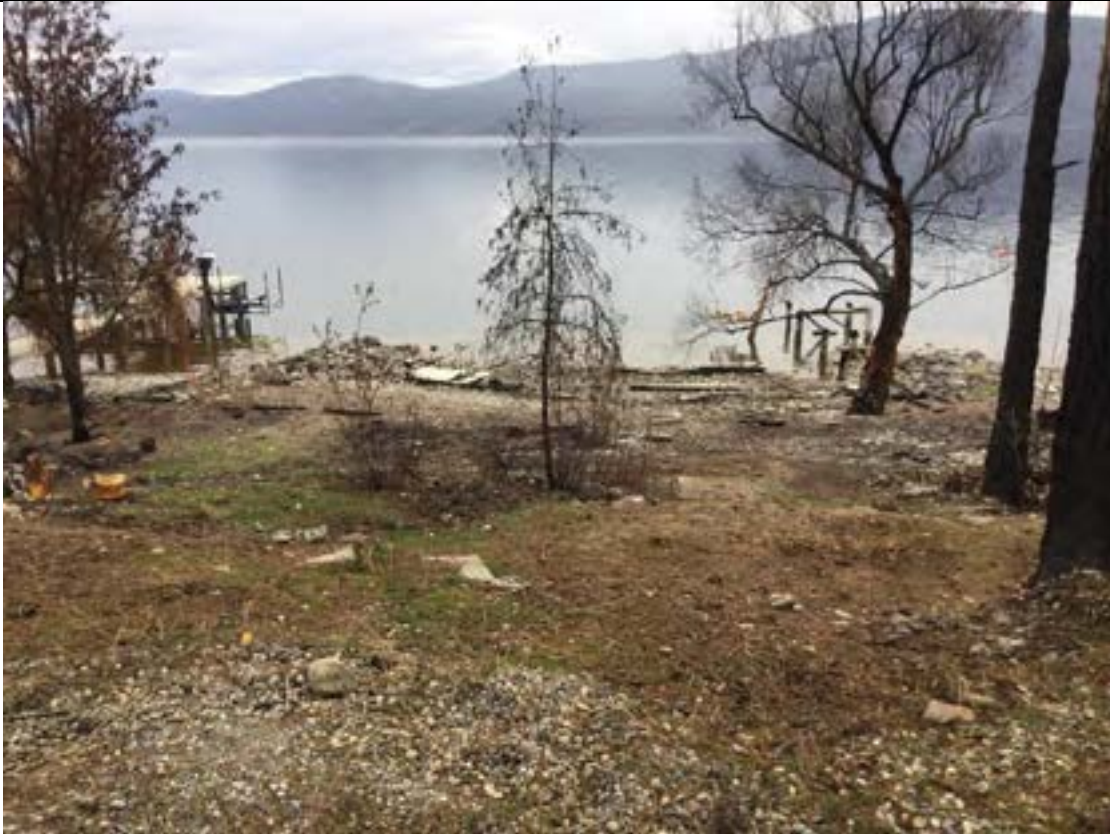
Photo 1: View of 79 Beachwood towards Okanagan Lake

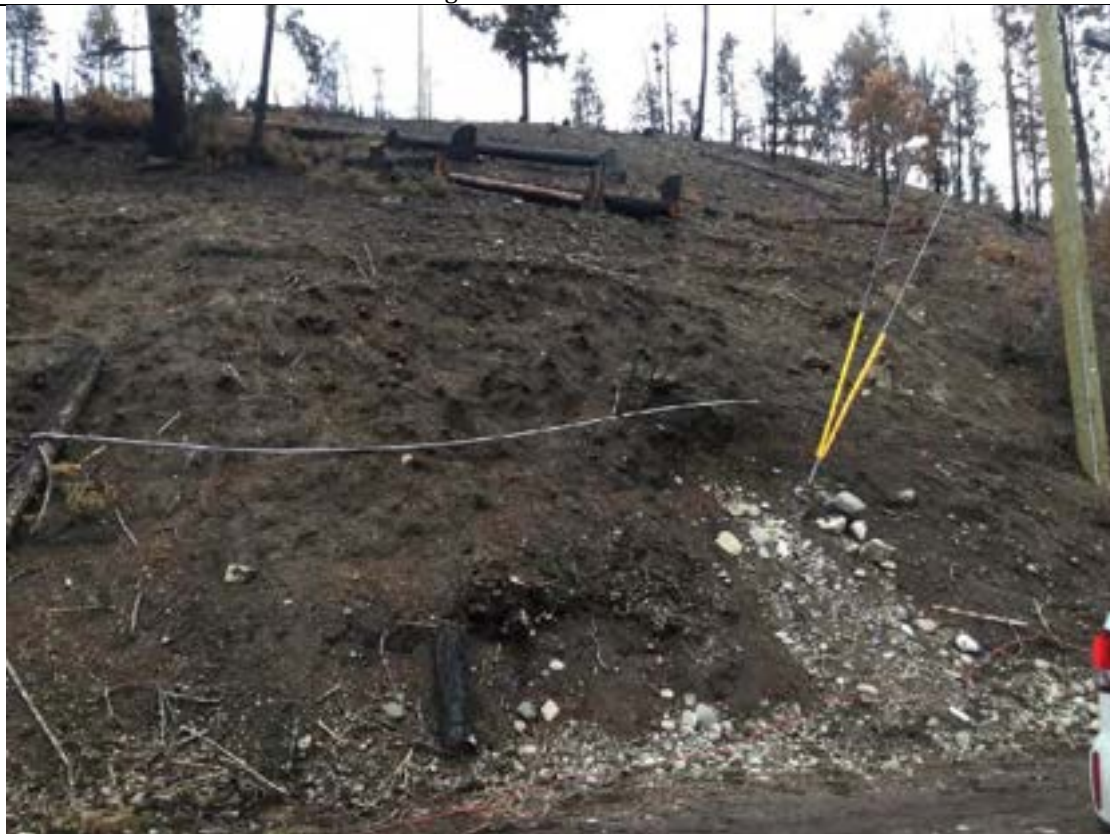
Hazards Noted:	Observed soil erosion and shallow soil slump/landslide.	
Spatial Likelihood:	Potential sediment delivery to Beachwood Rd and downslope properties.	
Hazard Level: MODERATE	Spatial Likelihood: HIGH	Risk Level: VERY HIGH

Photo 2: View upslope from lower part of Beachwood Rd.

Recommended Recovery Response and Considerations for Future Development:	Short term: Be prepared for higher than usual runoff and associated soil erosion from slopes above. Maintain ditches along Beachwood Road.
	Long term: Consider restoration plan for burned slopes.

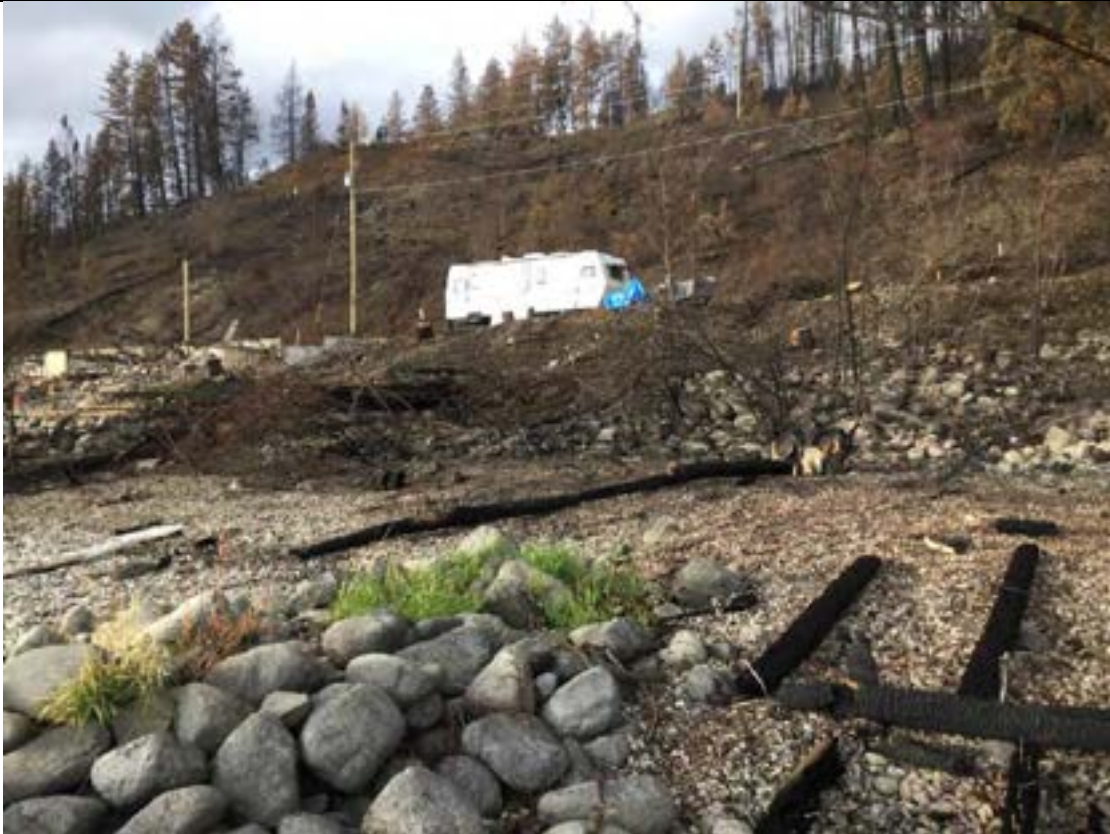
Photo 1: View of 85 Beachwood from Okanagan Lake

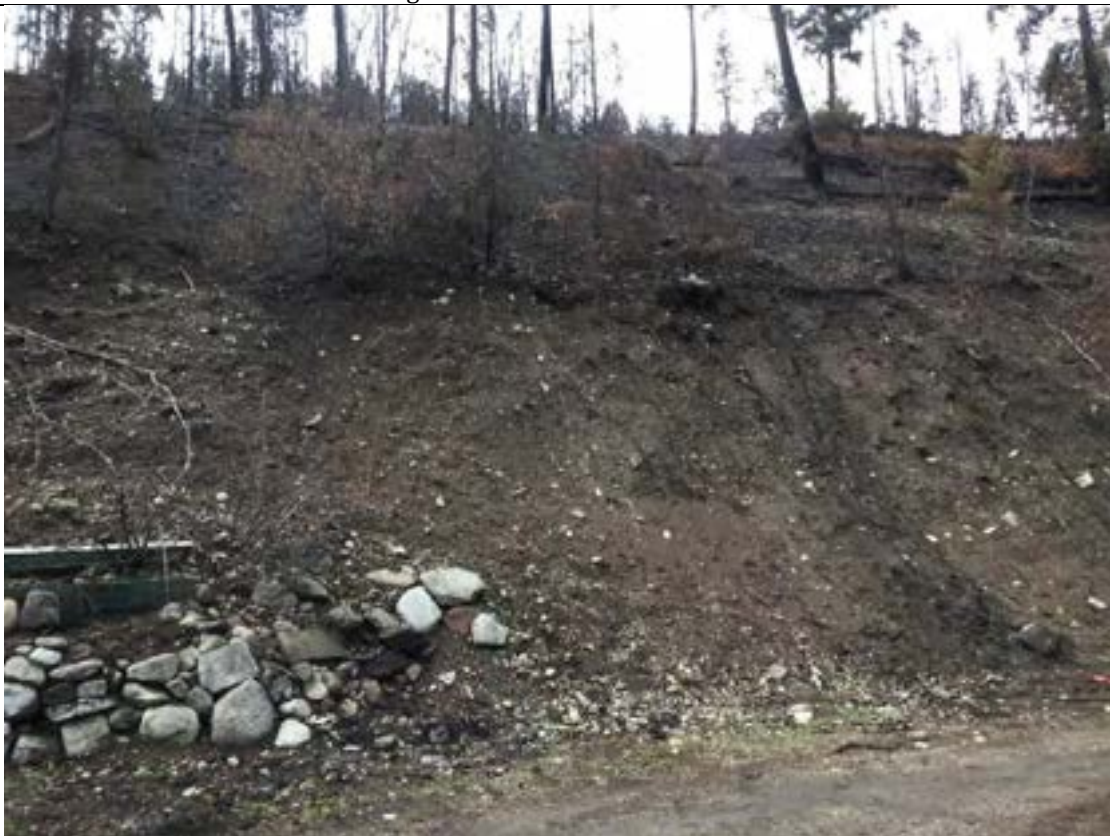
Wildfire Effects Upslope/Upstream:	Burned, steep slopes above, 60% slope, 2:1 cutslope above Beachwood exposes sandy gravel soils. Observed shallow soil instability upslope of Beachwood.

Hazards Noted:	Observed soil erosion and shallow soil slump/landslide.	
Spatial Likelihood:	Potential sediment delivery to Beachwood Rd and downslope properties.	
Hazard Level: MODERATE	Spatial Likelihood: HIGH	Risk Level: HIGH

Photo 2: View upslope from lower part of Beachwood Rd.

Recommended Recovery Response and Considerations for Future Development:	Short term: Be prepared for higher than usual runoff and associated soil erosion from slopes above. Maintain ditches along Beachwood Road.
	Long term: Consider restoration plan for burned slopes.

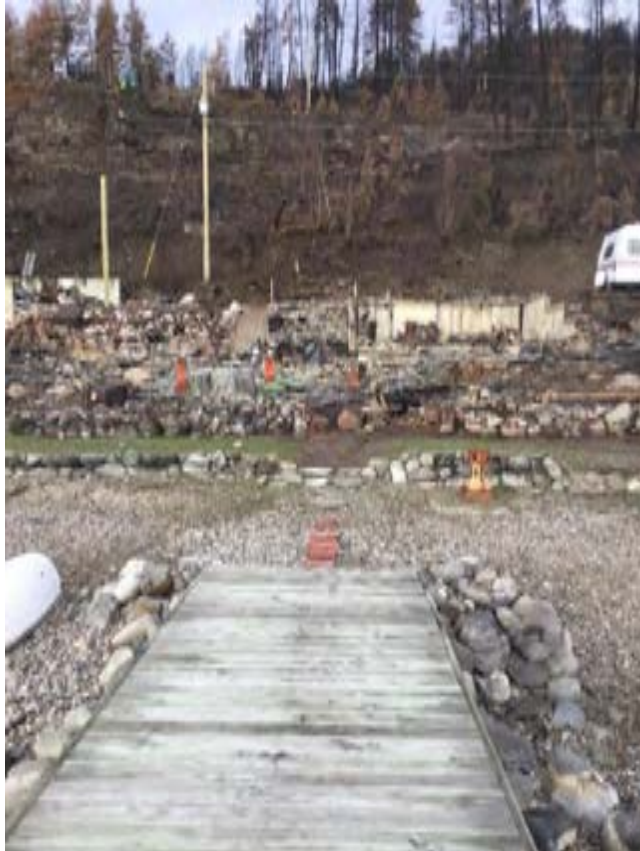
Photo 1: View of 91 Beachwood from Okanagan Lake

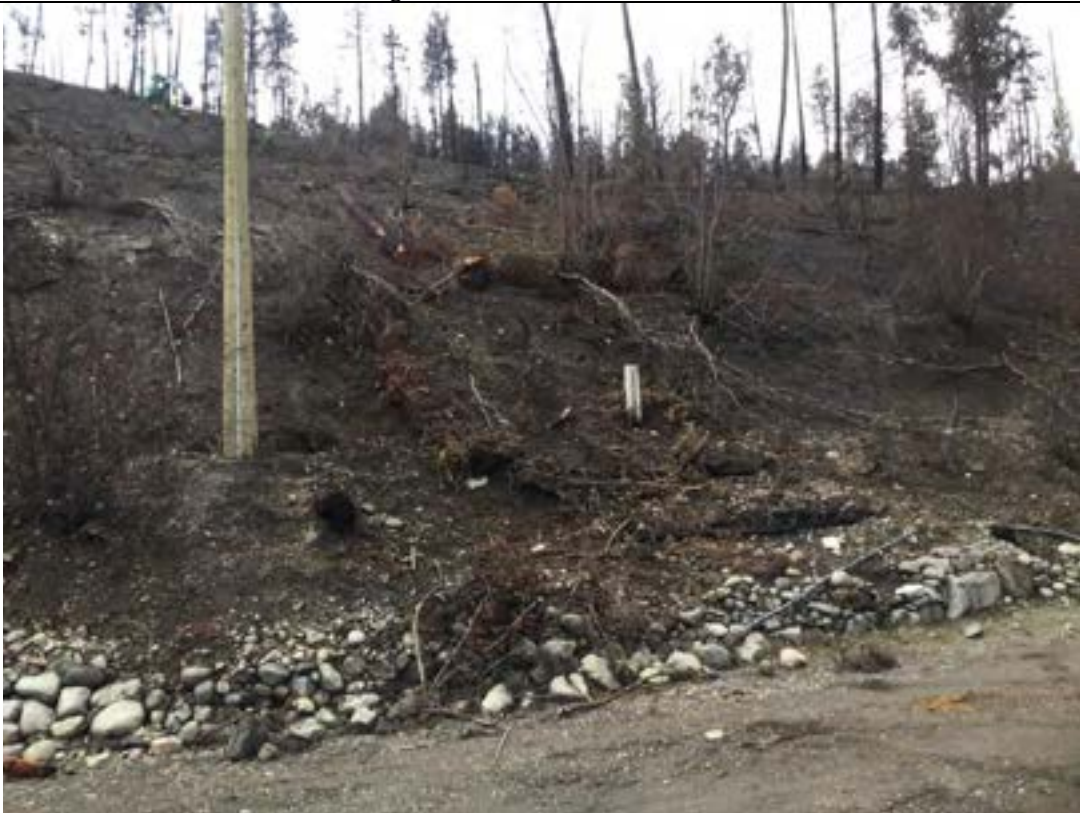
Hazards Noted:	Observed soil erosion and shallow soil slump/landslide. Recent planting and seeding reduces hazard.	
Spatial Likelihood:	Potential sediment delivery to Beachwood Rd and downslope properties.	
Hazard Level: MODERATE	Spatial Likelihood: HIGH	Risk Level: HIGH

Photo 2: View upslope from lower part of Beachwood Rd.

Recommended Recovery Response and Considerations for Future Development:	Short term: Be prepared for higher than usual runoff and associated soil erosion from slopes above. Maintain ditches along Beachwood Road.	
	Long term: Consider soils/geotechnical assessment for burned slopes. (planting completed in late fall 2021)

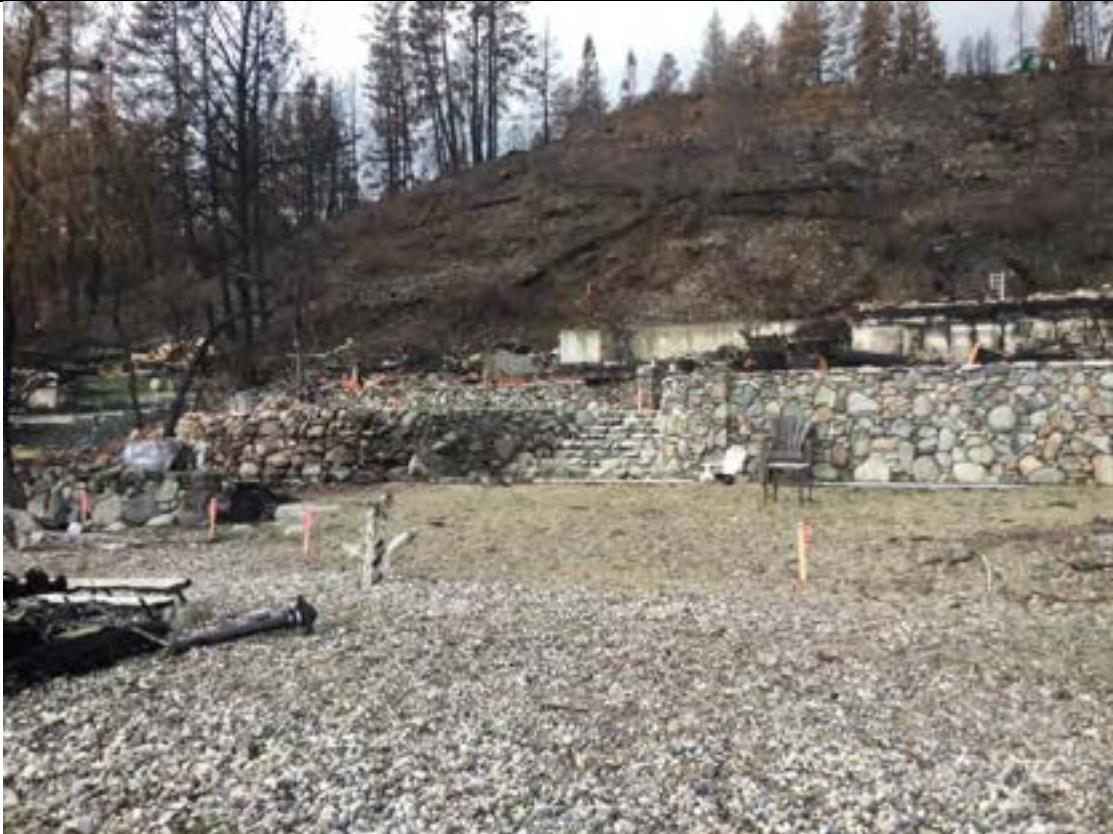
Photo 1: View of 95 Beachwood from Okanagan Lake

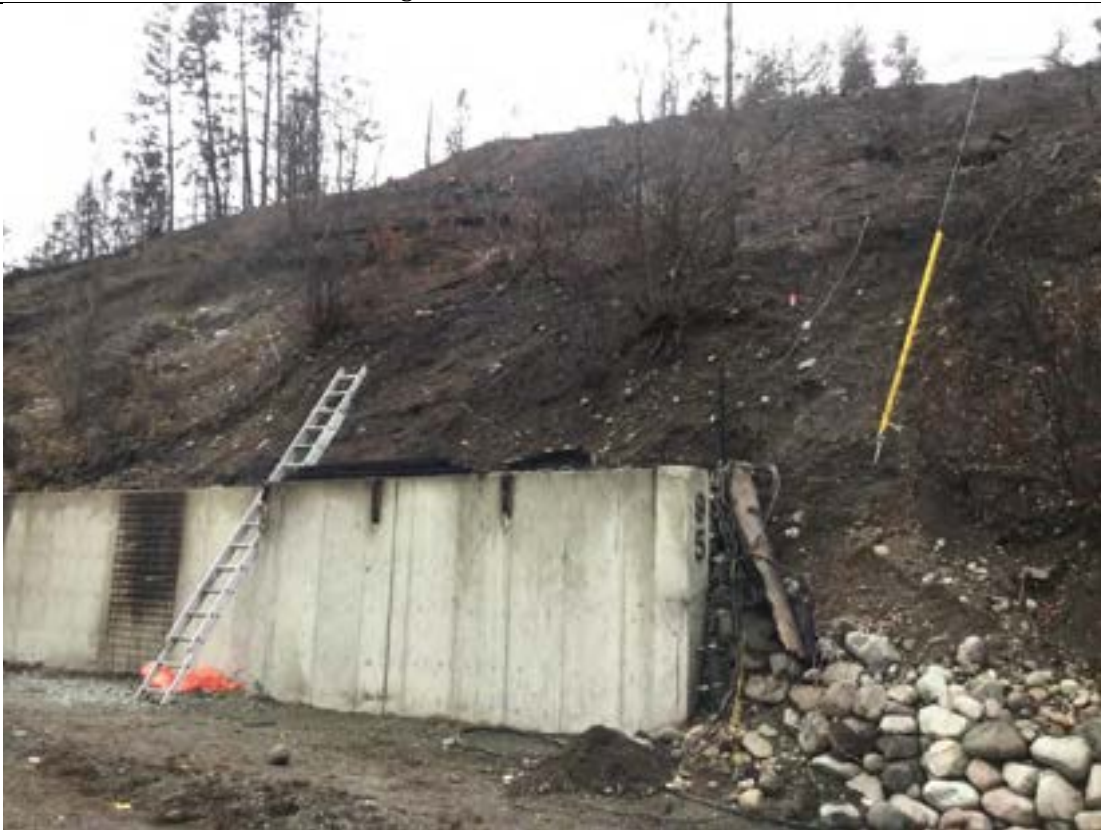
Wildfire Effects Upslope/Upstream:	High burn severity, exposed soils, potentially unstable, 2.5 m concrete retaining wall at toe of slope, 60% slope, sandy gravels, Cutslope

Hazards Noted:	Observed soil erosion and shallow soil slump/landslide. Rockwall potentially unstable. Recent planting and seeding reduces hazard.	
Spatial Likelihood:	Potential sediment delivery to Beachwood Rd and downslope properties.	
Hazard Level: MODERATE	Spatial Likelihood: HIGH	Risk Level: HIGH

Photo 2: View upslope from lower part of Beachwood Rd.

Recommended Recovery Response and Considerations for Future Development:	Short term: Be prepared for higher than usual runoff and associated soil erosion from slopes above. Maintain ditches along Beachwood Road.	
	Long term: Consider soils/geotechnical assessment for burned slopes. (planting completed in late fall 2021)

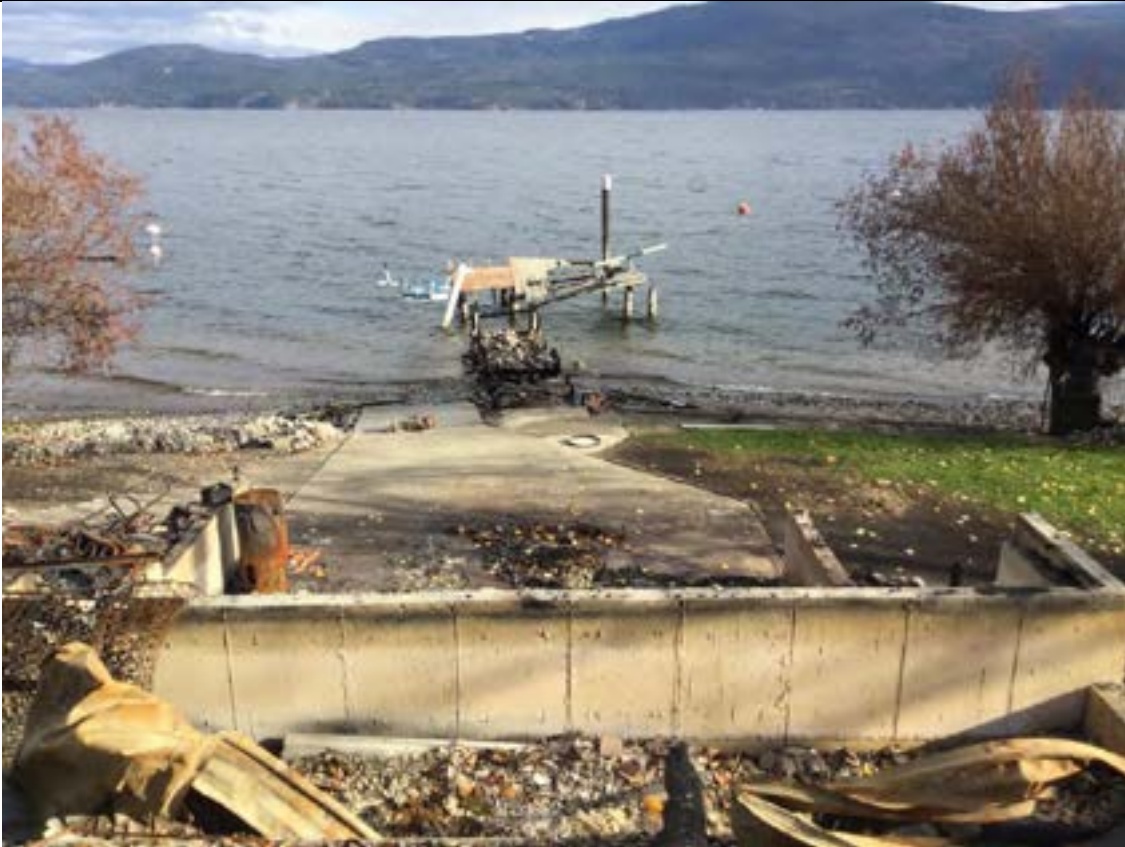
Photo 1: View towards lake at 2 Nerie Rd.

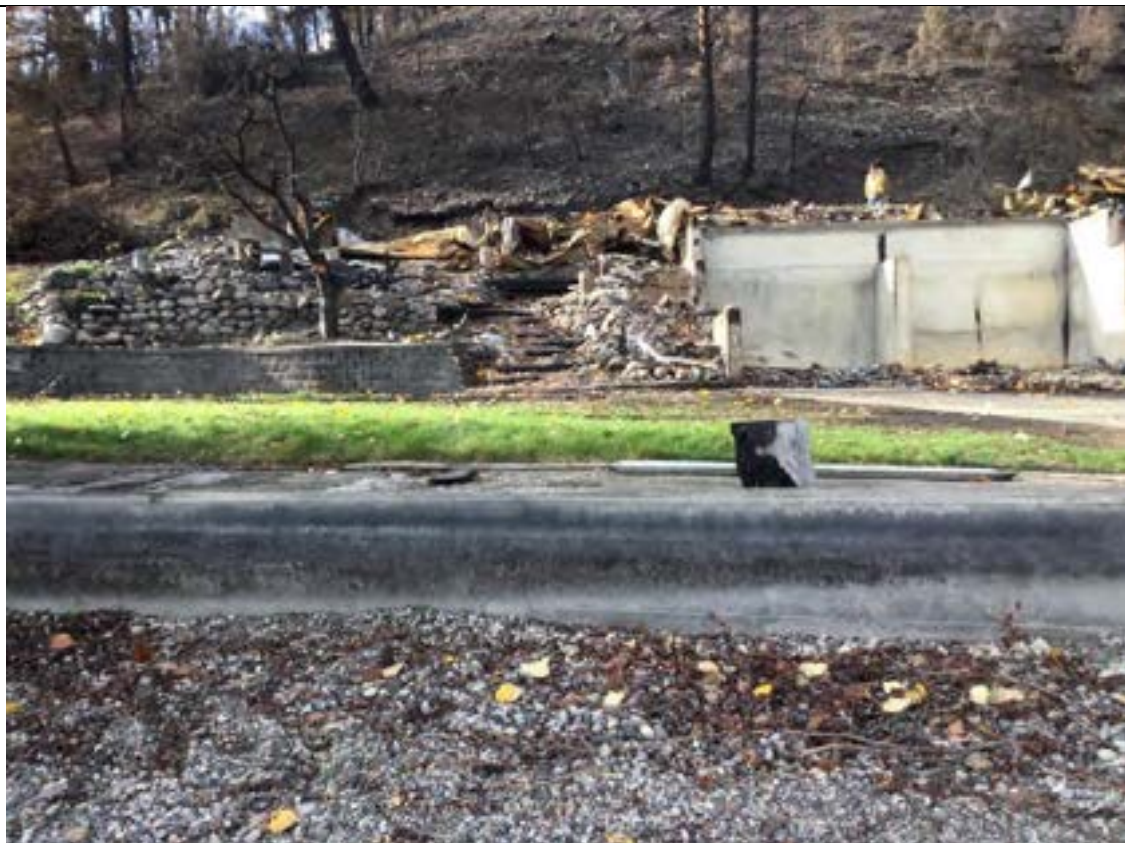
Wildfire Effects Upslope/Upstream:	Severely burned, no vegetation or surface organics, steep slopes, 1-1.5m high lock block wall in poor condition. Cutslope ~2 m high above lot.

Hazards Noted:	Potential for upslope soil erosion and shallow soil slump/landslide. Destabilized retaining walls.		
Spatial Likelihood:	Potential sediment delivery to lower slopes, moderate potential for sediment delivery to Okanagan Lake.		
Hazard Level: MODERATE	Spatial Likelihood: MODERATE	Risk Level: MODERATE

Photo 2: View of foreshore area at 2 Nerie Rd. with concrete retaining wall.

Recommended Recovery Response and Considerations for Future Development:	Short term: Be prepared for higher than usual runoff and associated soil erosion from slopes above.		
	Long term: Consider soils/geotechnical assessment for burned slopes. (planting completed in late fall 2021)

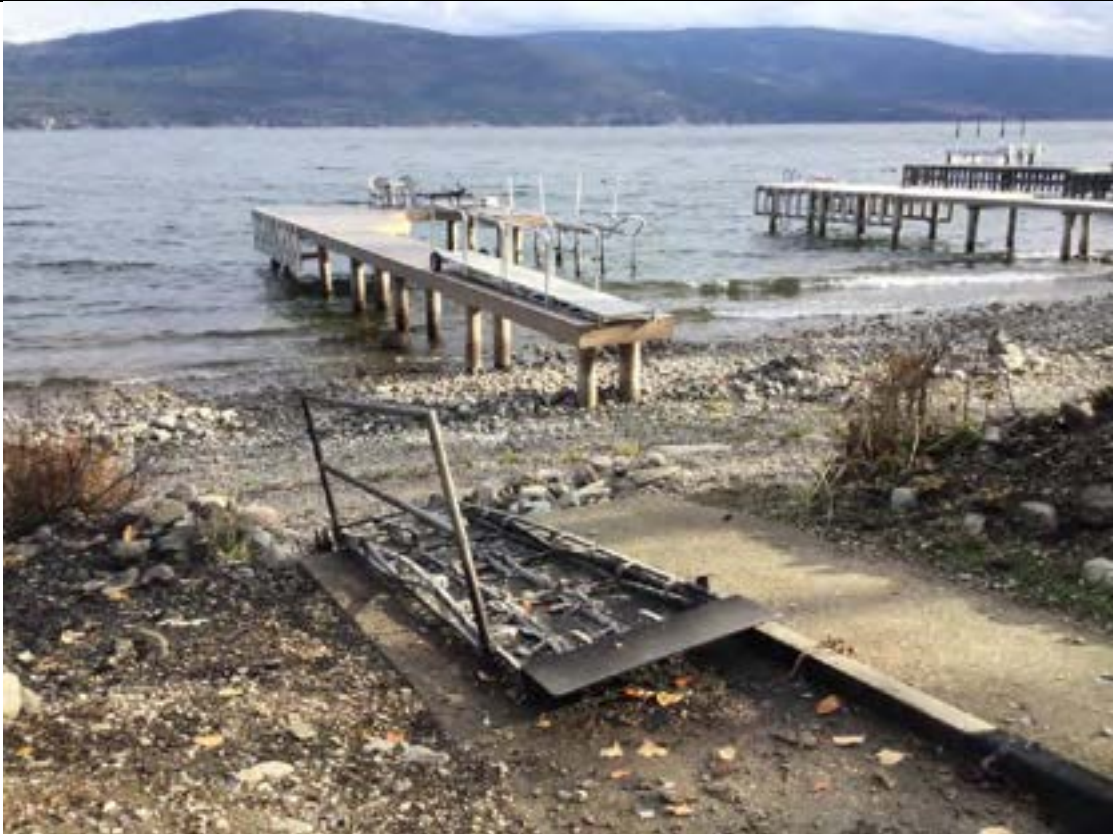
Photo 1: View of foreshore area at 7 Nerie Rd.

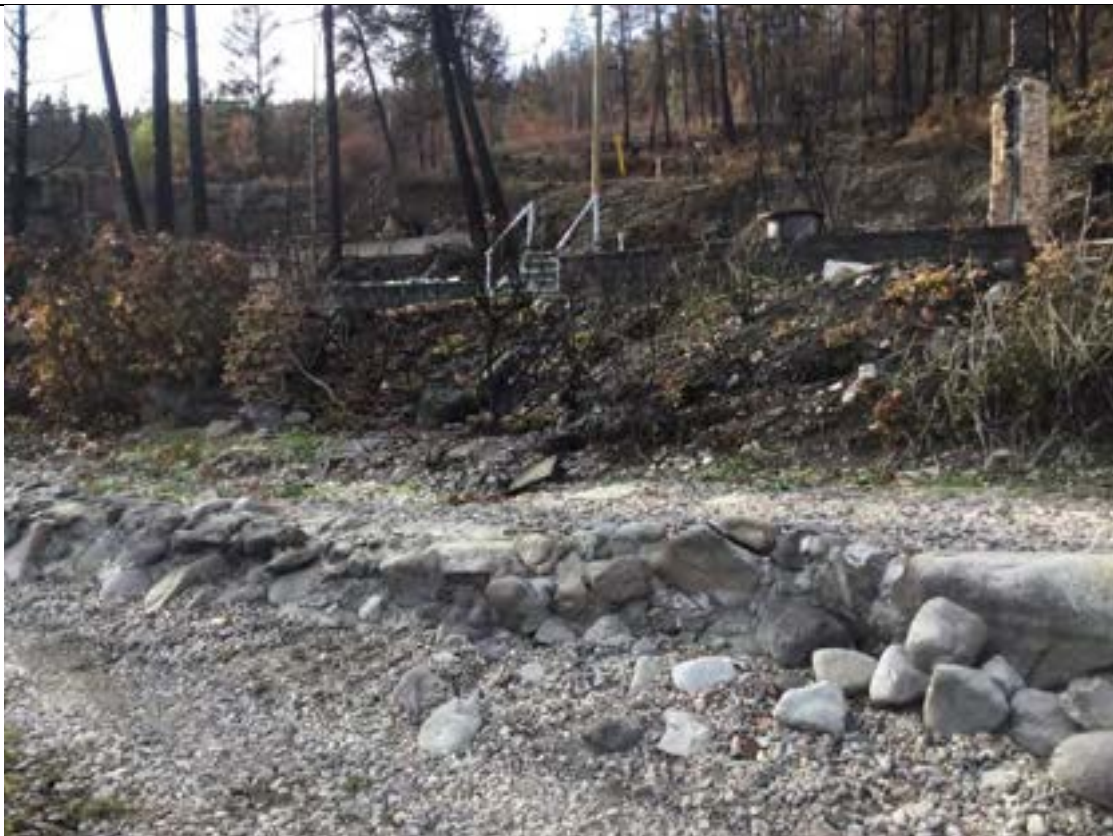
Photo 2: View from foreshore area at 7 Nerie Rd. with low mortared rock wall.

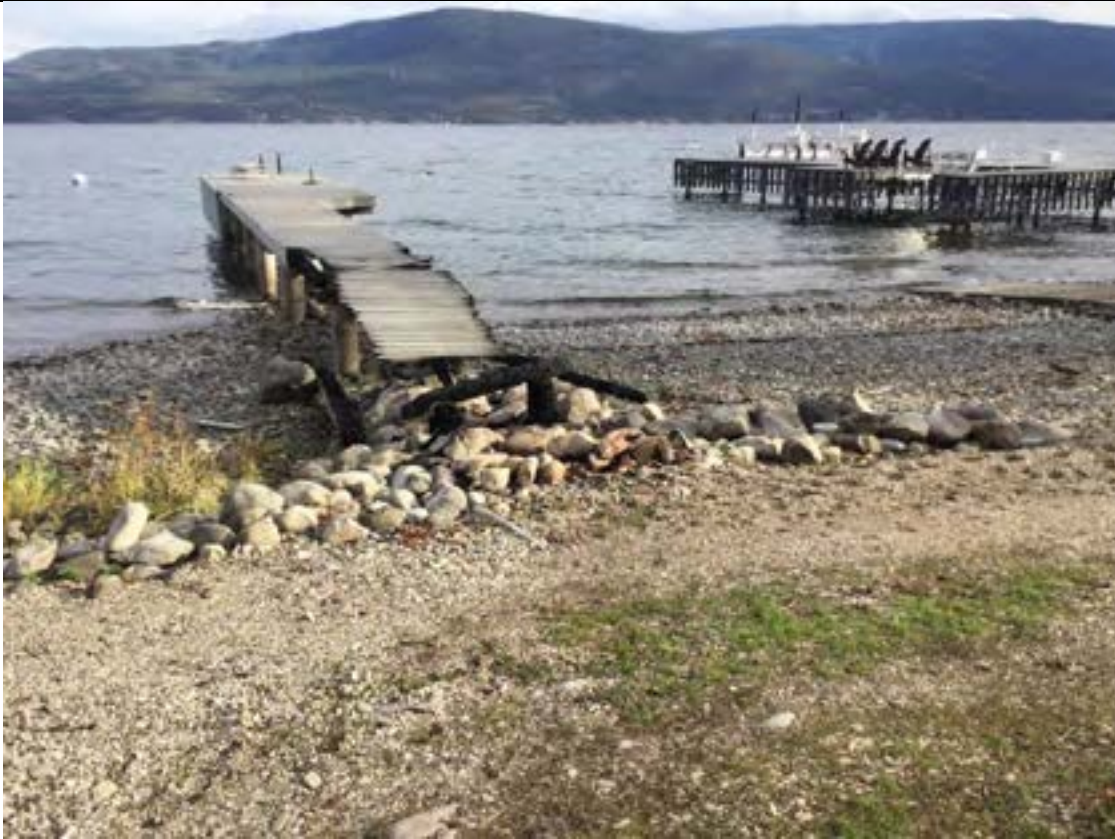
Photo 1: View of foreshore area at 11 Nerie Rd.

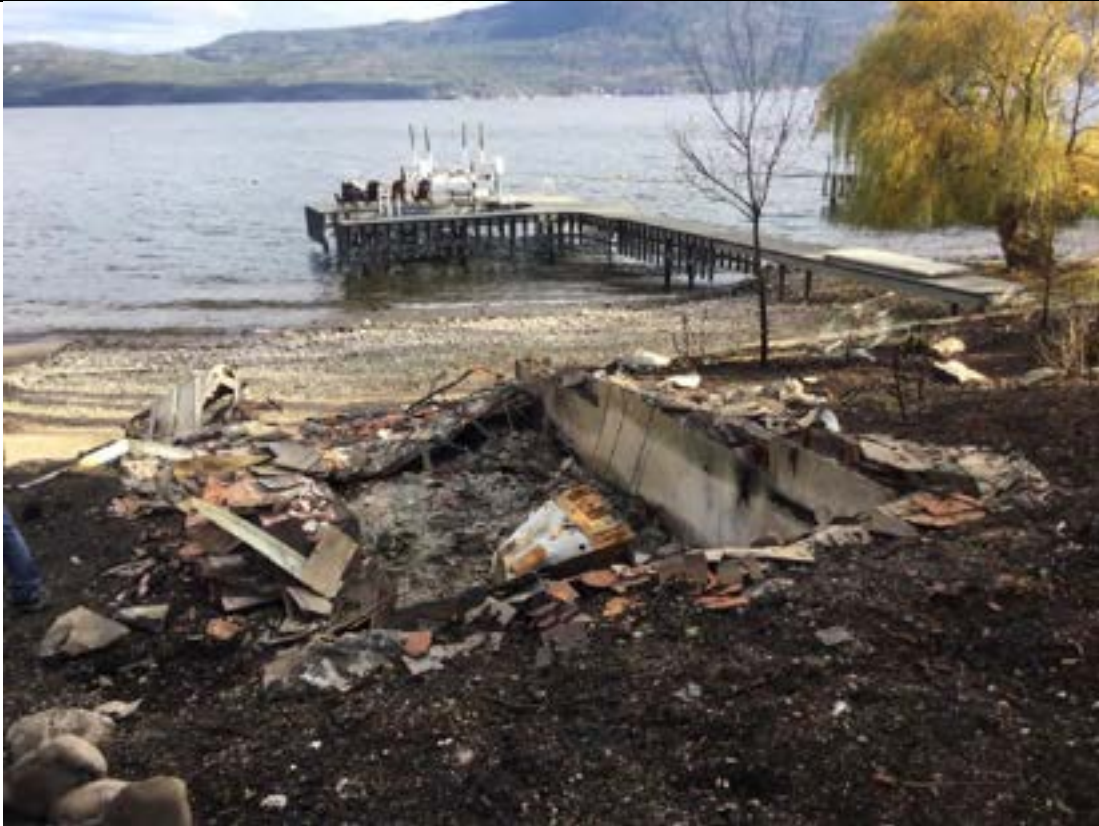
Photo 1: View of foreshore area at 13 Nerie Rd.

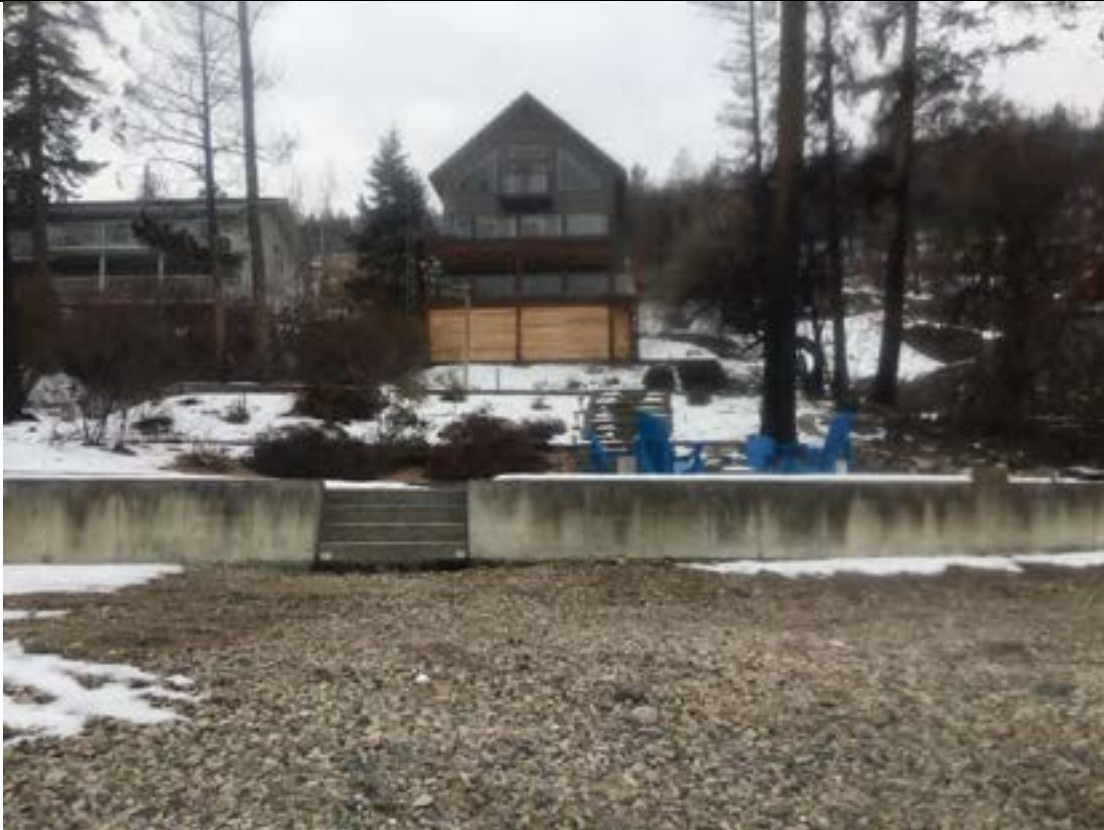
Photo 1: View upslope from foreshore area at 17 Nerie Rd.

Recommended Recovery Response and Considerations for Future Development:	Short term: Be prepared for higher than usual runoff and associated soil erosion from slopes above.	
	Long term: Consider riparian vegetation restoration to improve foreshore condition.

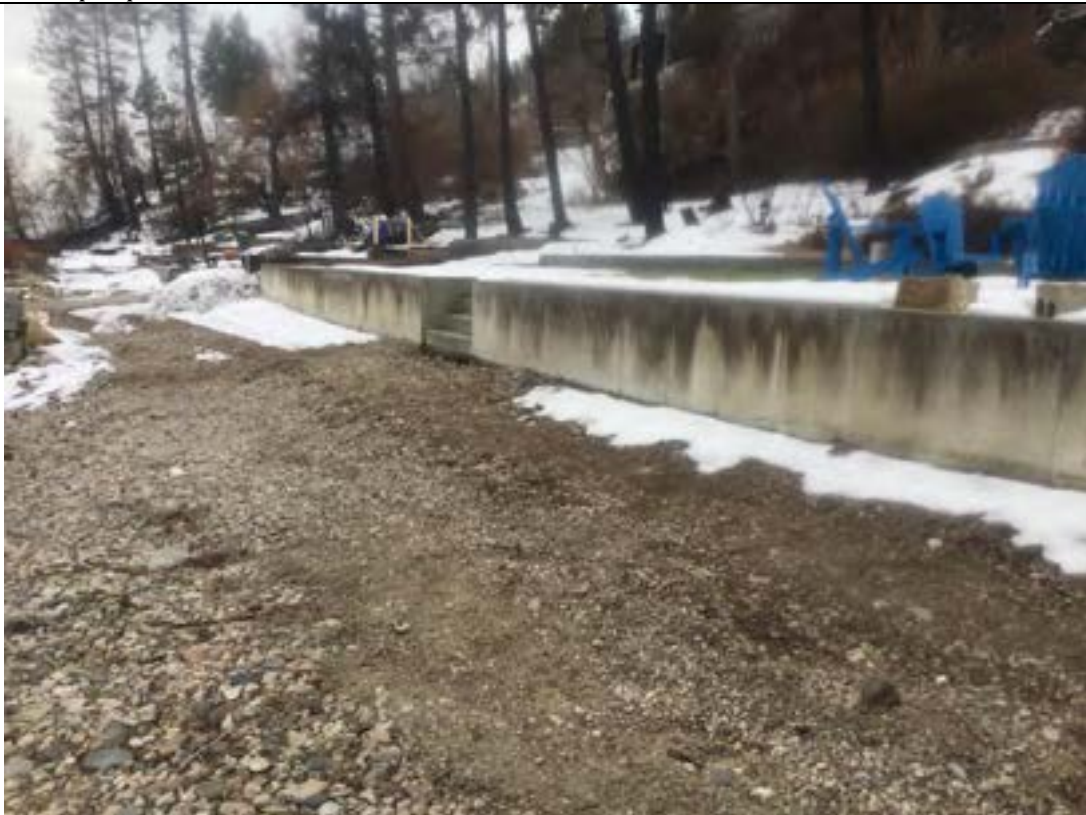
Photo 2: View of retaining wall along foreshore area at 17 Nerie Rd.

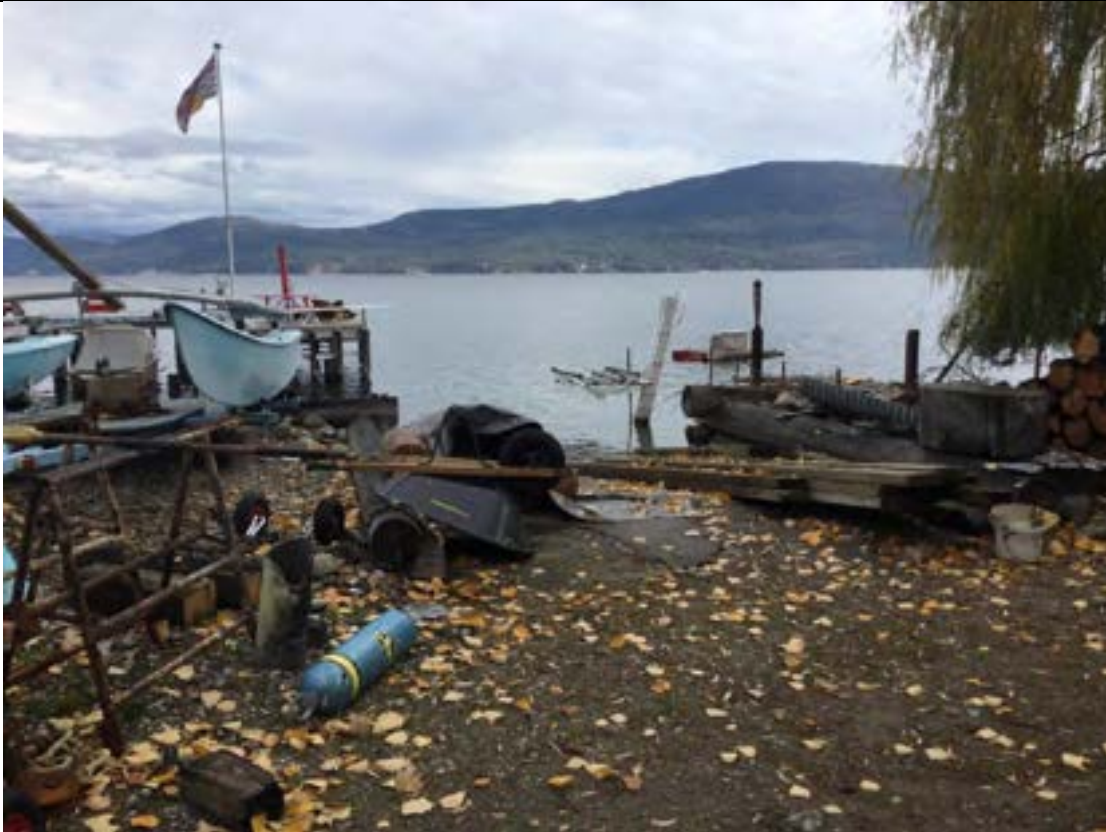
Photo 1: View of foreshore area at 23 Nerie Rd.

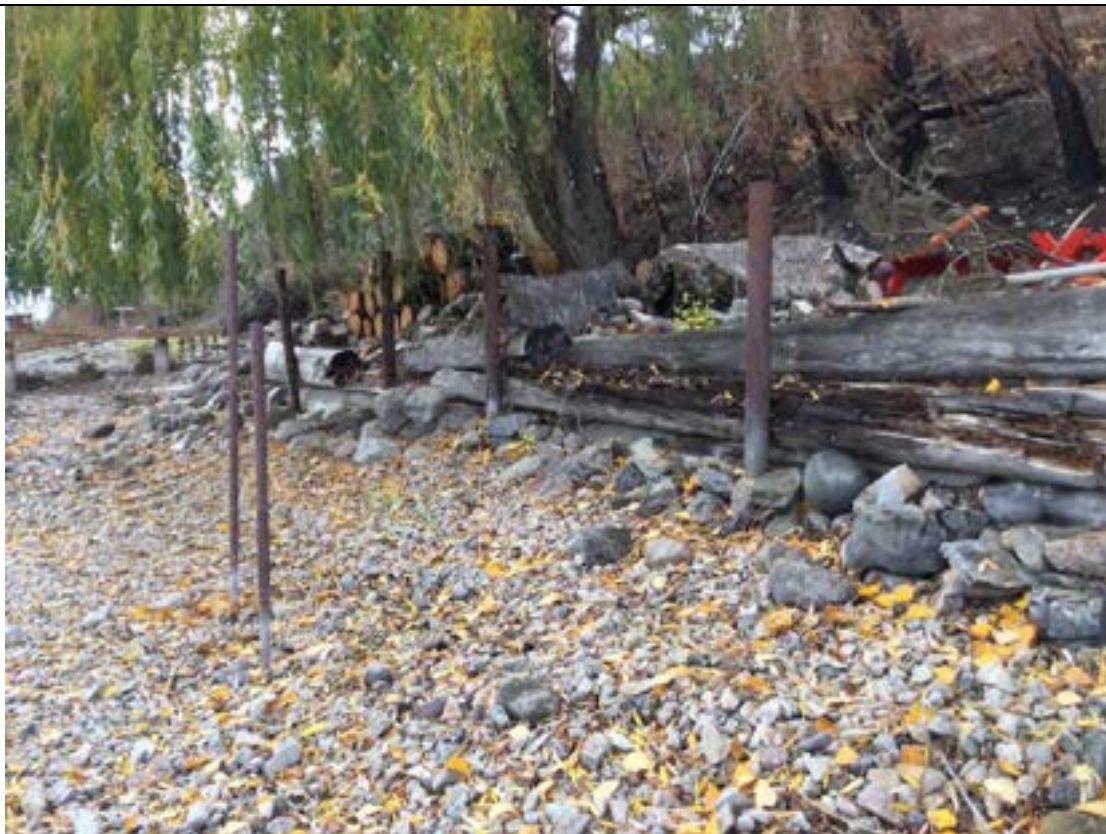
Photo 2: View of log retaining wall along foreshore at 23 Nerie Rd.

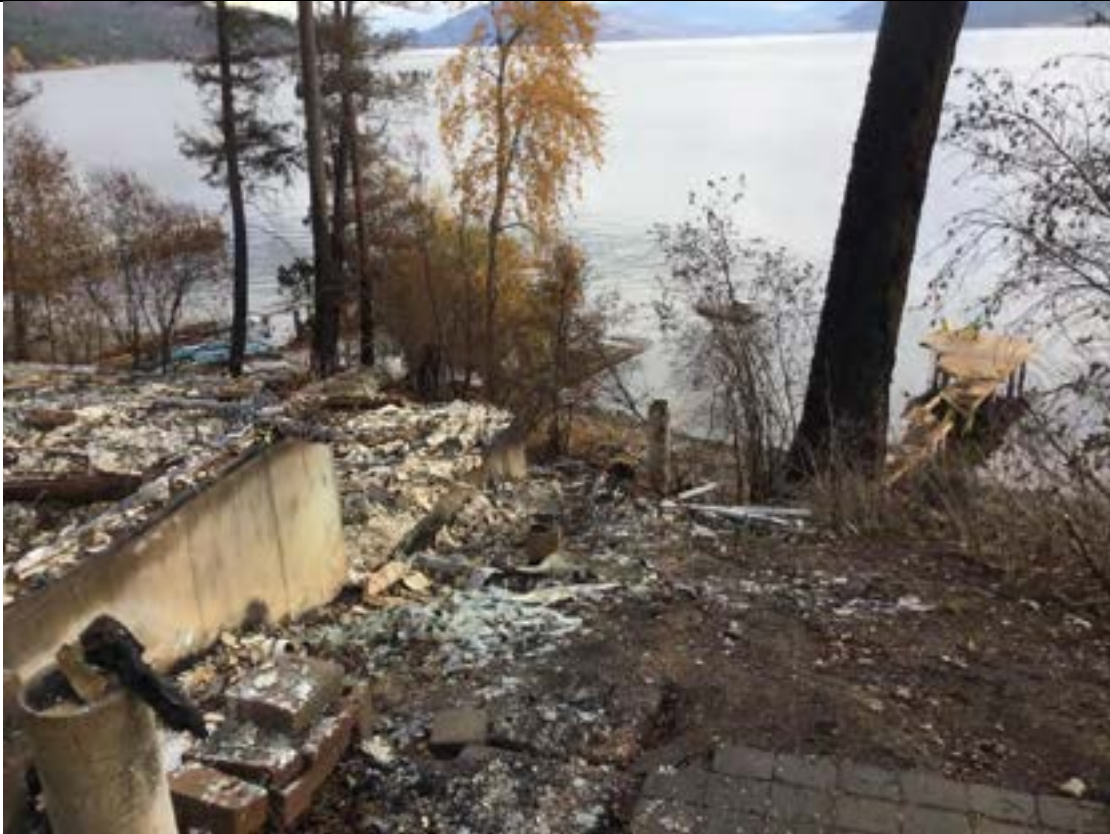
Hazards Noted:	Mineral soils are exposed and subject to erosion and shallow destabilization.	
Spatial Likelihood:	Potential sediment delivery to lower property, moderate potential for sediment delivery to Okanagan Lake.	
Hazard Level: HIGH	Spatial Likelihood: MODERATE	Risk Level: HIGH

Photo 1: View downslope towards lake at 25 Nerie Rd

Recommended Recovery Response and Considerations for Future Development:	Short term: Be prepared for higher than usual runoff and groundwater seepage.	
	Long term: Sediment and erosion control measures are recommended. Measures to manage onsite drainage may be needed. Consider geotechnical assessment for future development.

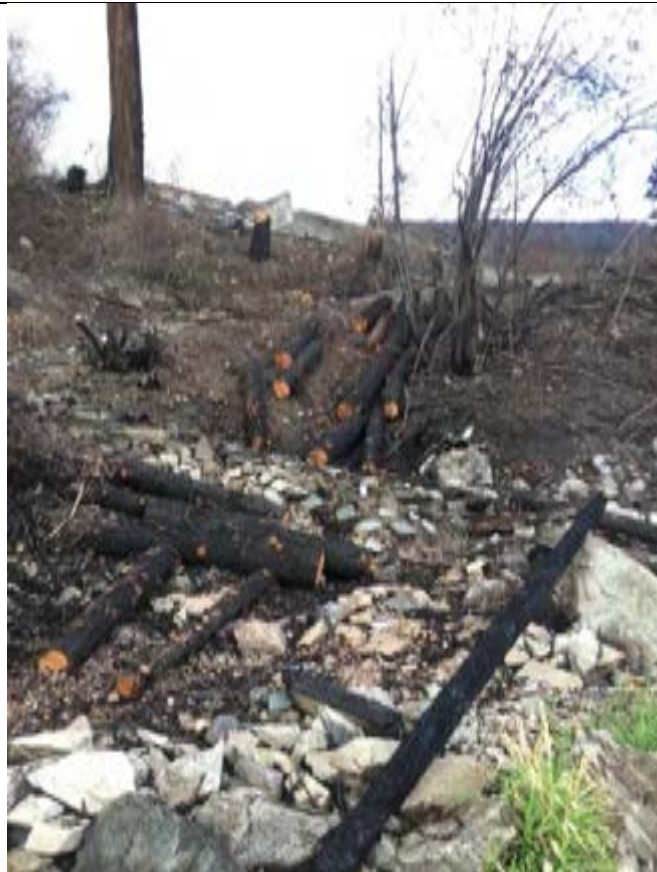
Photo 2: View upslope from toe of slope at foreshore at 25 Nerie Rd.

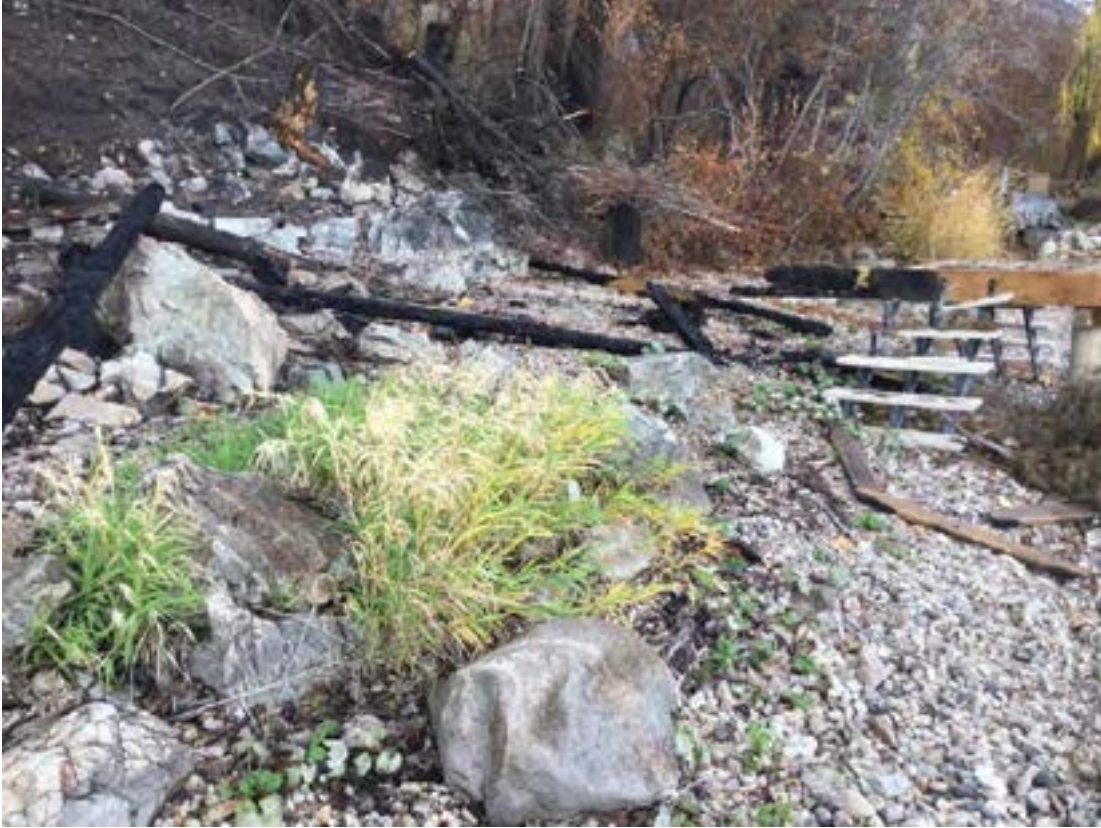
Foreshore Conditions:	Relatively natural shoreline, cobble gravel and rock, wood dock on wood piles is badly damaged		
Setback Distance & Elevation from HWM* or Top of Bank (SHIM):	Est. >15 m setback from lake to residence; est. >1.5m elevation. Setback from piped stream to be confirmed.		
Wildfire Effects Upslope/Upstream:	Terraced developed residential area, short slopes and terraced lots, scattered partial burn areas immediately upslope.

Photo 3: View of foreshore area at 25 Nerie Rd.
