CLARKE GEOSCIENCE LTD.

POST-WILDFIRE ENVIRONMENTAL AND HAZARDOUS CONDITIONS ASSESSMENT OF THE NORTH WESTSIDE ROAD AREA

Dated:	February 23, 2022
Presented To:	Regional District of Central Okanagan
Attention:	Brittany Nichols, Environmental Planner
CGL Project # 21-0115	EOC #A21-674
Document Control:	Version Rev. 1 (corrected civic and legal property addresses for 3 properties)

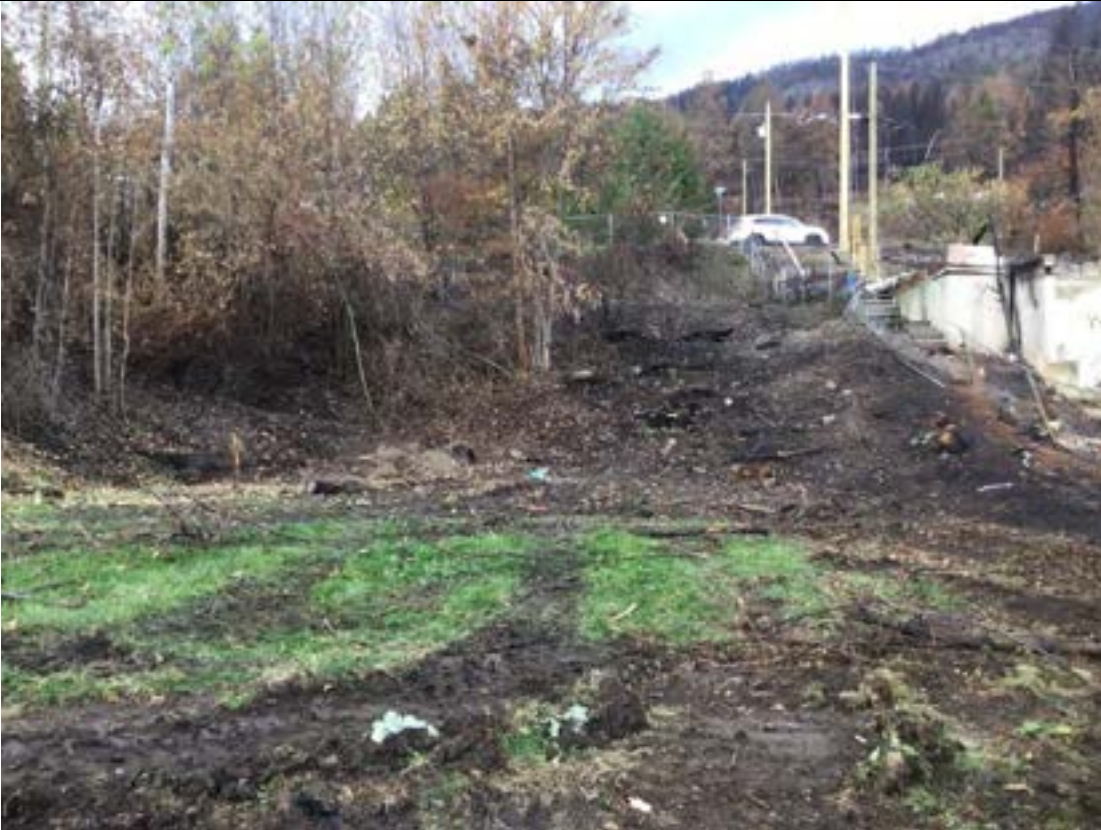
Photo 4: View upslope from upper part of lot towards Nerie Rd at 25 Nerie Rd.

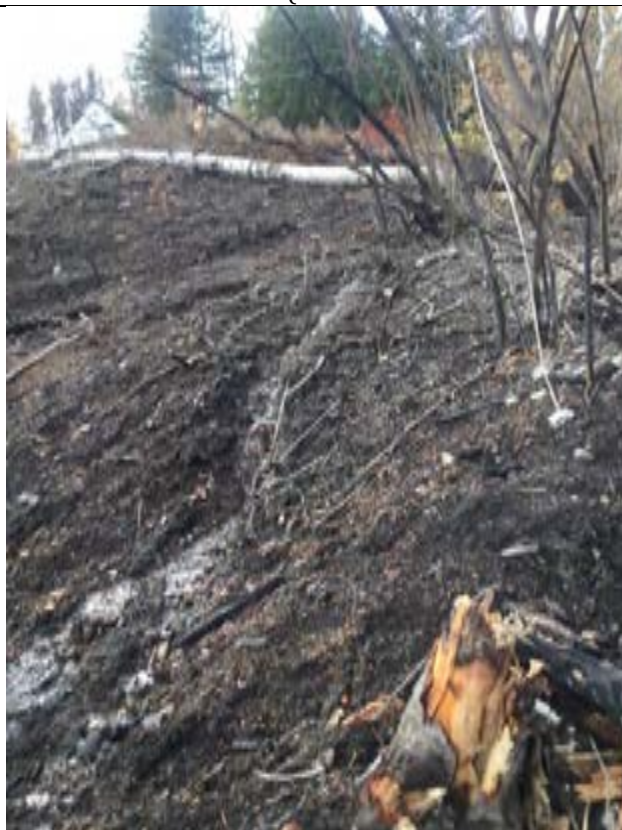
Photo 2: View of overland flow along upper part of 31 Nerie Rd.

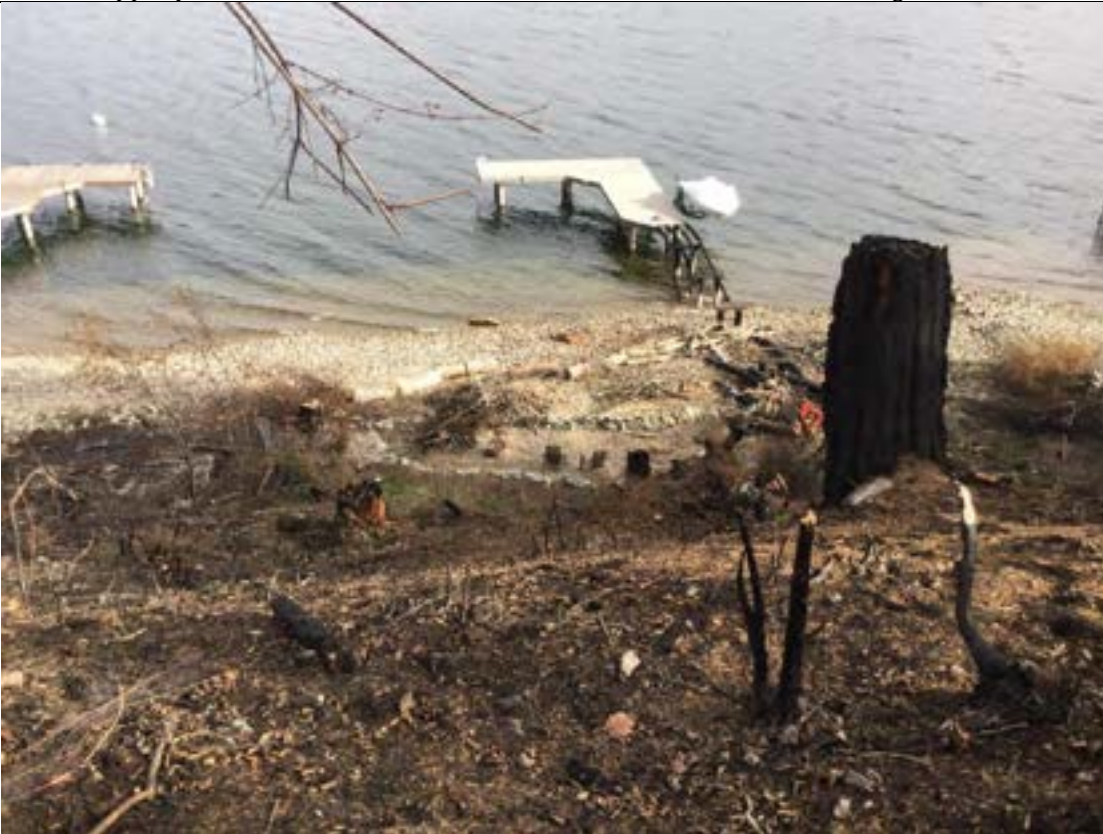
Photo 2: View of foreshore area at 37 Nerie Rd.

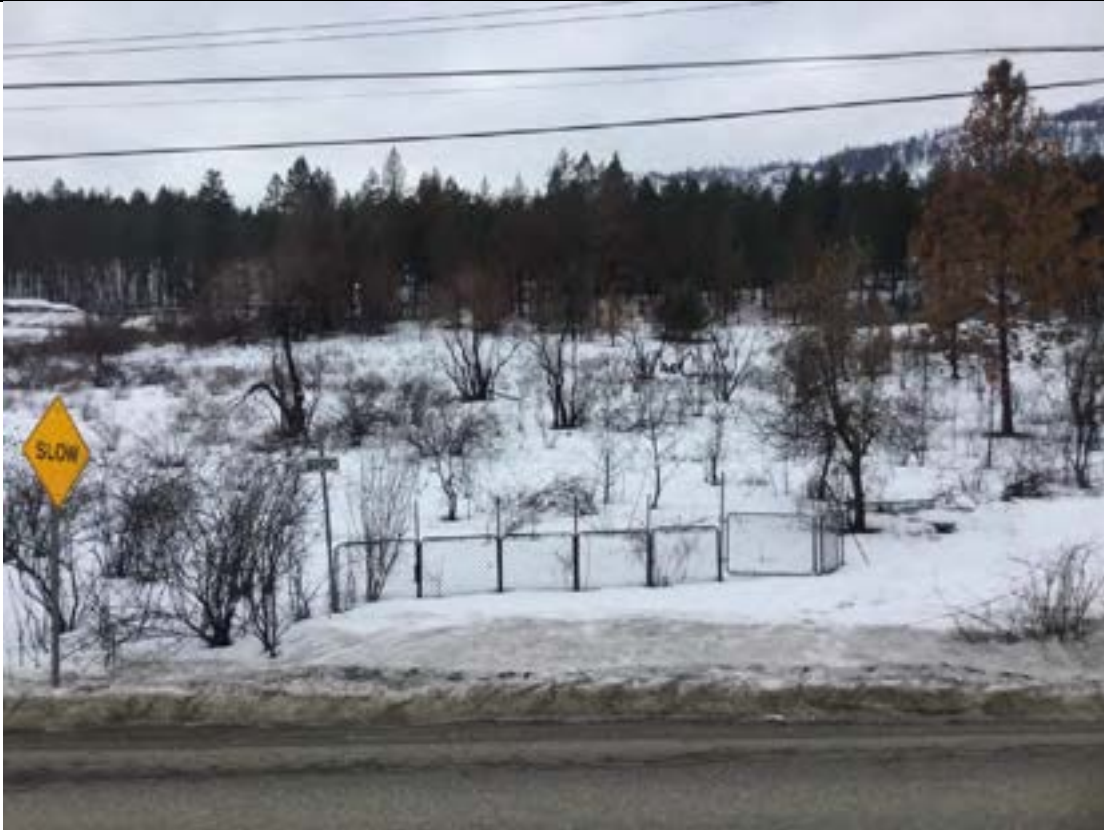
Photo 1: View upslope to 8700 N Westside Rd

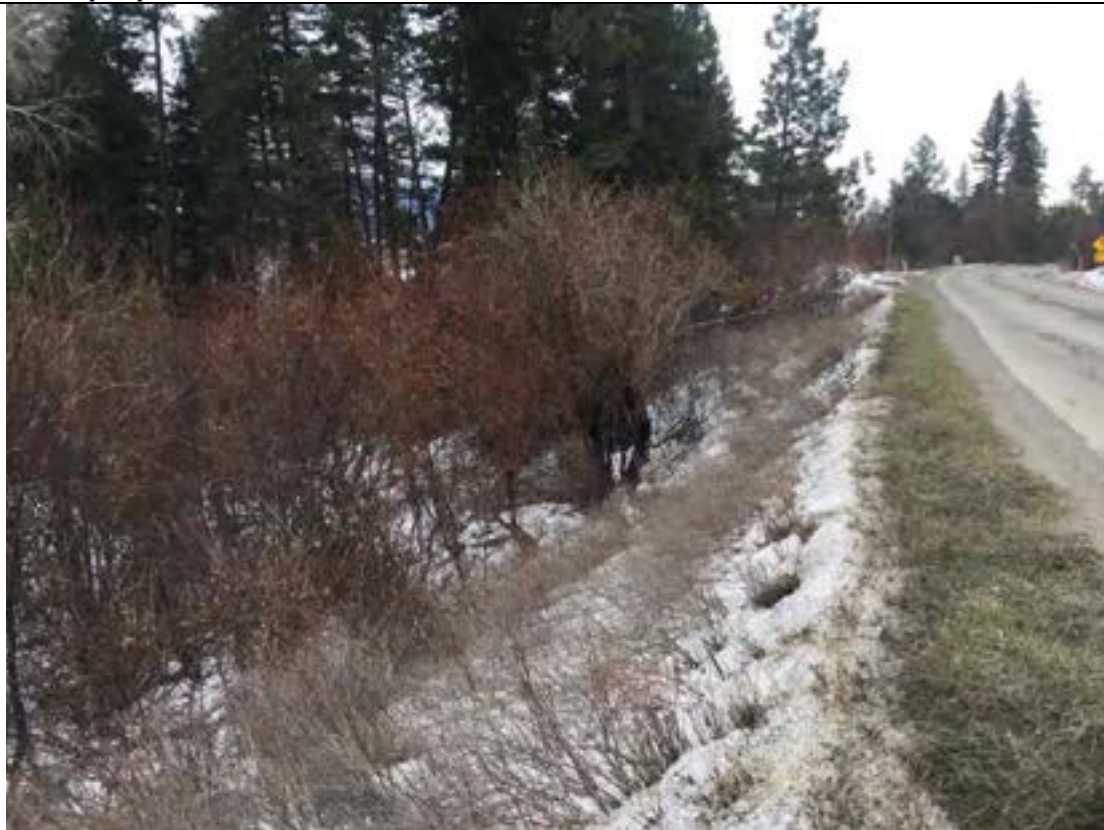
Photo 2: View of downslope side of road across from 8700 N Westside Rd at culvert crossing

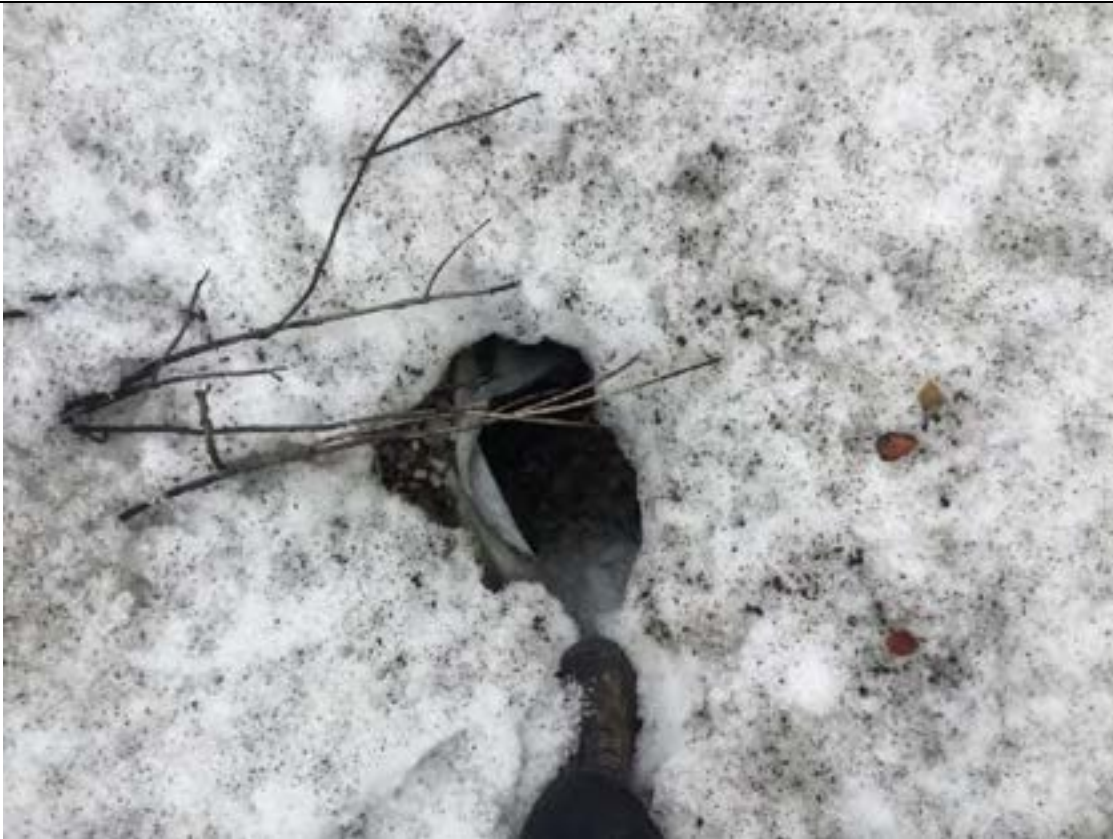
Photo 3: Partly obscured inlet of ~400 mm culvert at 8700 N Westside Rd.

Recommended Recovery Response and Considerations for Future Development:	Short term: Be prepared for higher than usual runoff from slopes above. Ensure clear passage through Westside Road culvert.

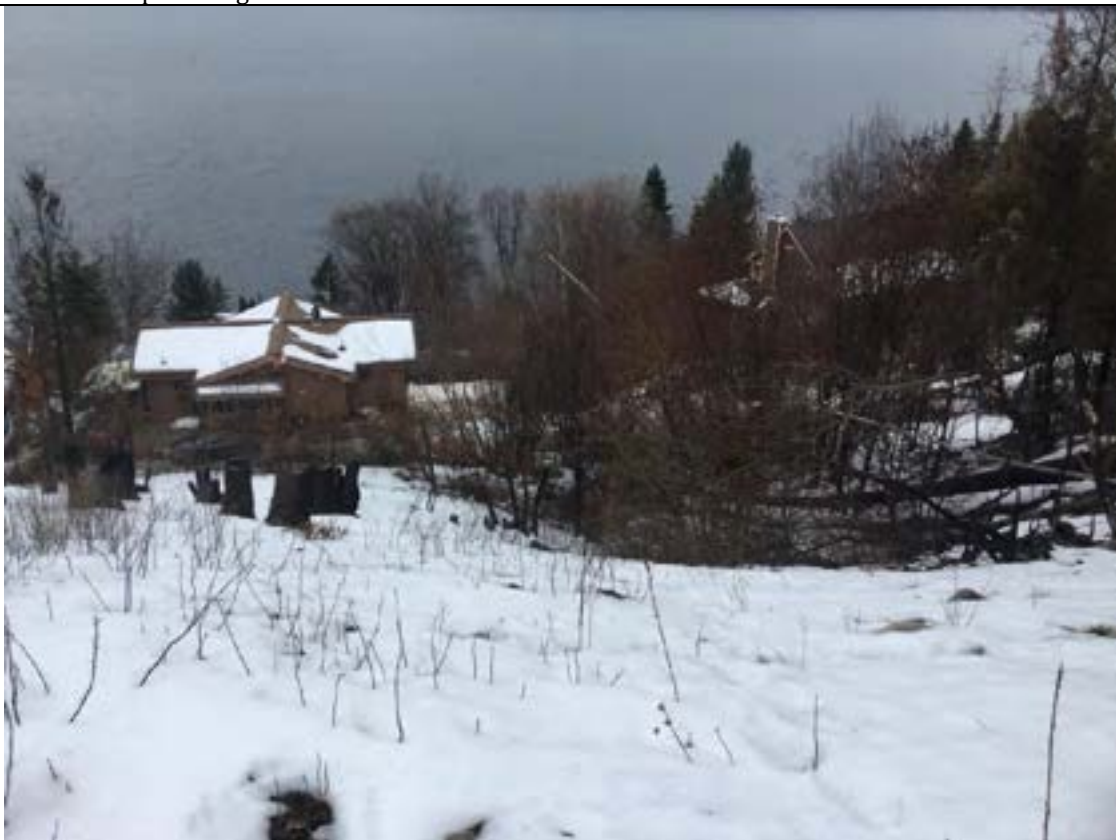
Photo 2: View downslope towards Okanagan Lake from 8715 N Westside Rd.

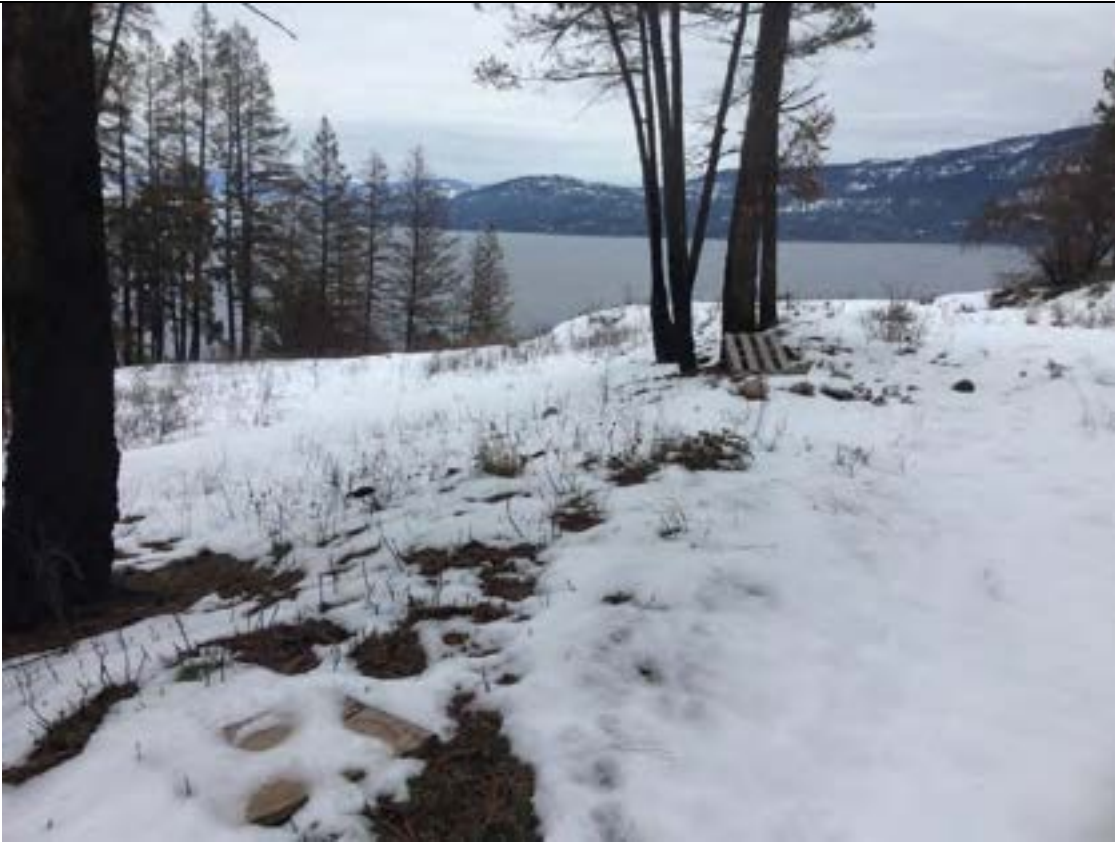
Photo 3: View of level area at top of 8715 N Westside Rd.

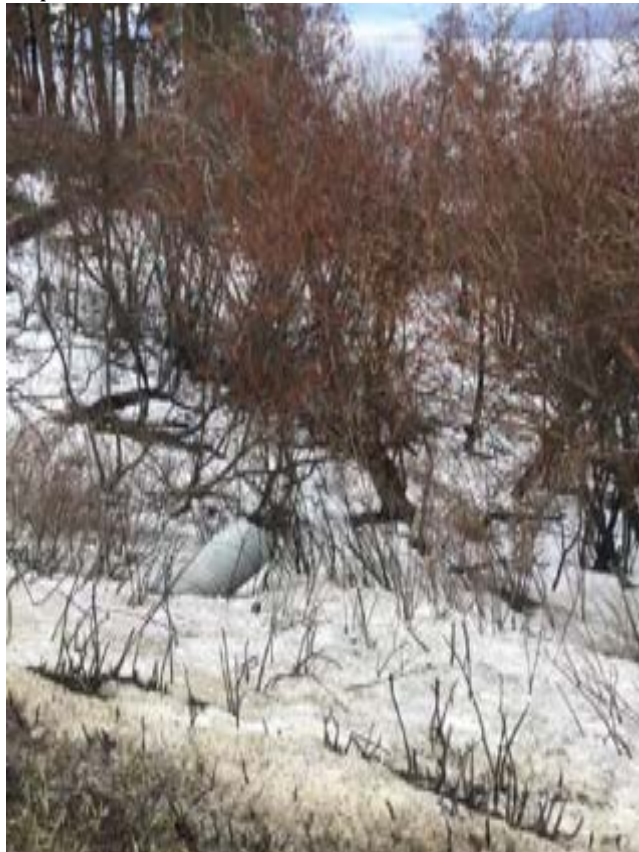
Photo 4: View of culvert outlet on Westside Road, draining into gully south of 8715 N Westside Rd.
